# Special Forces Camps in Vietnam 1961–70

Gordon L Rottman • Illustrated by Chris Taylor

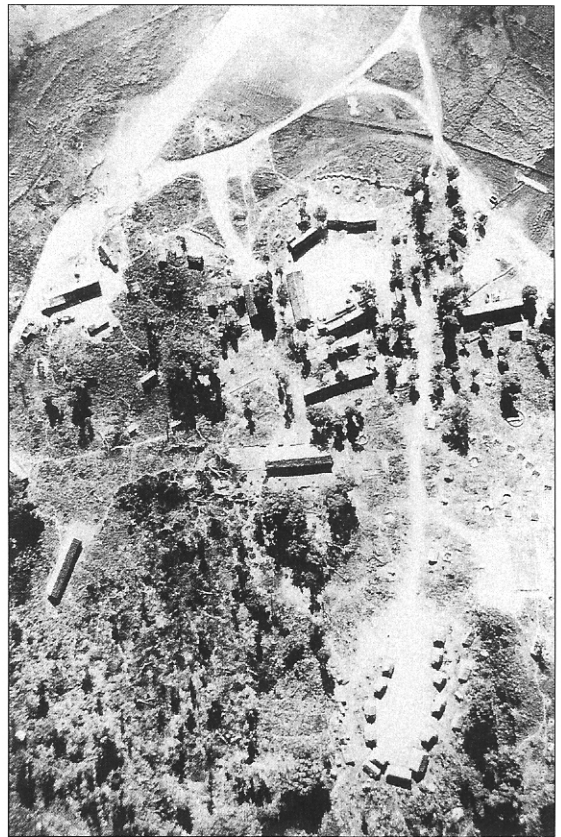
RIGHT Thien Ngon, A-323, III CTZ, opened February 1968. This was in the shape of a five-pointed star with broad arms (part of which are cut off) surrounding a large five-sided inner perimeter. The outer perimeter is a high earth berm lined with covered fighting positions and backed by CIDG and dependents' quarters. A circular road surrounds the inner perimeter, with a wire barrier on both sides. The 105mm howitzer platoon position is in the lower right arm. Camp Prek Klok, A-322, was of similar construction.

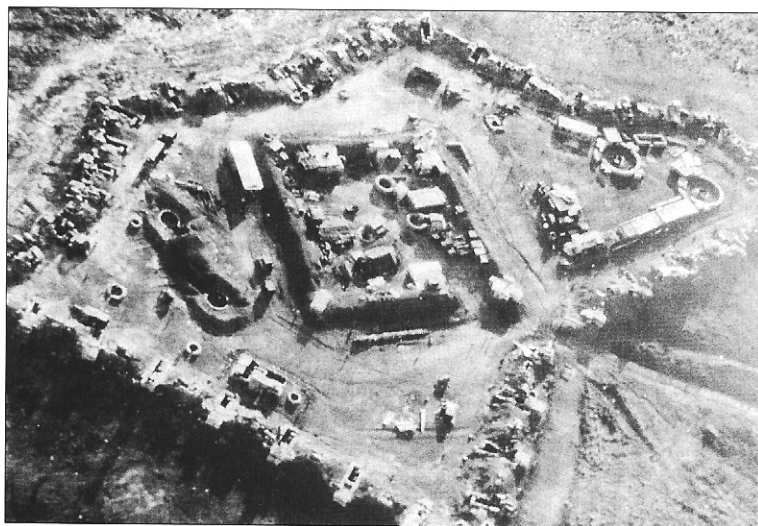
Camp Tong La Chon, A-334, III CTZ, opened March 1967. Most of the later camps were larger, but Tong La Chon was small and cramped. It was later enlarged. When attacked and almost overrun five months after its opening, conditions were so poor only 50 assigned CIDG remained (others had quit). It had to be defended by a company rotated from another camp plus almost 600 MIKE Force. The earth berm outer perimeter is defended by almost 40 fighting and living bunkers, each with its own well-revetted entry trench. Two 105mm howitzers are positioned in the right arm; two 81mm mortars are in the inner perimeter and two in the left arm.

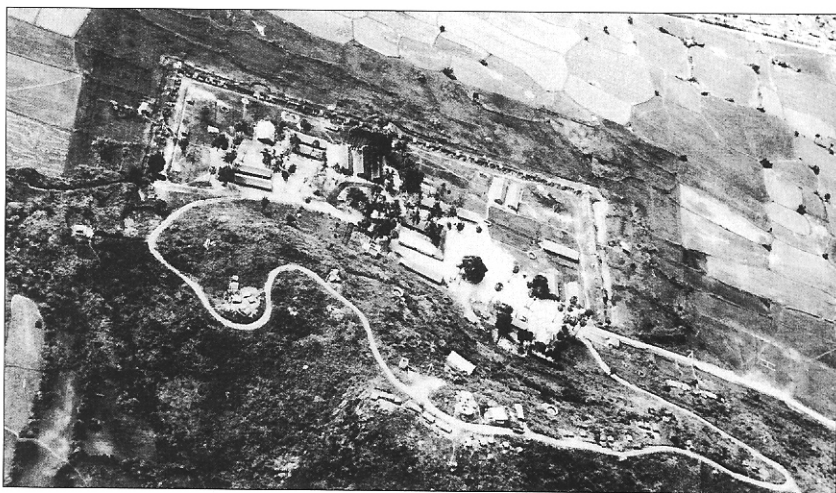
Camp Dan Thanh, A-423, IV CTZ, opened April 1964. This rectangular camp was built at the base of Ap An Nong Hill (115ft above sea level), which was incorporated into the camp. There is both an inner perimeter in the lower camp and a stronghold atop the hill. The outer perimeter is an earth berm with individual fighting positions.

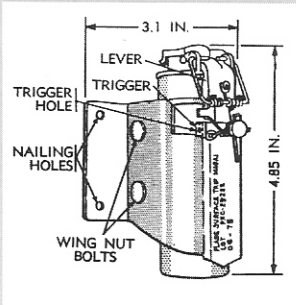
#### M49A1 Trip Flare

The olive drab-painted M49A1 trip flare was 1½ in. in diameter, almost 5 in. long, and weighed 15 oz. They were attached to barbed wire pickets or stakes by a mounting bracket, or simply wired to a stake without the bracket, several inches above the ground within barrier wire entanglements and rigged to be activated by a tripwire up to 40 ft in length. When activated the magnesium flare ignited immediately, burning for 55–70 seconds (60 seconds on average) at 50,000 candlepower at 4,200 °F and illuminating an area up to 985 ft in radius.

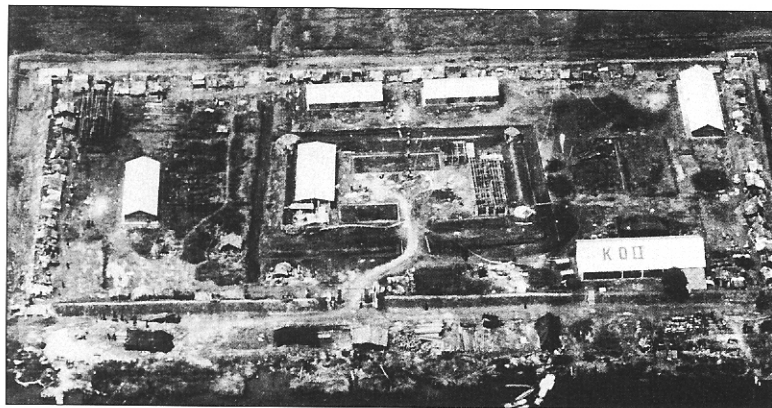
Kinh Quan II, A-412, IV CTZ, opened October 1965. KQ II is still under construction in this photo. The outer berm is lined with temporary fighting and living bunkers, but with few on the river side. Buildings inside the inner perimeter are still under construction. The inner perimeter is unique in that it possesses a moat. It appears the camp was built over an existing fortification.

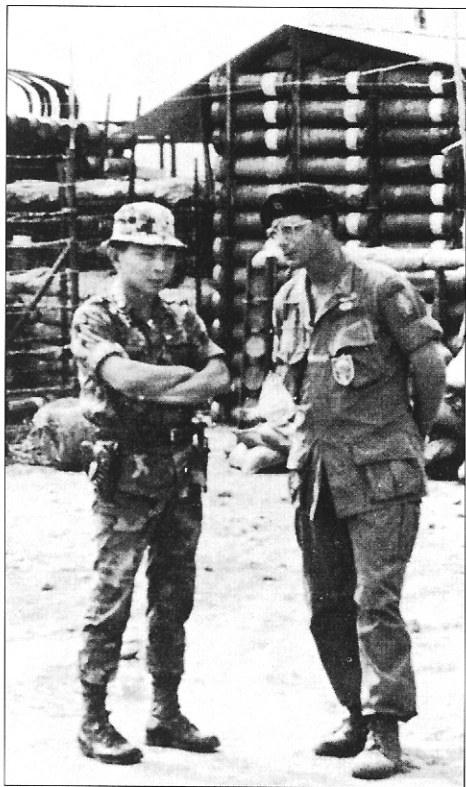
**ABOVE LEFT** The wood-frame building is protected from mortar fragments and sniper fire by soil-filled steel 8in. howitzer propellant charge tubes.

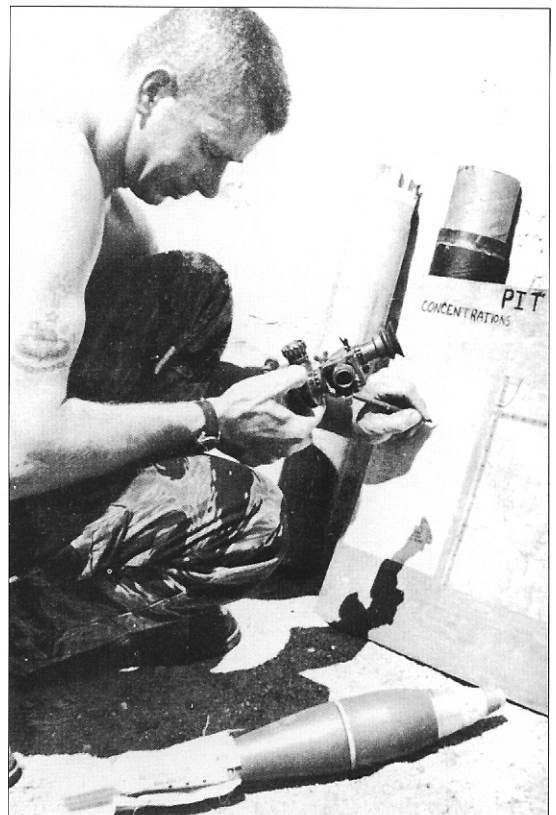
ABOVE RIGHT A USSF weapons NCO plots DEFCON sight elevation data on a mortar pit's firing data board. On the ground is an 81mm M374 HE round. Most of the charge bags on the fins will be removed because of the DEFCON's short range.

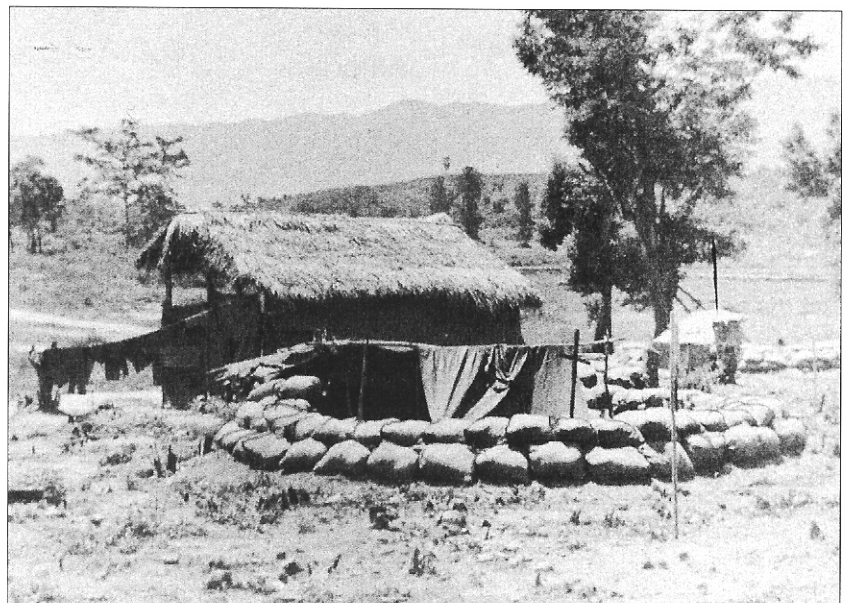
RIGHT This is an example of a very early camp's 81mm mortar pit: merely a pit dug in the ground with a low sandbag parapet. The hooch behind it is constructed of thatch and bamboo rattan; typical local materials.

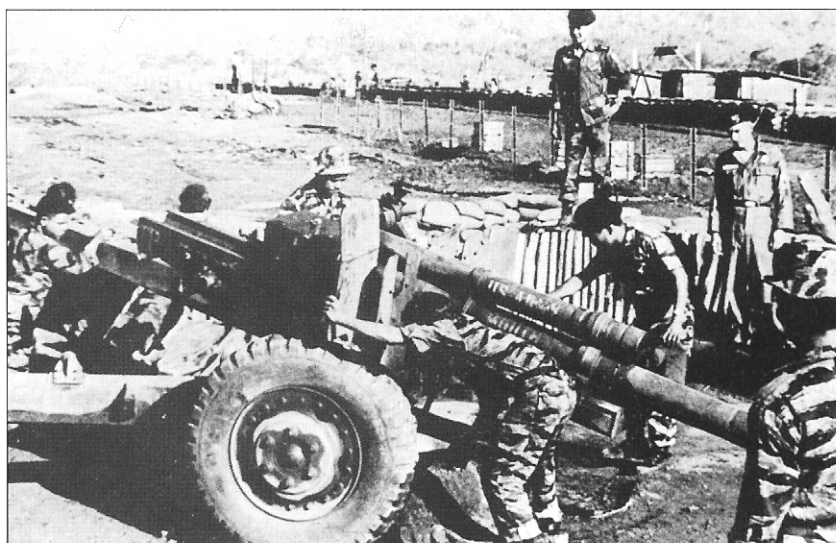
Strikers wheel a 105mm M101A1 howitzer into a newly completed firing position revetted by vertical stakes and sandbags. One or two ammunition bunkers were attached to each “gun pit.”
