New Vanguard

# German Panzers 1914–18

Steven J Zaloga • Illustrated by Brian Delf

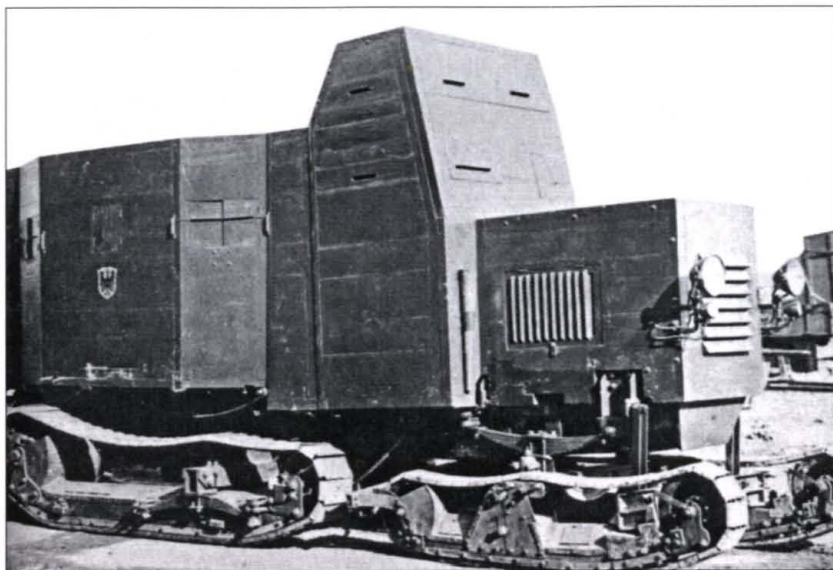
The first serious German effort to develop an armored fighting vehicle was an armored version of the tracked Bremer-Marienwagen. Even with only a mocked-up wooden superstructure, it proved to be hopeless in cross-country travel. (Patton Museum)

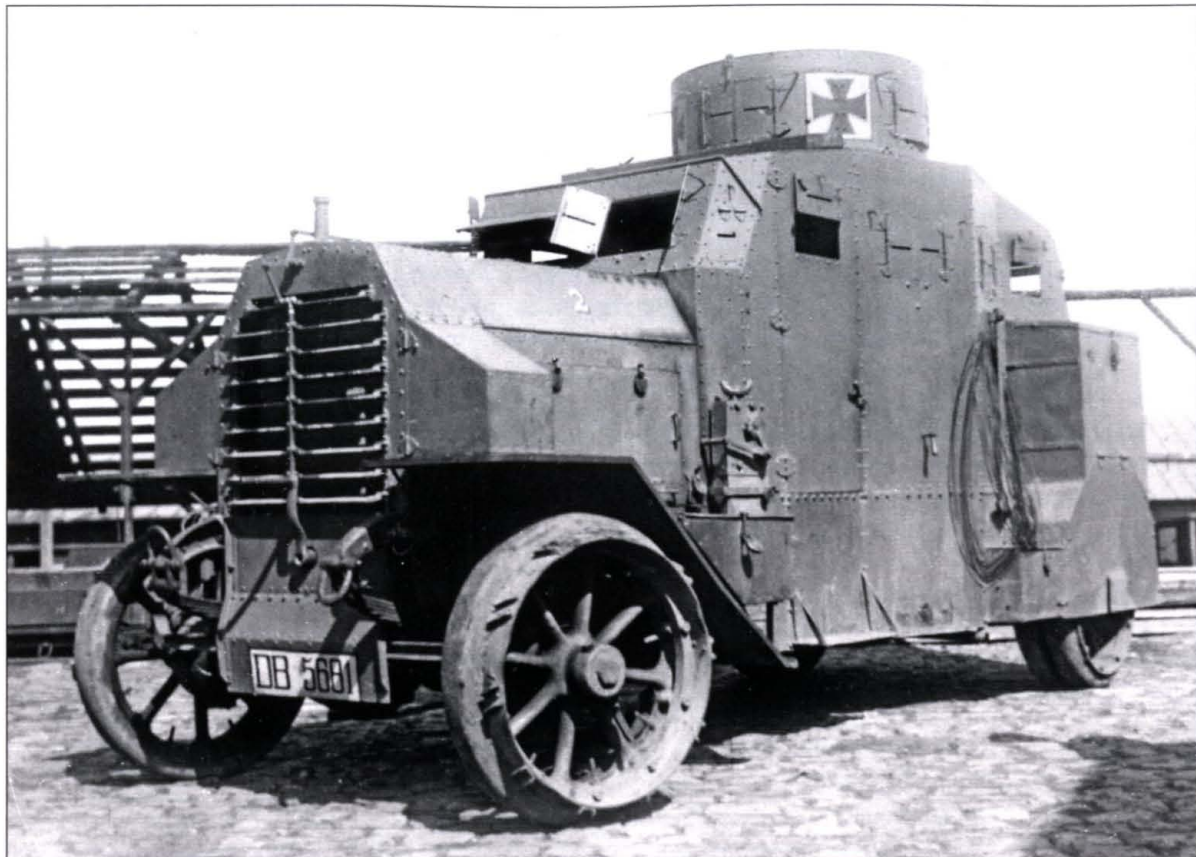
**The only type of German armored car to reach serial production was the Erhardt E-V/4 in 1917. Most of these saw service in 1918 in Russia on occupation duty, which is when this one is seen in Rostov. (NARA)**

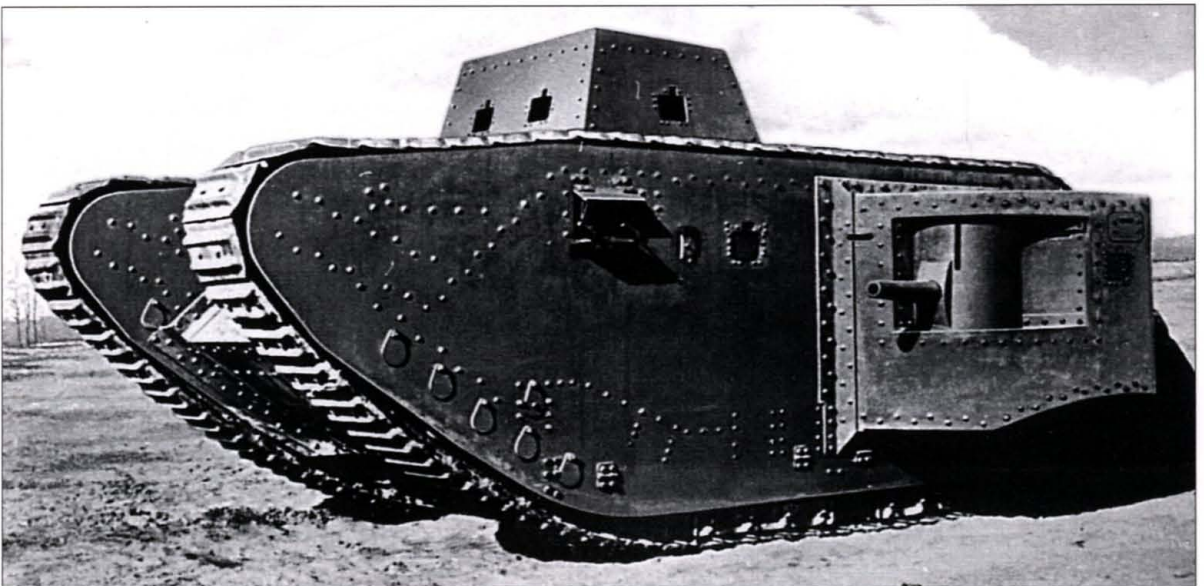
**A single A7V chassis was built in the A7V-U configuration, mimicking the British rhomboid tank. Its late completion and poor performance prevented any serial manufacture. (Patton Museum)**

Besides the pilot chassis 500 used as a driver trainer, at least ten other A7V chassis were assigned to other variants. The best known was 524, used as the basis for "Hedi," the A7V-U, which was completed in late June 1918 and used for trials. In April 1918, Chefkraft recommended a program to build 240 A7V-U's by 1919, but this did not take place due to its poor performance in trials. After testing, the A7V-U was assigned to the tank driving school of the Garde Kraftfahr battalions in Berlin and later dismantled. Three chassis were assigned to a project to develop an A7V-Flakpanzer for mobile anti-aircraft defense. This resembled the Gelandewagen but had two 76.2mm anti-aircraft guns on pedestal mounts on either side of the engine platform. Although photographs of these exist, little detail has survived about them. One of the more unusual applications for the A7V chassis was as a trench-digging machine – the A7V-Schützengrabenbagger. At least one was deployed in the field in late 1918. Two chassis were set aside for an A7V-Funkpanzer (radio-tank) based on a March 1918 order from the Signal Troops. Surviving drawings show a conventional A7V tank with multiple aerials and a "clothes-line" antenna circling the roof. The Graben-Funkstation 16 radio transmitter was tested for use on the A7V tank, but it is unclear if any radio-command tanks were ever built. One chassis was set aside for the Artillery Test Commission to examine its use as a heavy artillery tractor.

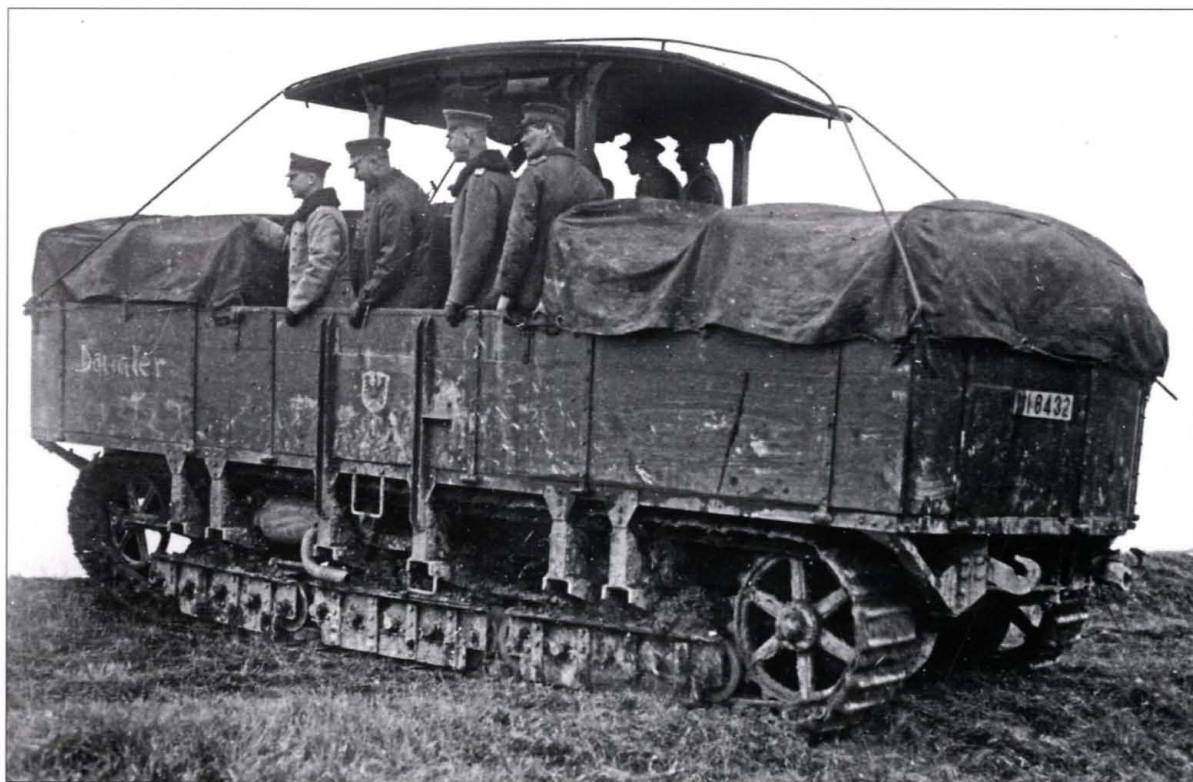
**The first version of the A7V to enter production was the Geländewagen prime mover, designed to bring critical supplies to the frontline troops across rough terrain. (NARA)**

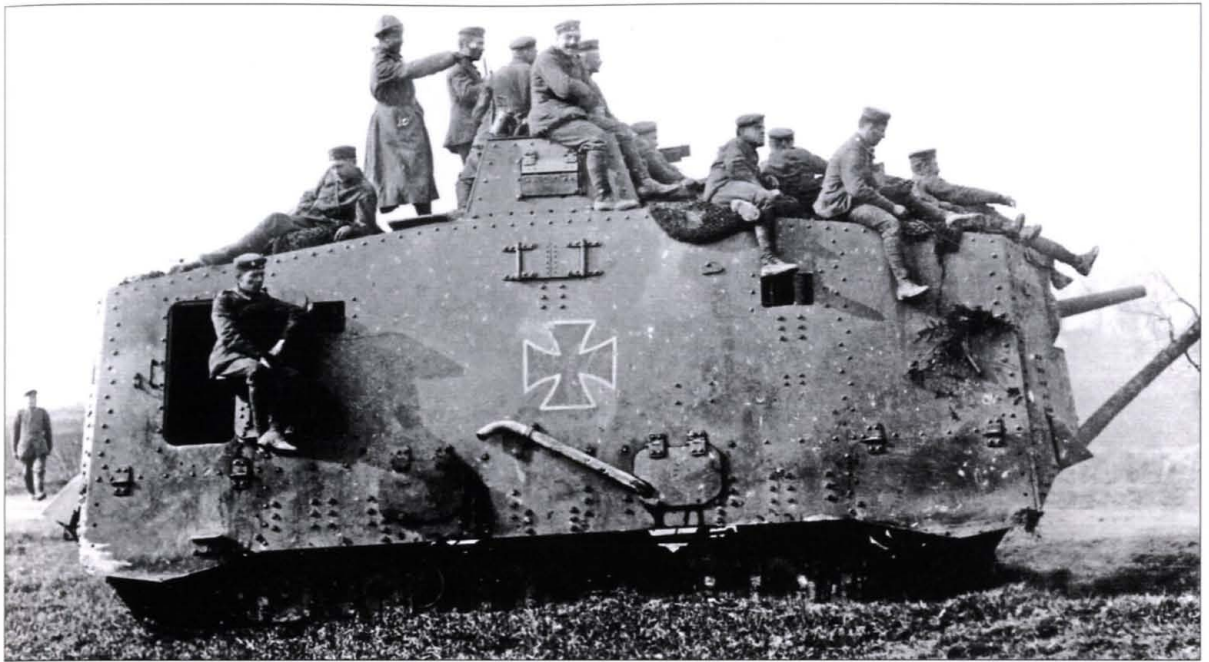
Panzer 525 "Siegfried" is seen in the summer of 1918 after the Villers-Brettonneux fighting. Close examination of the photo shows evidence of numerous machine-gun strikes on the side armor. The interior of the tank was extremely hot and noisy, so the crew rode outside when possible. (NARA)

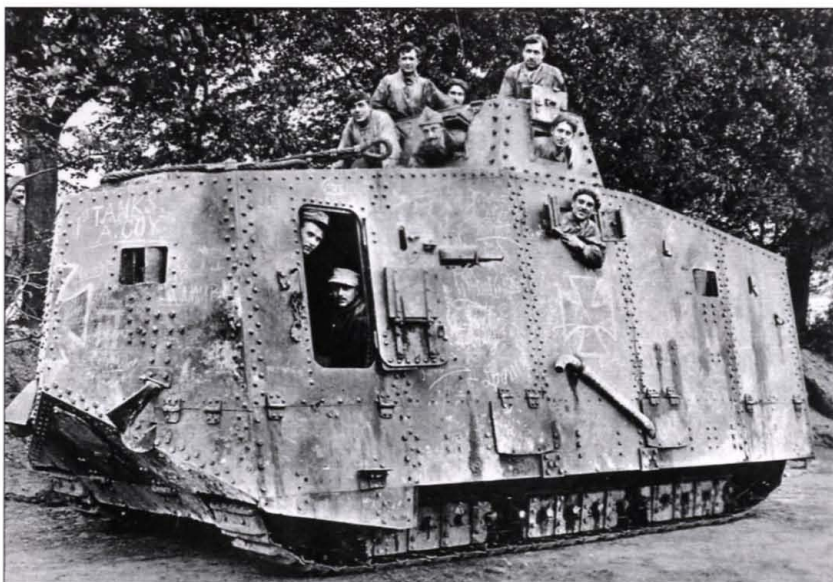
**Panzer 506 "Mephisto" is seen here in September 1918 near Poulainville after having been recovered by the Australians. The heavy damage to the roof was caused by a German patrol sent out to demolish another abandoned A7V, "Elfriede." Mephisto is the only surviving A7V, preserved at the Queensland Museum. (NARA)**

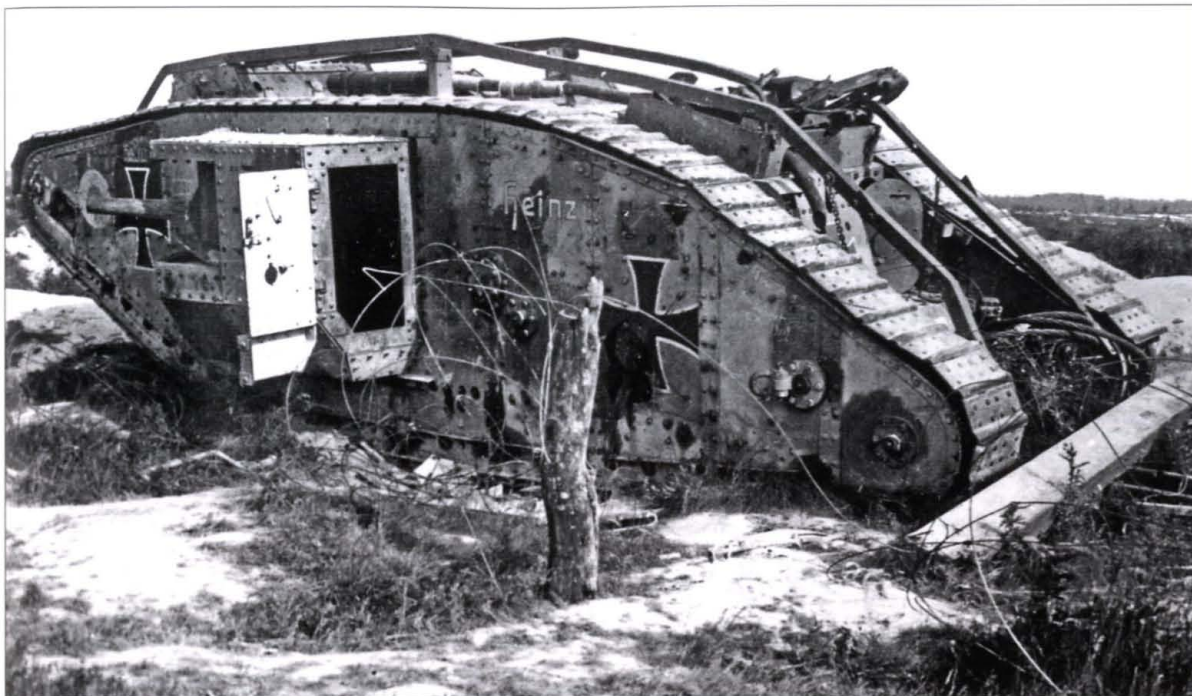
**A rear view of Abteilung 2's Panzer 542 "Elfriede," which was abandoned in April 1918 during the fighting for Villers-Bretonneux. It is seen here after it was recovered by French troops. (NARA)**

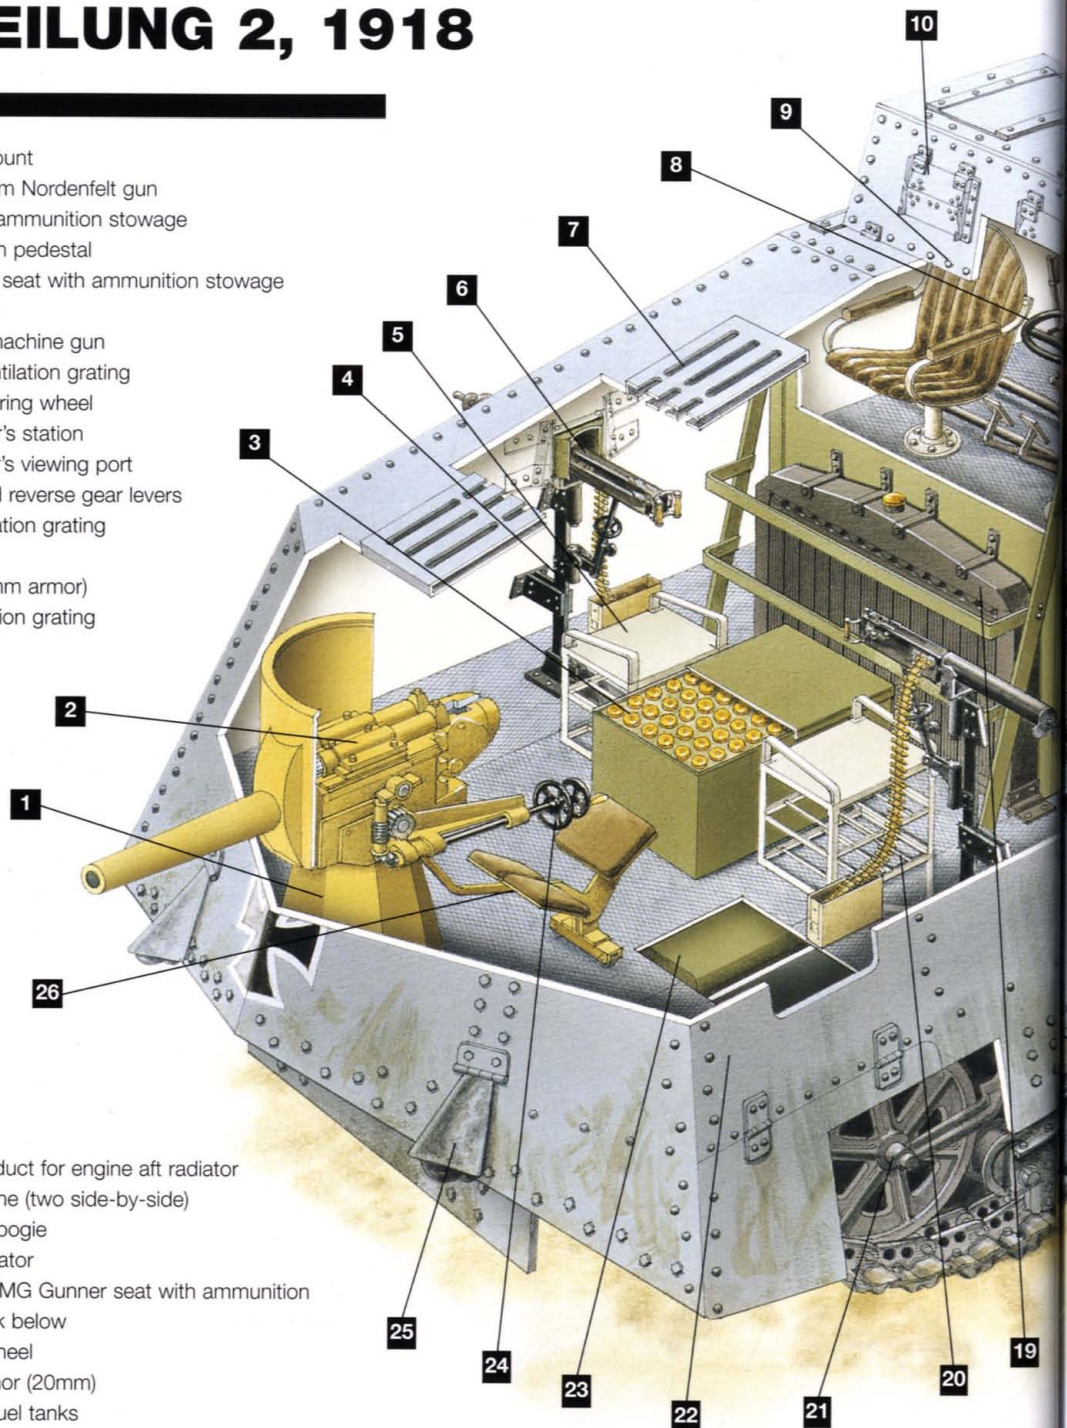
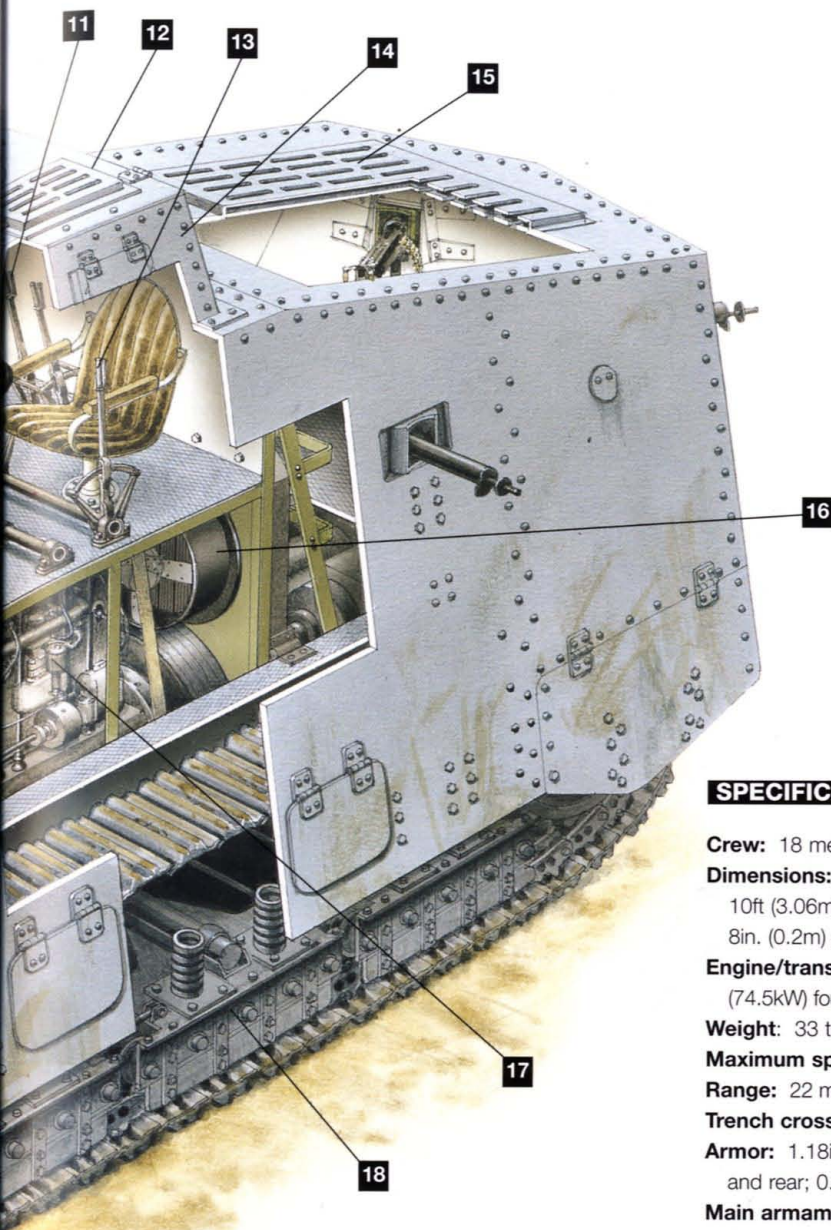
# D: A7V-PANZER 563 "WOTAN," ABTEILUNG 2, 1918

## SPECIFICATIONS

**Crew:** 18 men+

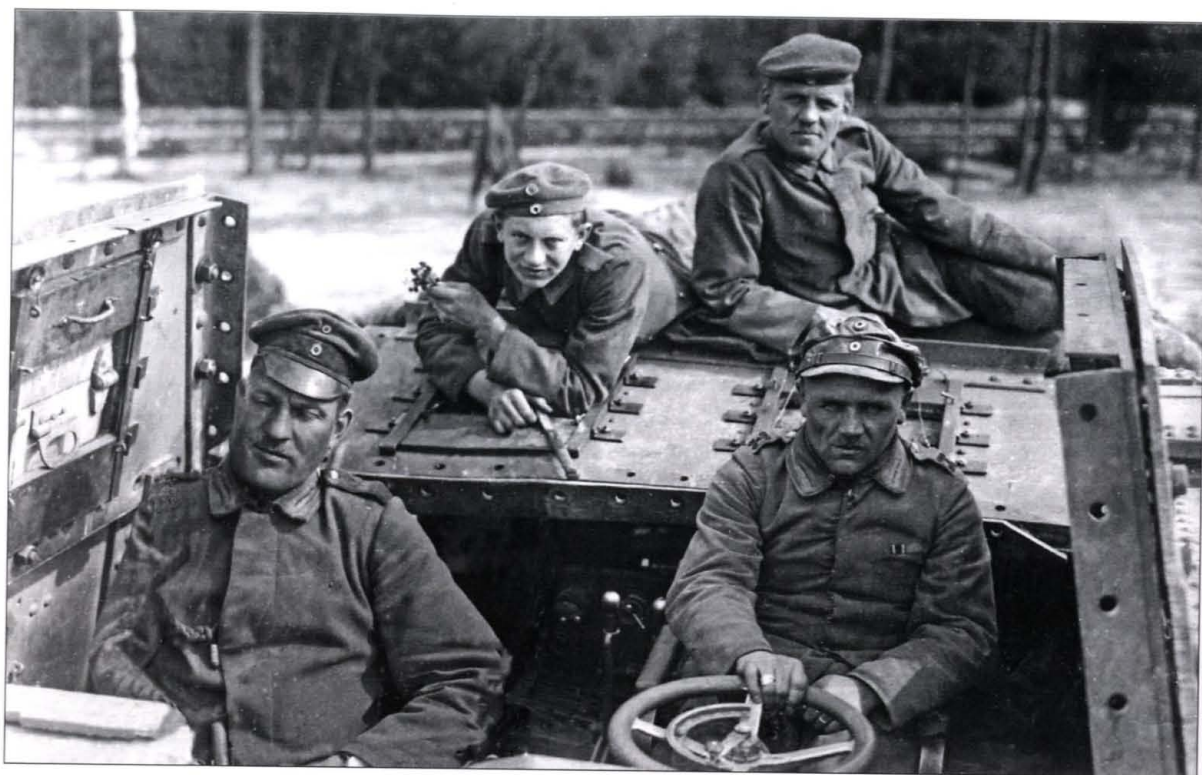
**ABOVE** The roof of the command cupola could be removed and the front and rear panels folded down to make it easier to drive the A7V when outside the combat area. This is the crew of Panzer 563 "Wotan" during a rail movement in July 1918. Like the rest of the final production batch, Wotan was fitted with appliqué armor on the cupola. (NARA)

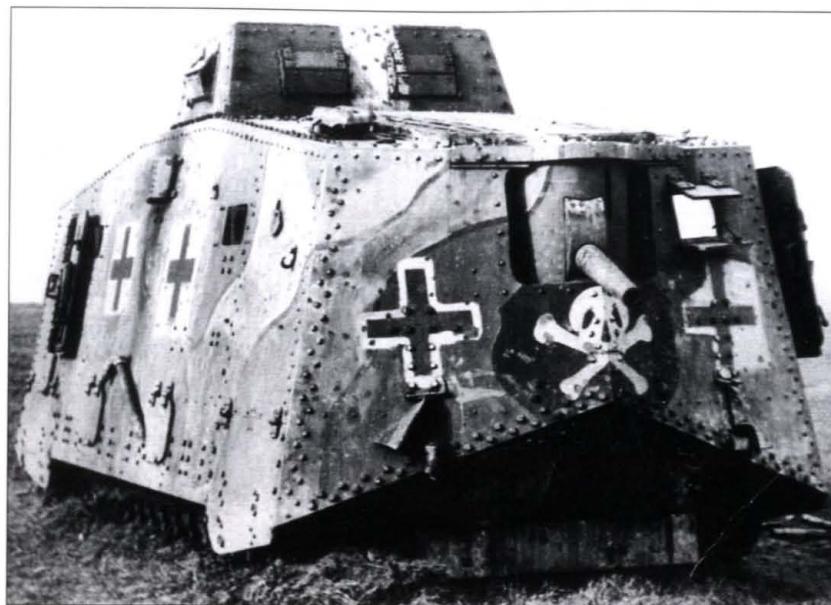
Panzer 503 of Abteilung 3 survived the final fall 1918 battles, but had to be abandoned at Charleroi when BAKP 20 evacuated to Wiesbaden in October 1918. The photo provides a good view of the new markings adopted on October 6, 1918, which were supposed to consist of a Balkan cross on a white square. This A7V was one of the early production batch with the trestle gun mount, later rebuilt with the pedestal mount as seen here. (Patton Museum)

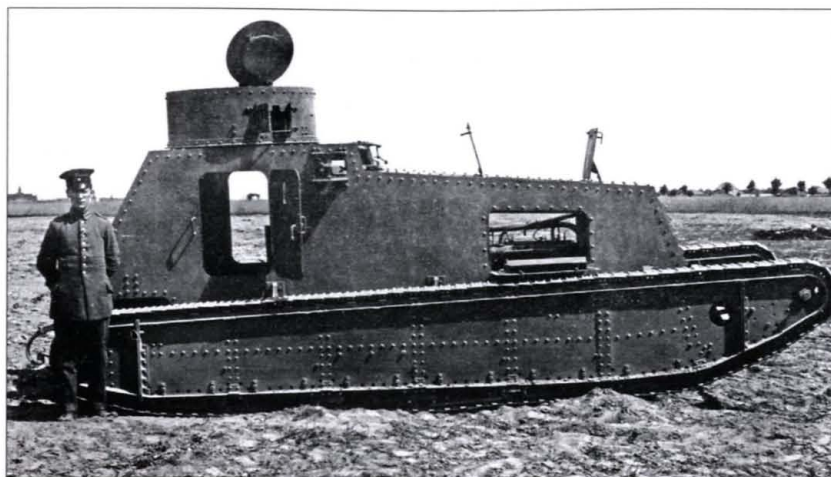
This single LK I light tank was constructed in 1918, but the armor was unacceptably thin. Plans were underway in the fall of 1918 to build the improved LK II but the war ended before any were ready for army service. (Patton Museum)

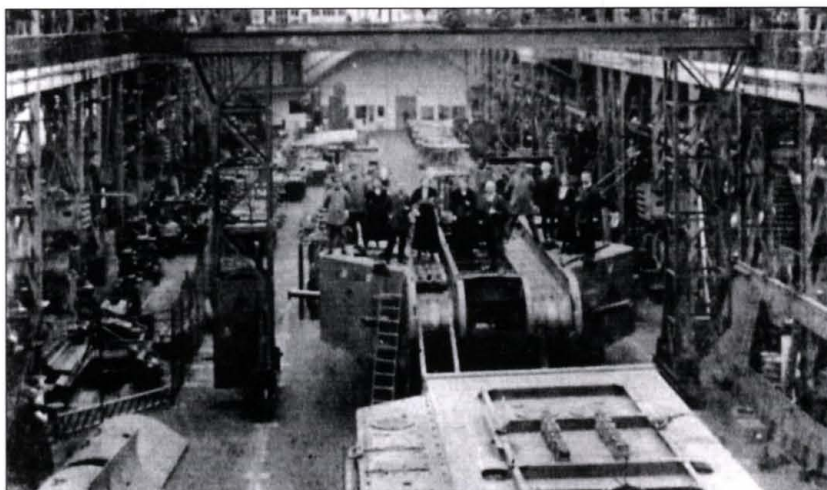
Two K-wagen heavy tanks were under construction at the Riese plant near Berlin. Although one was ready for trials, the war ended before it ever left the factory. Under the watchful eyes of the Allied Control Commission, both were broken up. (NARA)
