ARMOR AT WAR SERIES

# TANK WARFARE IN KOREA 1950 - 53

Steven J. Zaloga and George Balin

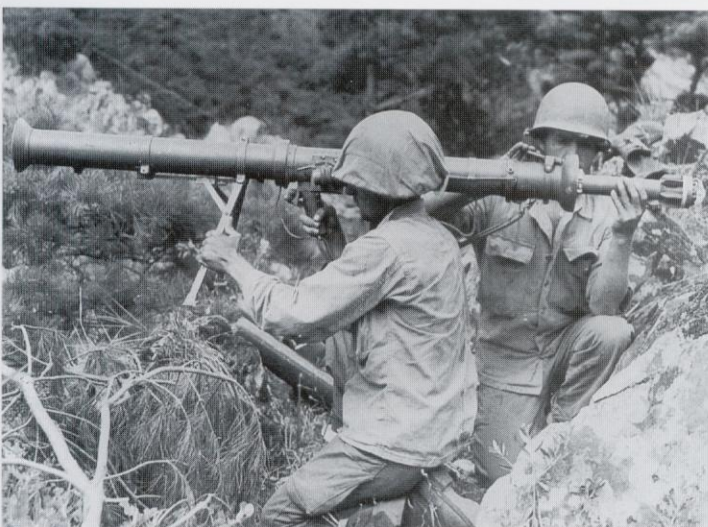
An infantry team demonstrates the new M20 3.5 inch rocket launcher during training on 20 July 1950. This bazooka could penetrate the armor of the T-34-85, except for the thicker front turret armor. It usually took several hits to score a penetration, and even then, the energy of the warhead was often so spent that little internal damage was done to the T-34-85 tank.

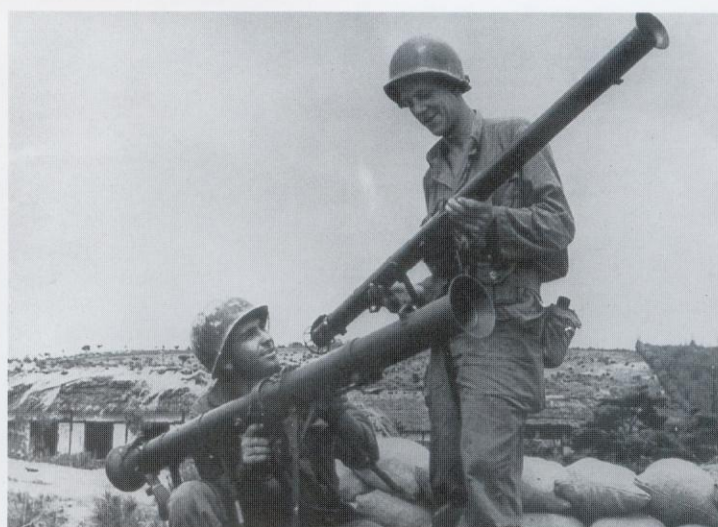
At the outset of the war, US infantry units in Korea were armed only with the M18 2.36 inch rocket launcher, seen here to the right. It proved totally ineffective against the T-34-85. In early July, the first supplies of the larger M20 3.5 inch "super-bazooka" (seen here to the left) were airlifted to Korea, and first used in the battle for Taejon on 20 July.

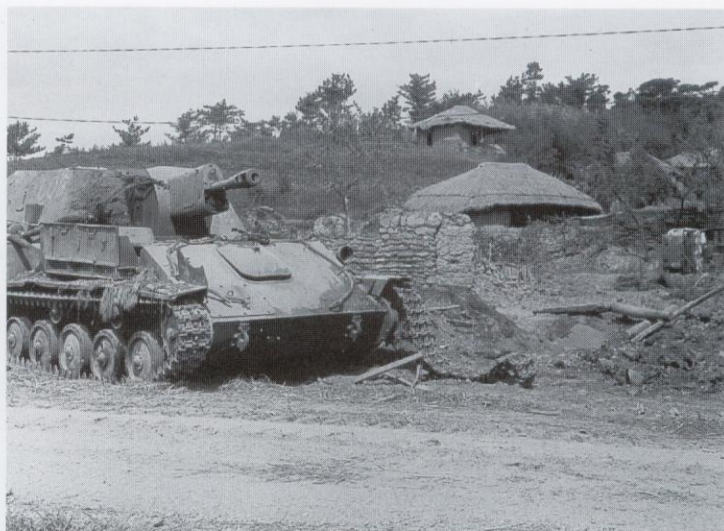
A NKPA SU-76M assault gun of the 308th Armored Battalion, 105th Armored Division, knocked out by the 35th Infantry along the road to Chinju on 12 August 1950. The vehicle is in sorry shape, with its left track broken, its gun out of battery in full recoil from damage to its recuperator and the engine evidently causing problems with the engine housing open. It had probably broken down before being knocked out by the US infantry.

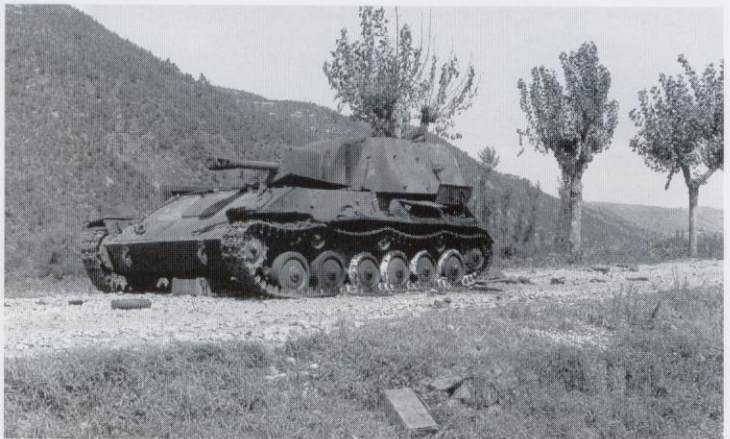
A SU-76M burned out along the road to Taegu in Waegwan sector of the Pusan perimeter during the fighting on 20 August 1950 by the 27th Regimental Combat Team (RCT), 25th Infantry Division. The vehicle has suffered an ammunition fire in the rear compartment which blew debris out of the rear, and set the four rear roadwheels on fire.

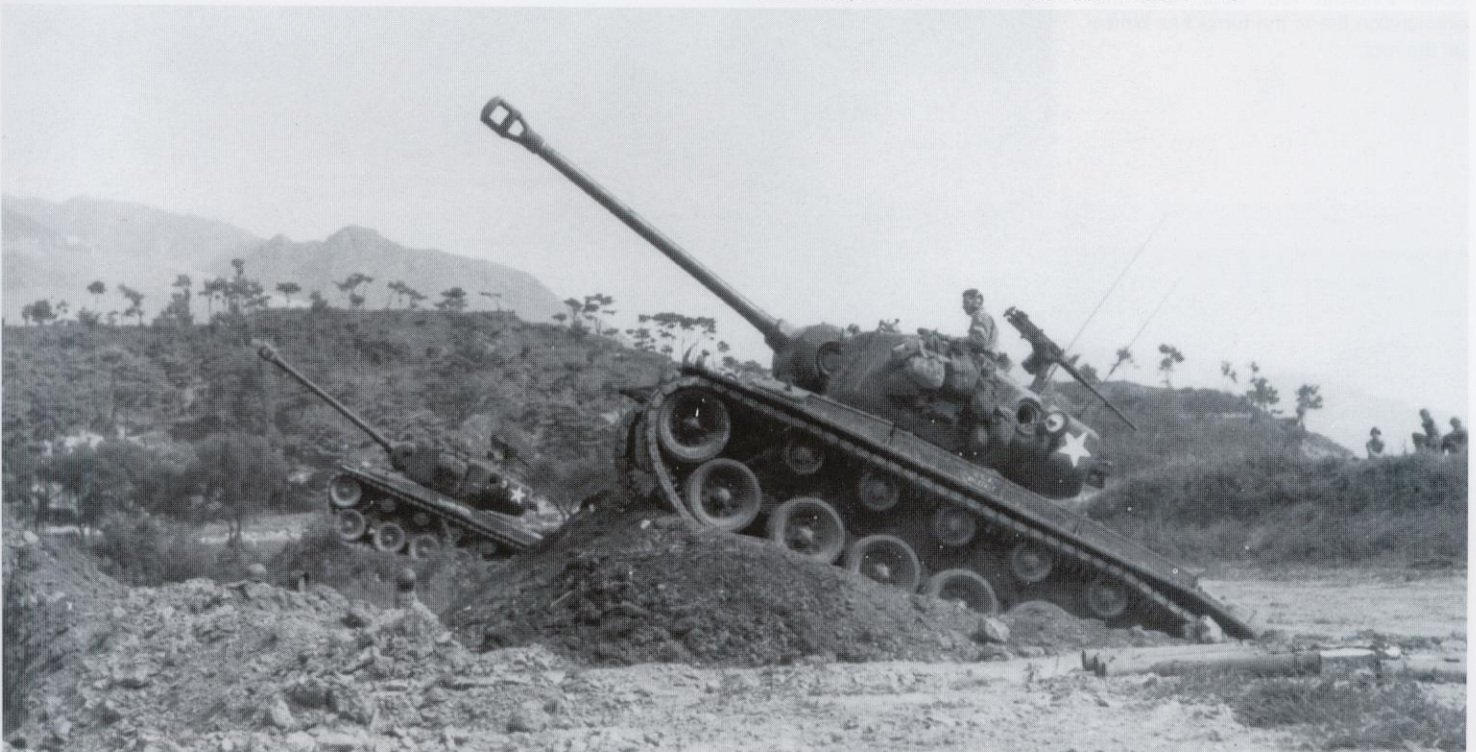
M26 Pershing tanks of Co. B, 89th Tank Bn. are used for improvised artillery support of the 29th Infantry Regt. on 25 August during the fight for the Pusan perimeter. This was not an approved tactic for tanks. The tanks have been driven up earth ramps to increase their maximum elevation.

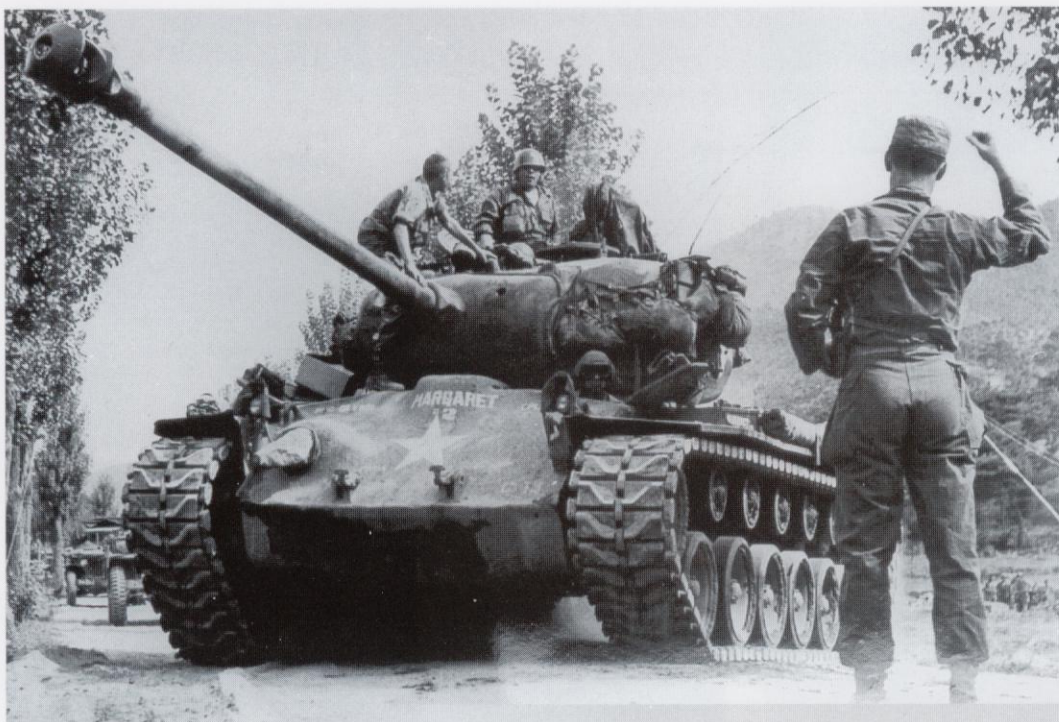
An Army M26 Pershing tank named "Margaret" moves up in the Pusan perimeter on 27 August 1950. The M26 was the most common US Army heavy tank in Korea in 1950, though it was gradually replaced with the M46 Patton in subsequent years.

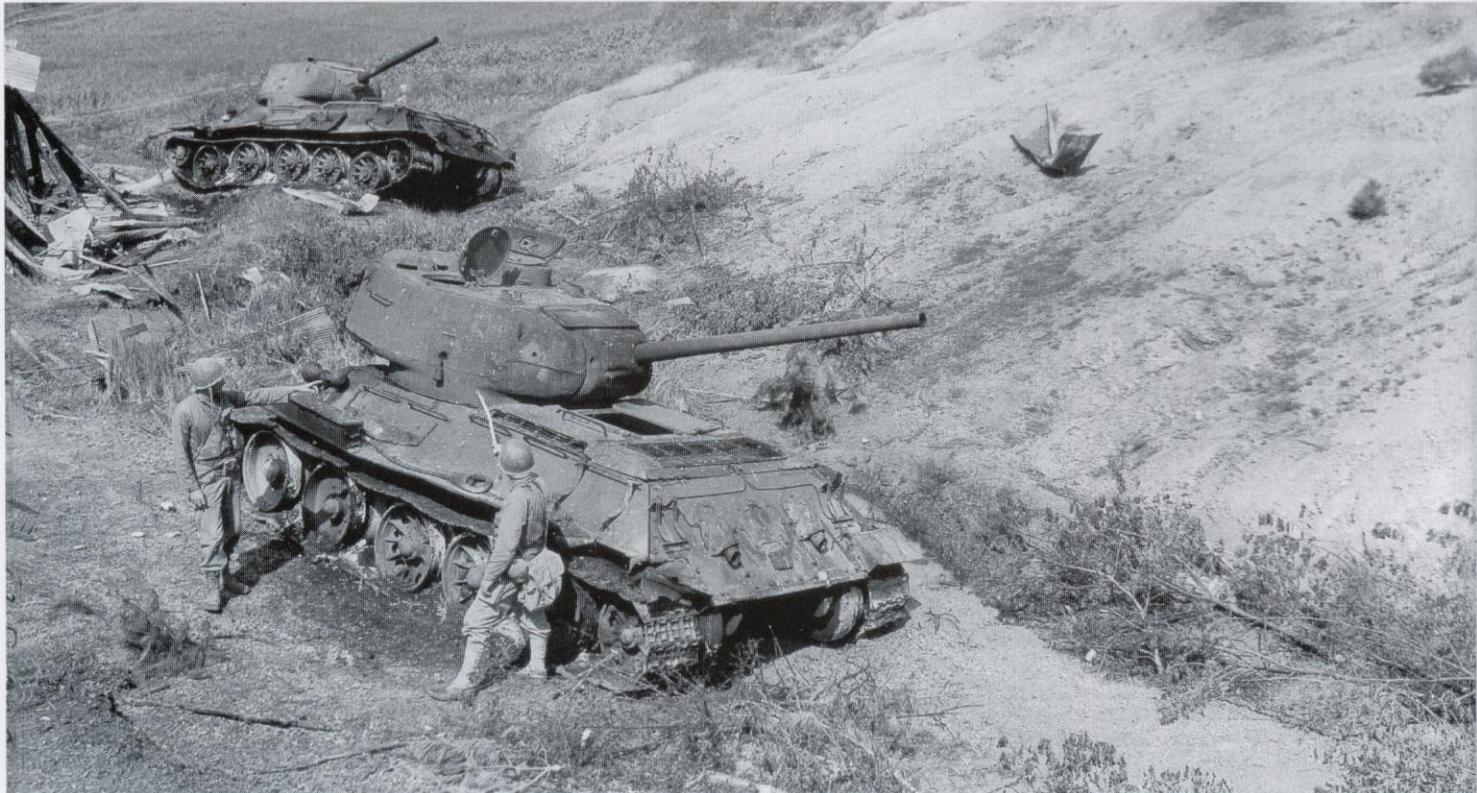
Two T-34-85 tanks of the NKPA 16th Armored Brigade, knocked out by Marine M26 Pershings during fighting near Yongsan on 3-4 September are inspected by Marines of Co. B, 1/5th Marines. The nearest tank has taken a hit on the front side of the turret which evidently led to a vehicle fire which burned the tank out. Notice that the intense heat of the fire has burned the rubber rims off the road-wheels.

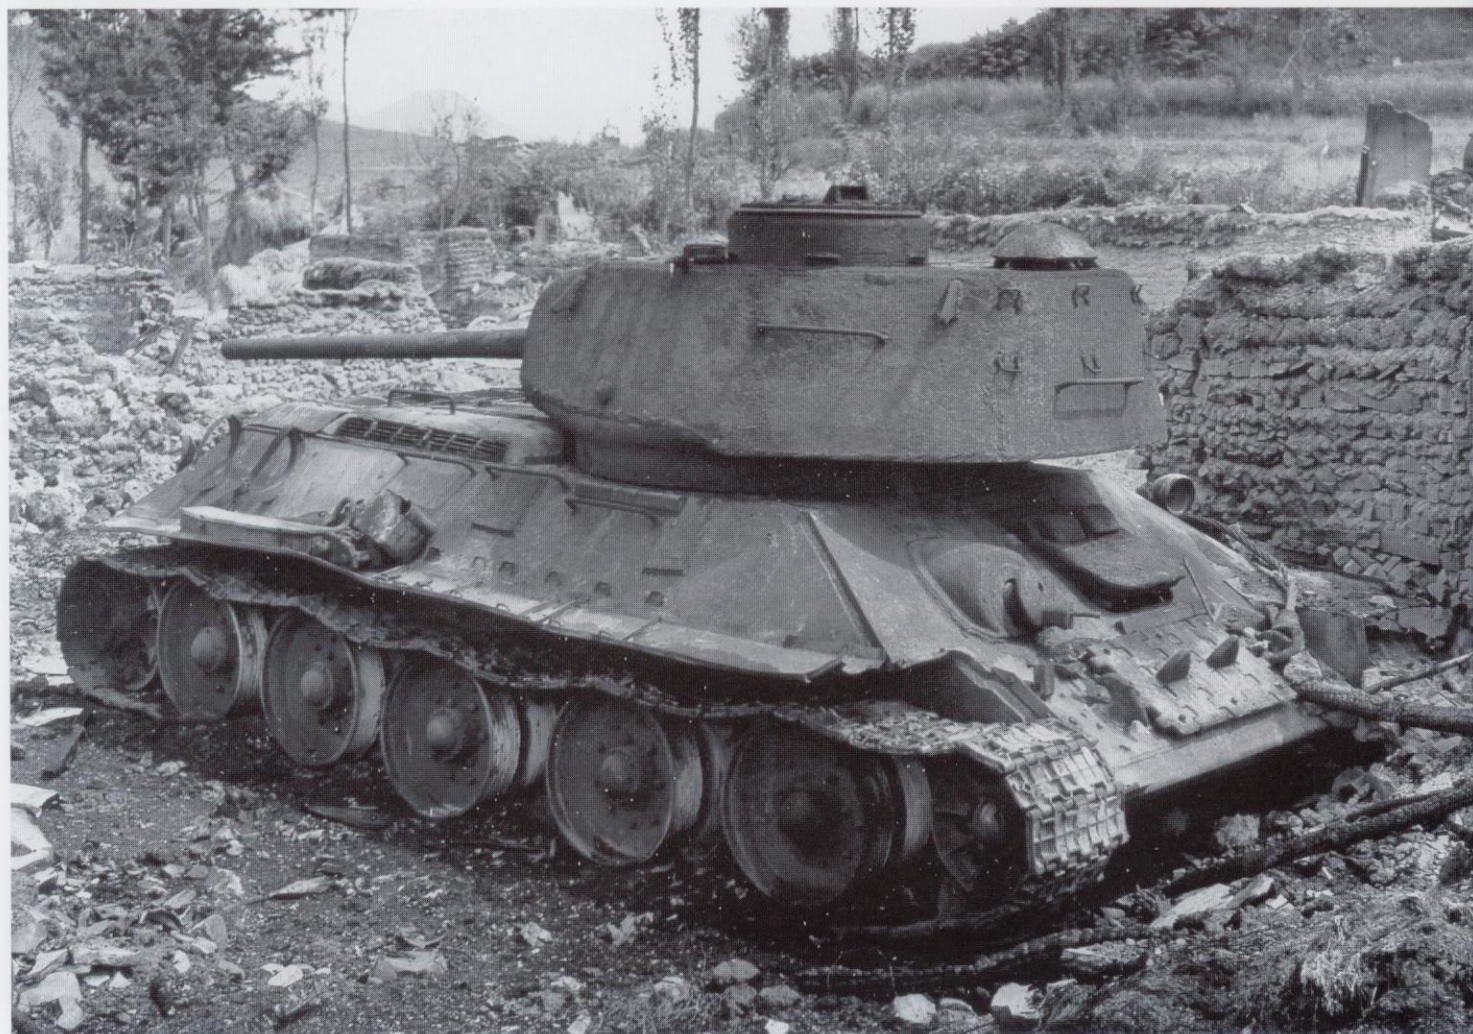
Another T-34-85 of the 16th Armored Brigade knocked out near Yongsan by an air attack, probably napalm, which has completely burned the tank. The tank is numbered 819, and had a small star behind the number. This particular style of T-34-85 turret with two split turret roof vent domes is typical of post-war production types from one of the Soviet tank factories.

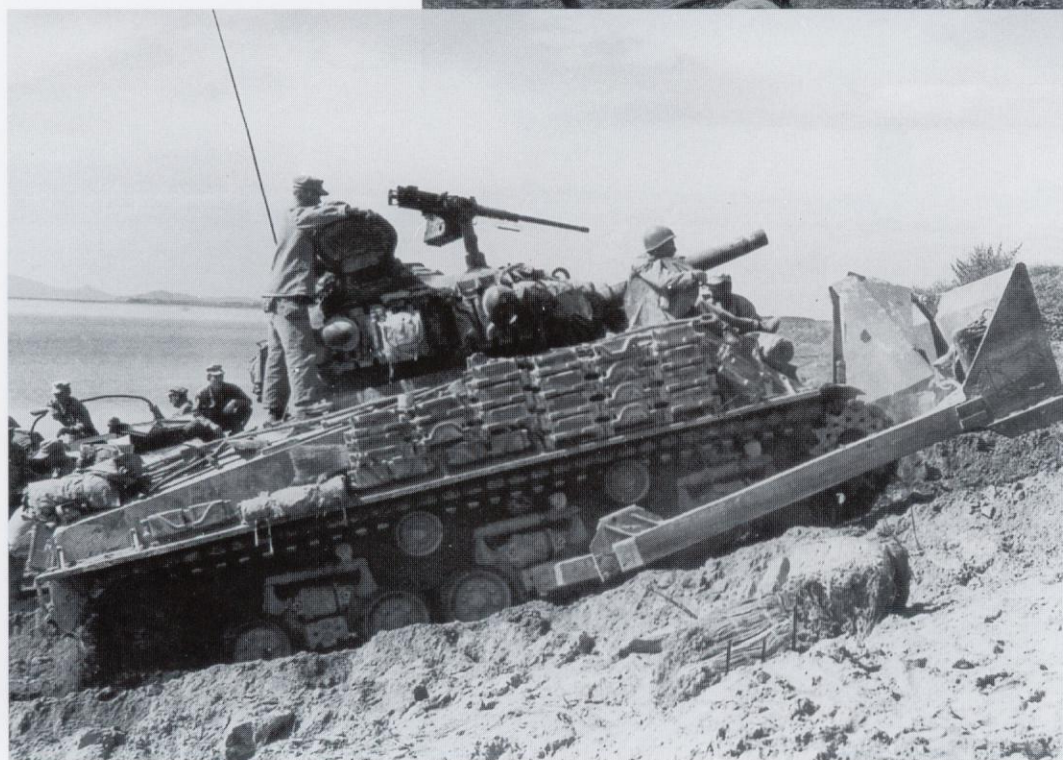
A M4A3 (105) howitzer/dozer is used to prepare approaches for the amtracs on the Kimpo side of the Han river on 20 September. Tanks were ferried over to the Seoul side of the river using bridge sections. The extensive spare track fittings on the side were intended to provide extra armor for the crew.

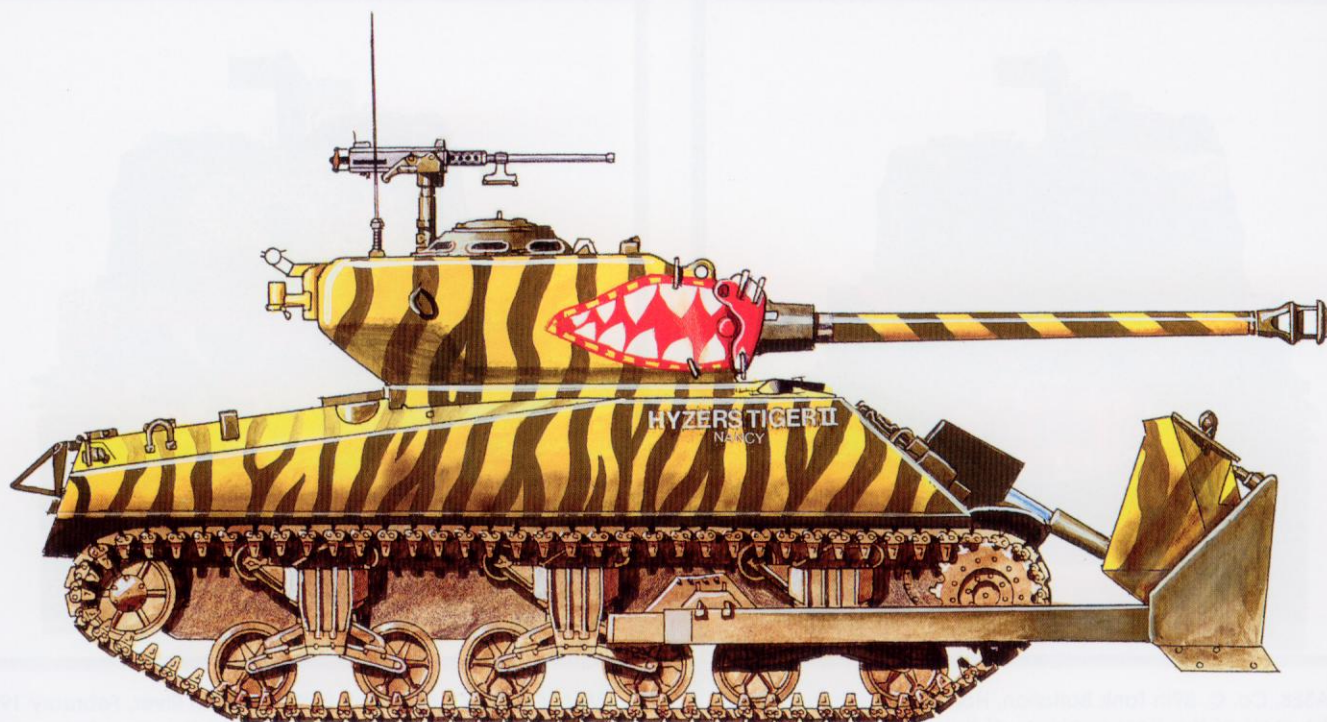
**M4A3W(76) with M1 dozer, 3rd Engineer Combat Bn., Han River, February 1951.**

Hyzer's Tiger II is an unusual bulldozer tank attached to the 3rd Engineer Combat Bn., 24th Infantry Div. Unlike most M4s that served in Korea it is still fitted with the old VVS suspension. The tank was named after Peter C. Hyzer, who commanded the battalion, and the name "NANCY" is painted below this in white. The tiger scheme consists of yellow stripes over the usual olive drab finish, with a garish red and white mouth. Further details of the tactical numbers on the front of this tank will be found in the accompanying photos.

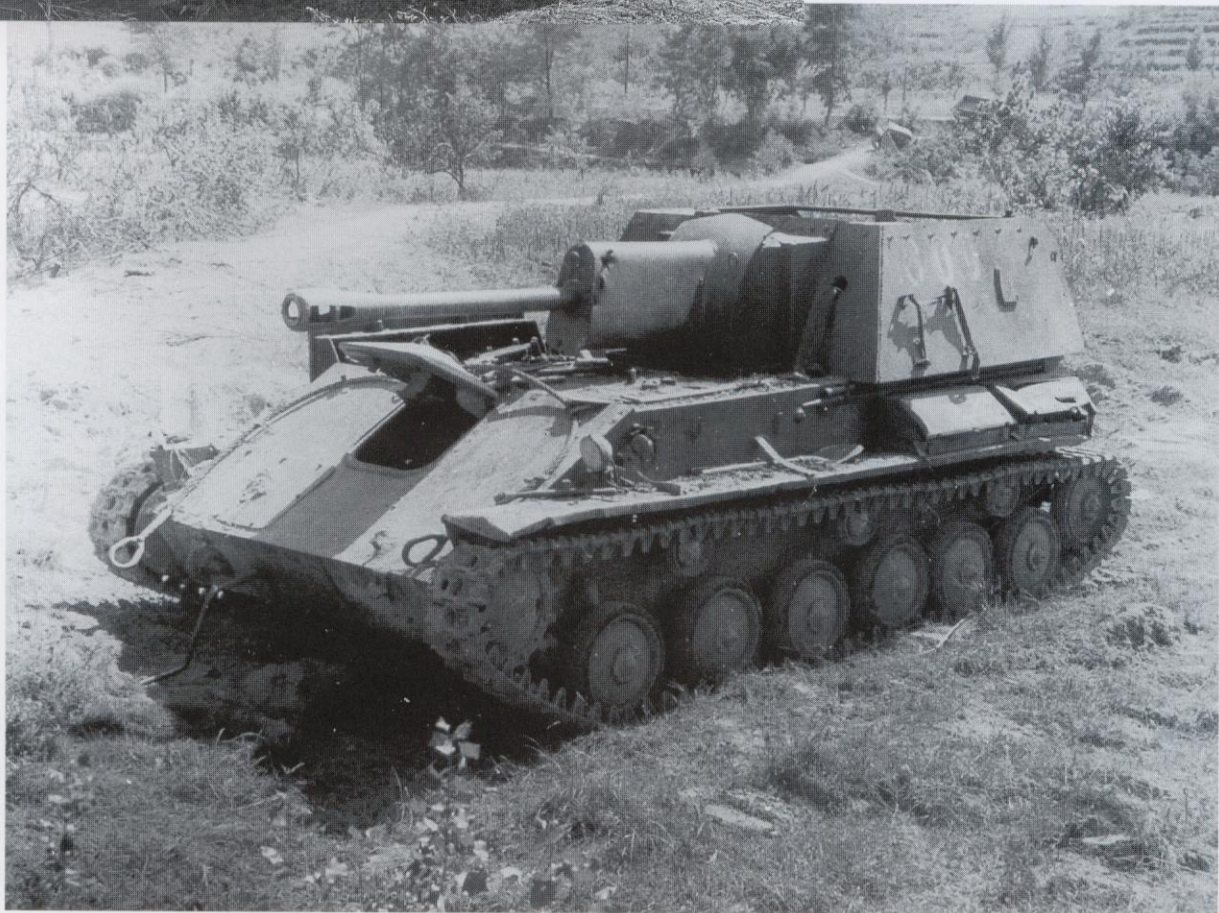
A SU-76M abandoned near Kumchon on 21 September 1950. The vehicle tactical number appears to be 809. This SU-76M seems to be another victim of engine failure; the SU-76M used two automobile engines mated at the crankshaft which led to frequent mechanical problems.

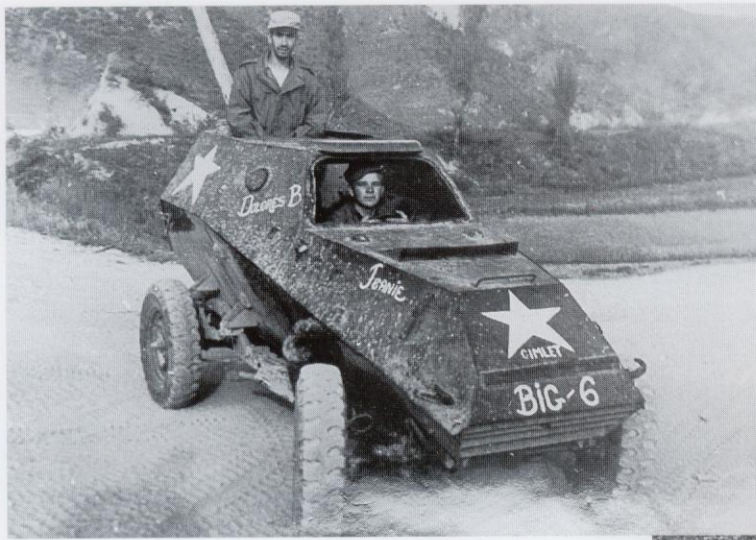
The BA-64B armored car was used in small numbers by NKPA armored units for scouting. After removing its turret, fenders and driver's armored visor, the 21st Infantry put this captured example back to use.

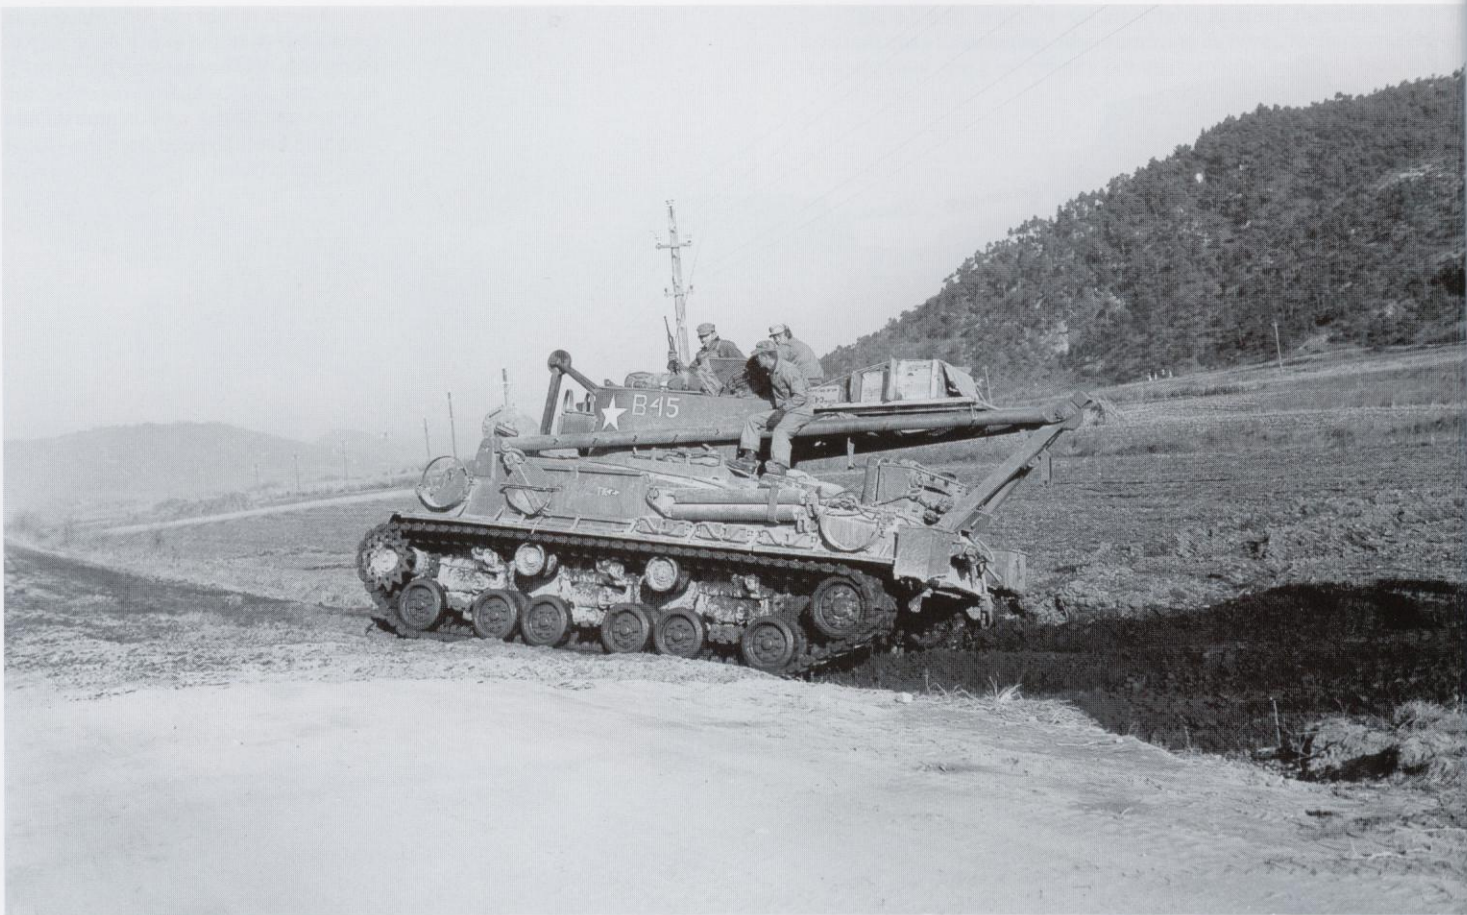
A M32A1B3 armored recovery vehicle of the Marine 1st Tank Bn. in operation near Hamhung on 10 November 1950. Because each tank company operated independently in support of Marine regiments, it was the usual practice to allot at least one of these per tank company.

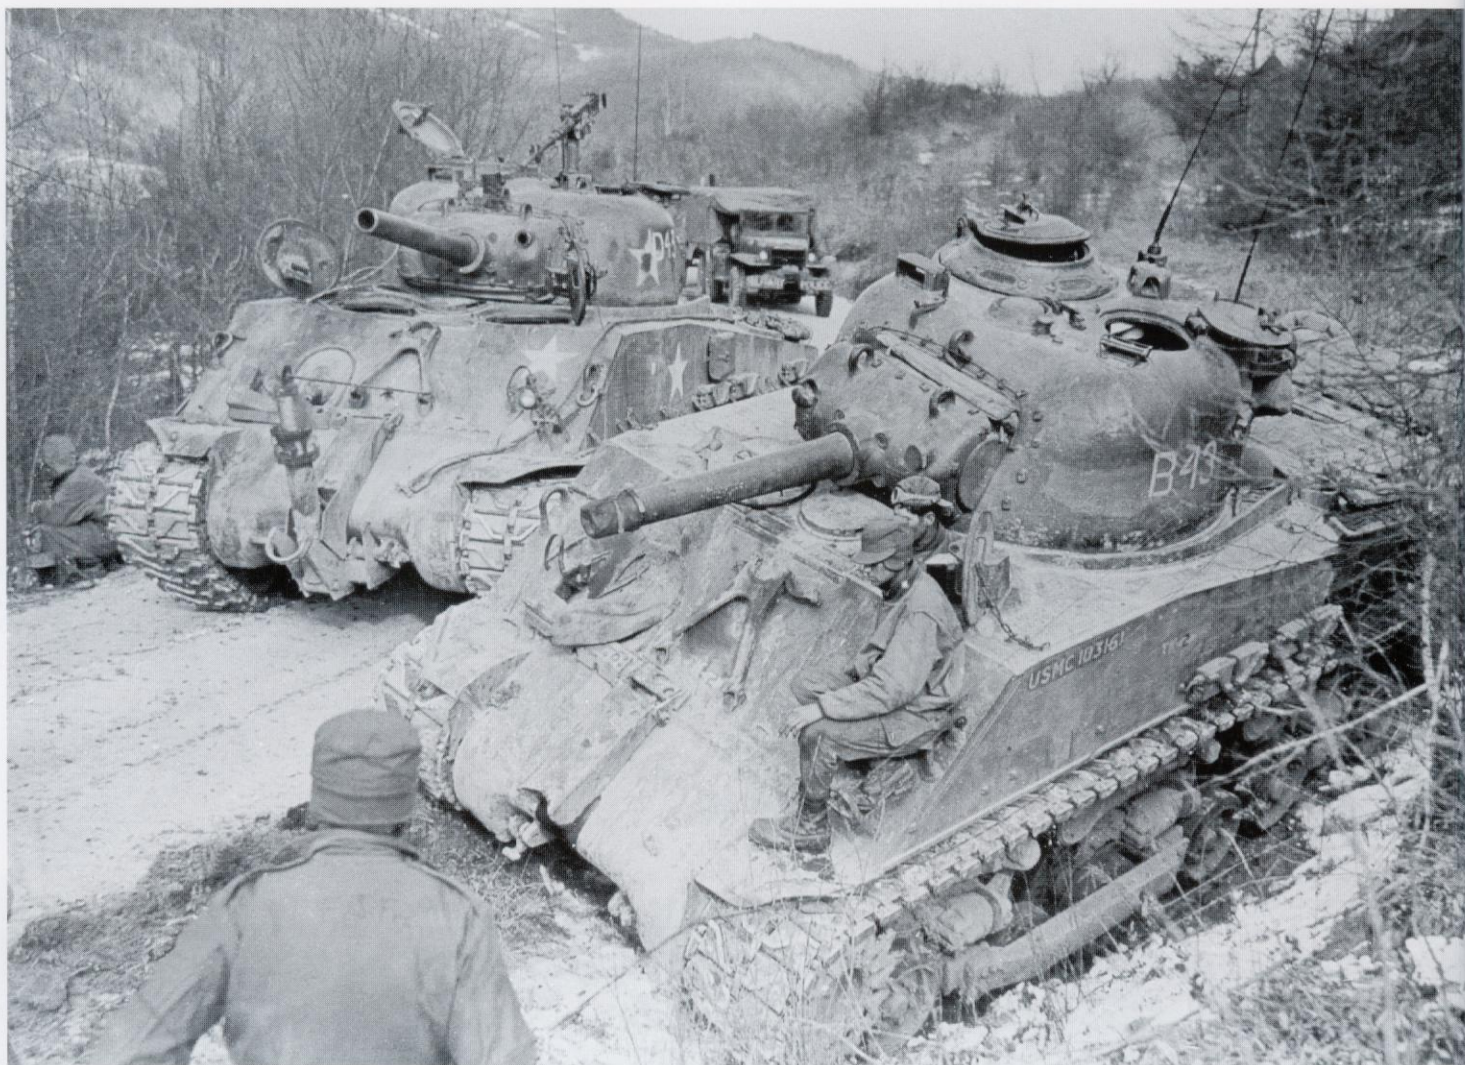
A pair of Marine M4A3 (105) howitzer/dozer tanks near Hamhung after the Chosin retreat. This gives a good view of the connections needed to attach the M1 bulldozer blade to the tank.

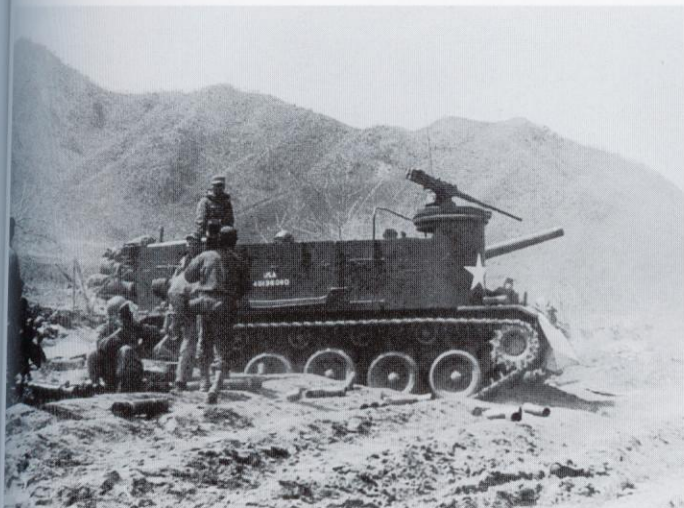
A M37 105mm howitzer motor carriage of the 58th Field Artillery Bn. supports the 3rd Infantry Div. during fighting on the Imjin river on 12 April 1951. The M37 was based on the M24 light tank chassis, and was intended to replace the old M7 105mm HMC on the M4 medium tank chassis.

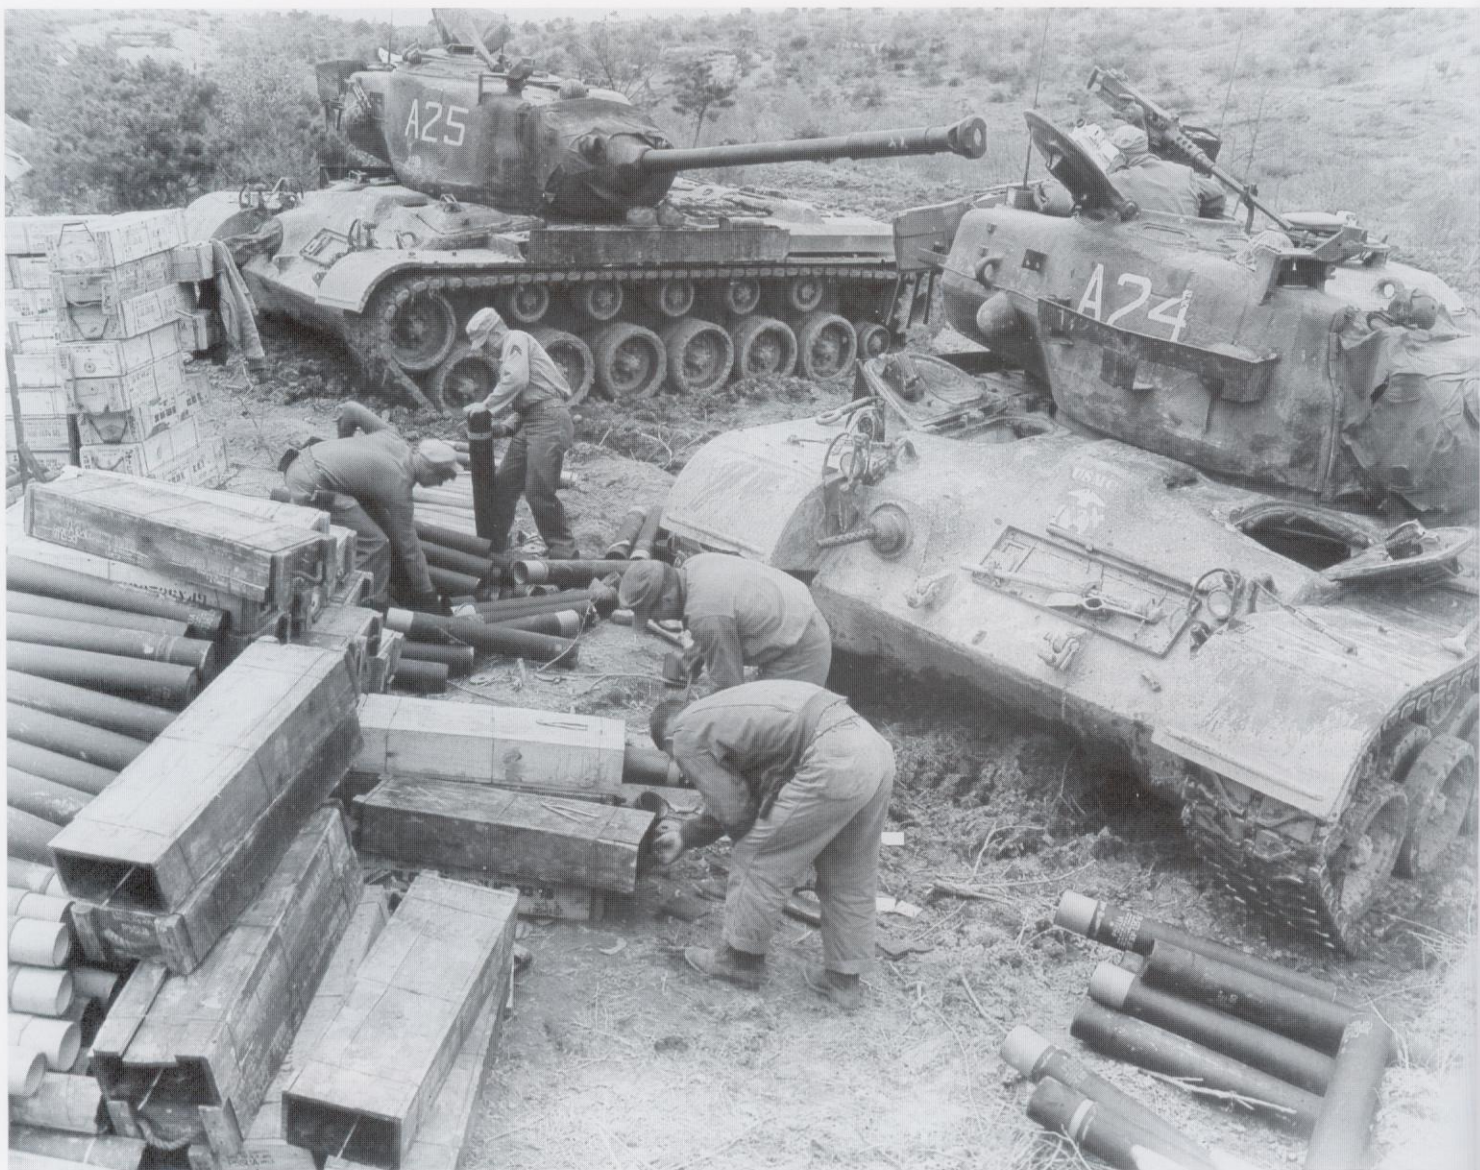
A good detail shot of the rearming process. The 90mm ammunition was delivered in two-round wooden crates, while the rounds themselves were stored in black fiberboard tubes for added protection. The markings on the Marine M46s at this time were very simple, the tactical number in white on the hull front and turret sides, and the USMC globe and anchor insignia on the bow between the driver's hatches.

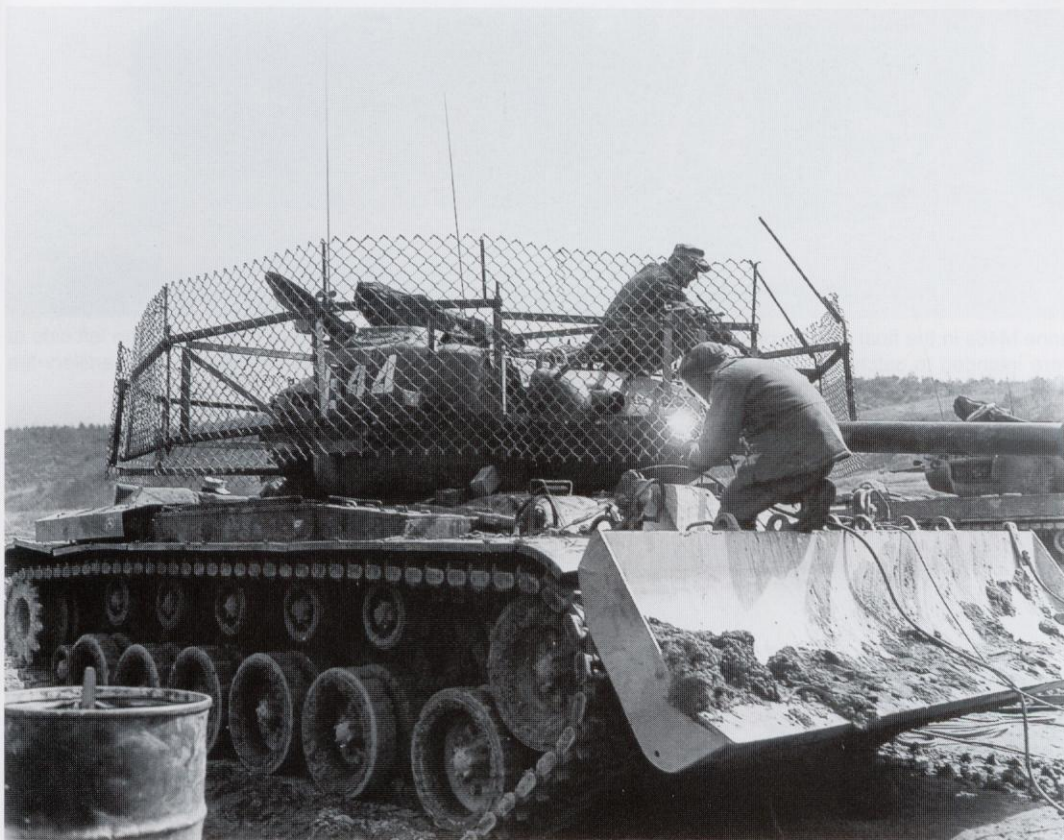
During the outpost fighting in 1952-53, Chinese or Korean troops would infiltrate through UN lines with captured bazookas to attack entrenched UN tanks. Here, a Marine dozer M46 is fitted with an improvised anti-bazooka screen made from chain-link fence.
