# 4. Panzer-Division

## on the Eastern Front (2) 1944

Text by Robert Michulec

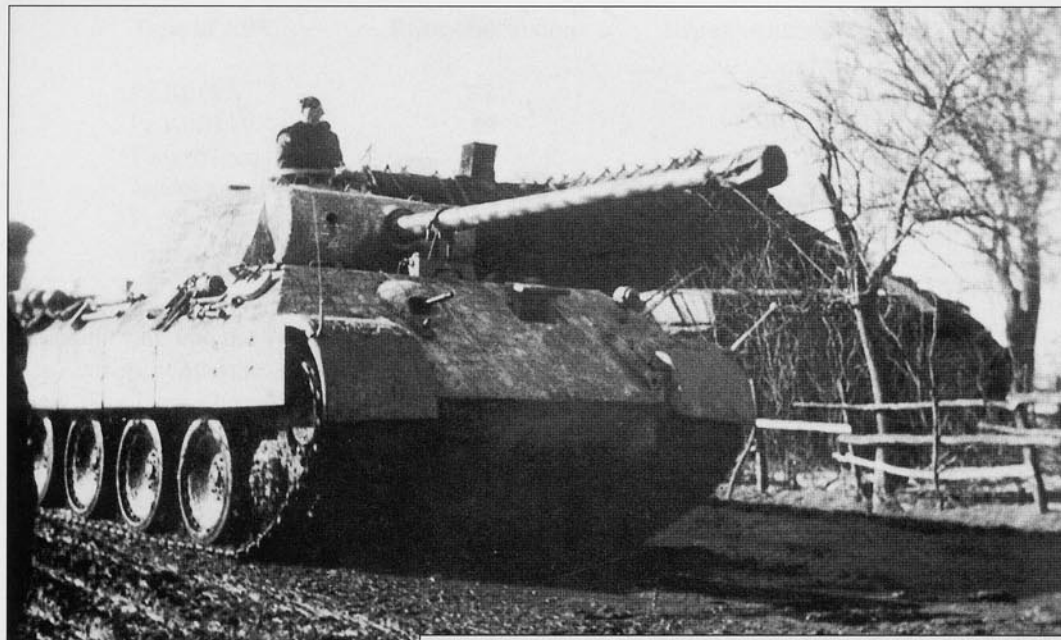
The same vehicle photographed shortly after, passing through one of the numerous Russian villages encountered by 4.Panzer-Division during its attack from the town of Osaritschi on the lower Dniepr River, in the sector of 9.Arme. The weather conditions in the last two weeks of December were excellent with clear skies and temperatures around -2°C. The tubes being carried on the side of the vehicle appear to be stovepipes.

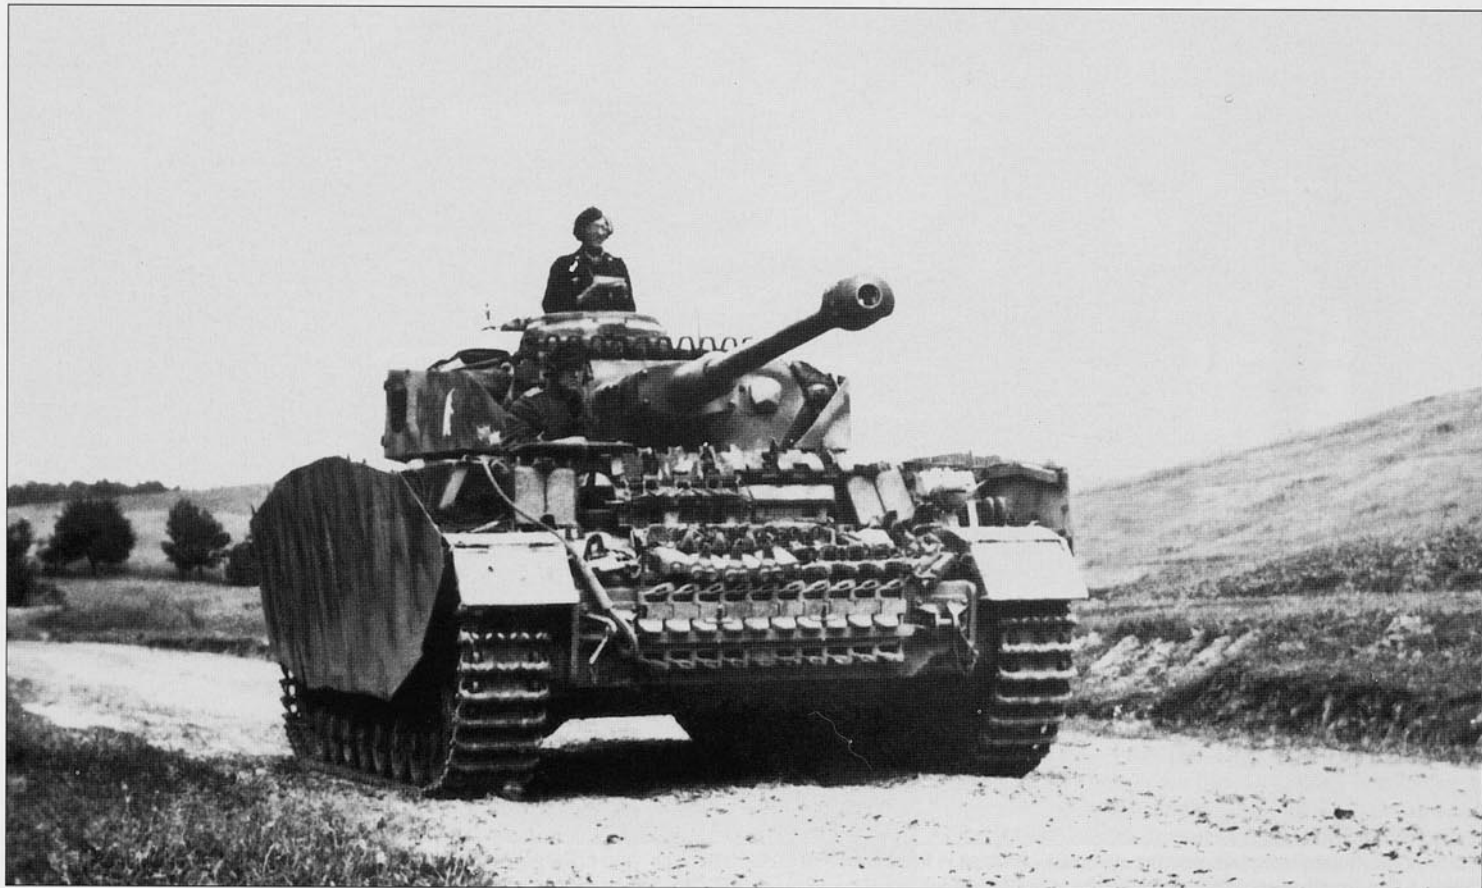
This closeup of a Pz.Kpfw.IV shows the unusual pattern of the Zimmerit which is probably a field application. A faint camouflage paint scheme can be seen on the hull side skirts. Note how scratched the paint is on the side skirts caused by brushing against trees and bushes. The tank commander is wearing his M1943 uniform tunic instead of his black Panzer jacket.

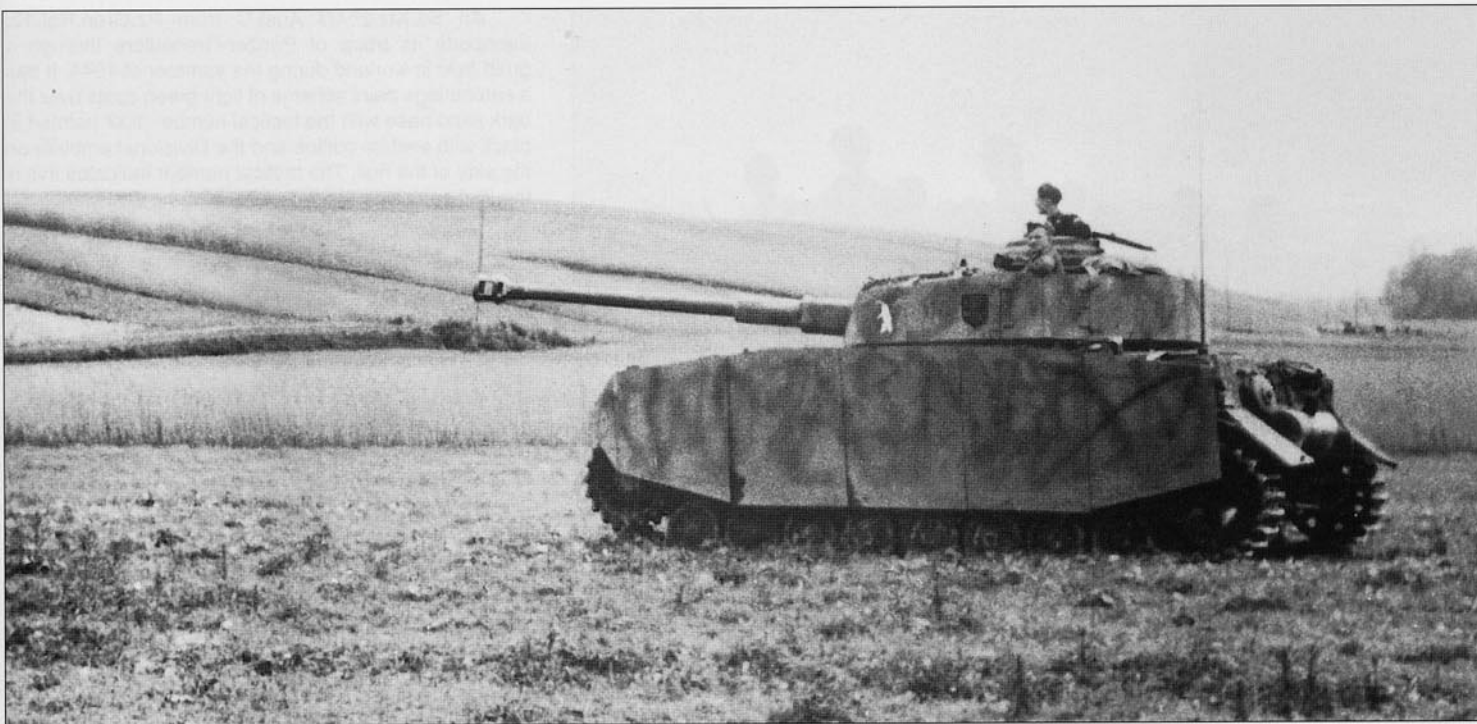
The same late Pz.Kpfw.IV Ausf.G or early Ausf.H seen in the previous photographs giving a good view of the damaged side skirts. The rear skirt is missing and the support angle has been bent back causing the skirts to almost touch the ground. This shot also shows the white standing bear emblem painted on the turret skirt along with the tactical number '532' painted in yellow.

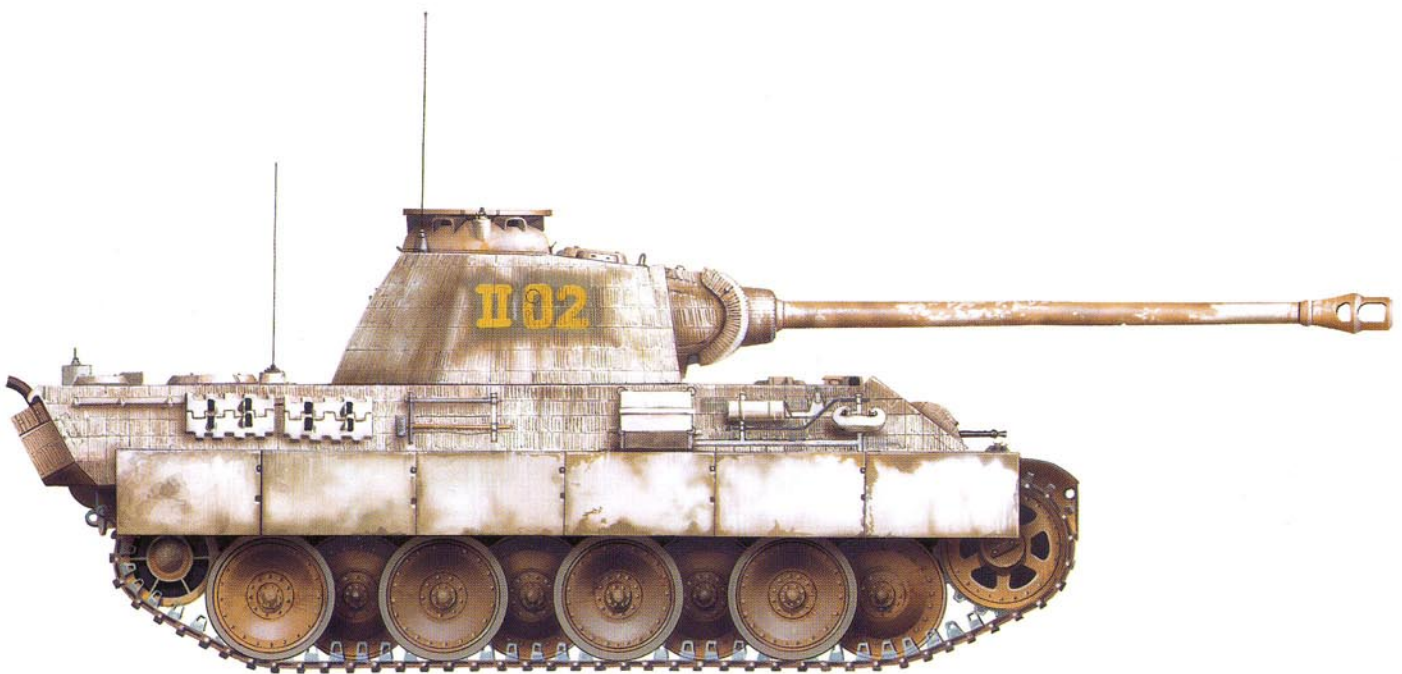
**Pz.Bef.Wg.V 'Panther' Ausf.A, 5.SS-Panzer Division 'Wiking', Kovel, April 1944**

II./SS-Pz.Rgt.5 was attached to 4.Panzer-Division for the battles in the Kovel area in April 1944. This is a II.Abtl. staff vehicle which has been painted with a white winter camouflage paint and carries the tactical number '1102', most likely in yellow paint on the turret. The star antenna normally carried on the rear of the engine deck is missing.

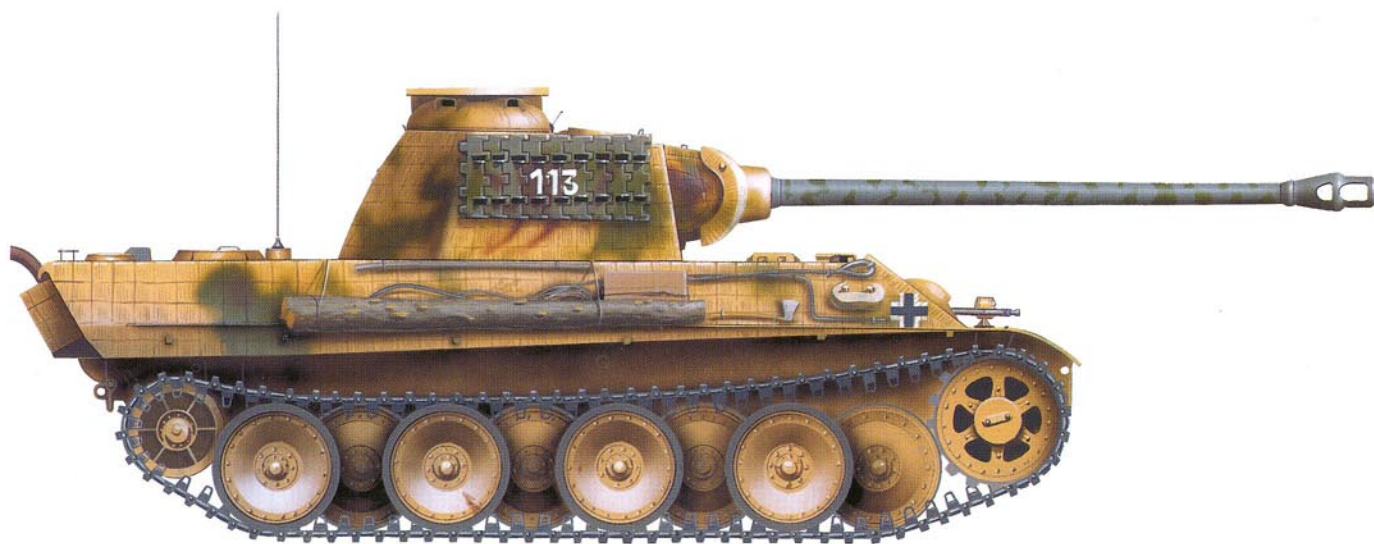
**Pz.Kpfw.V 'Panther' Ausf.G, I./Pz.Rgt.35, Kurland, September 1944**

This Panther Ausf.G has an interesting camouflage pattern of green lines and spots applied over the hull and turret. The gun barrel is darker, possibly indicating it is a replacement barrel. Spare track links have been attached to the turret in an unusual manner and the tactical number, a white '113' has been painted on them.

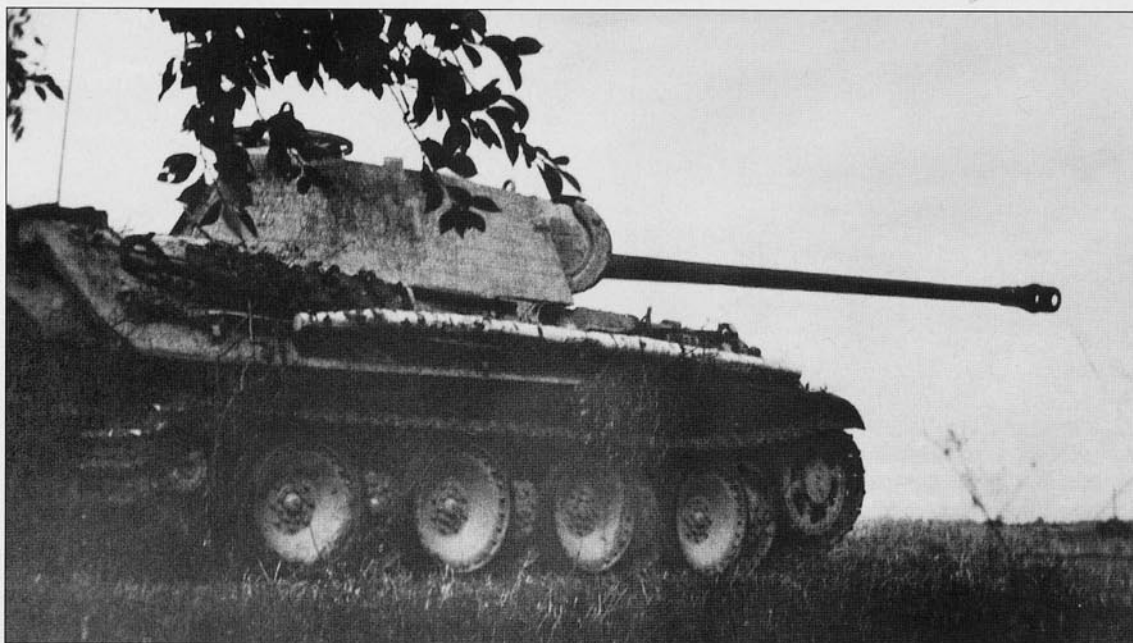
Two photos of a Pz.Kpfw.V 'Panther' Ausf.G with a birch log hanging from the side as it advances through a harvested grain field. Part of the tactical number is visible showing the tank is from 1.Kompanie. The gun barrel is a very dark color probably indicating it is a replacement barrel which has not been painted.

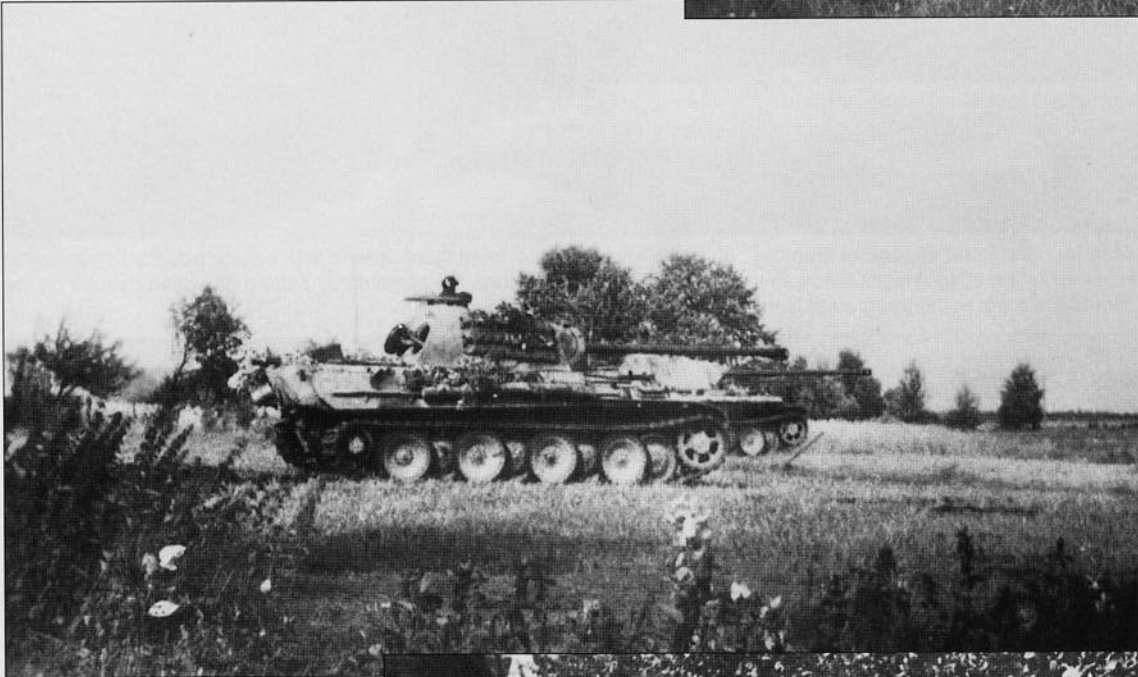
The crew of this Pz.Kpfw.V 'Panther' Ausf.G has hung additional track links on the side of the turret in a way not commonly seen on the 'Panther'. A white tactical number '113' has been painted on the tracks indicating that their purpose is probably to provide additional armor protection. The camouflage scheme appears to be green lines and spots applied over the dark sand base on the hull and turret except for the gun barrel, which looks to be darker. This vehicle is probably a replacement for the 'Panther' Ausf.A seen earlier with the same tactical number.

Another photo of the same Panther, this time showing the whole vehicle. The spare tracklinks on the turret are obviously the ones normally mounted on the rear side of the hull.

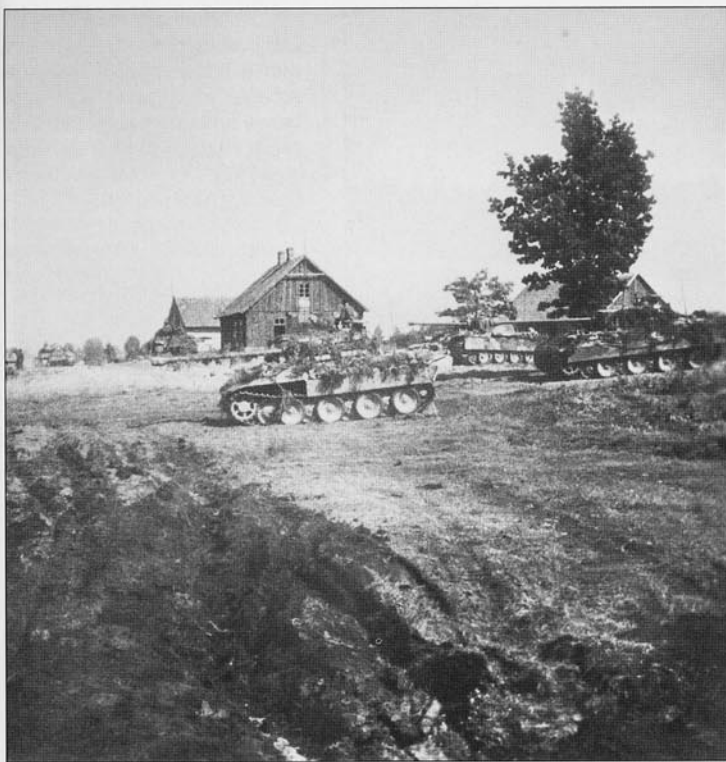
A closer view of the two 'Panthers' at the right of the above photo. Both are Ausf.G models and, judging by the lack of battle damage, appear to be relatively new. Note the difference in color of the gun barrels of these two tanks.

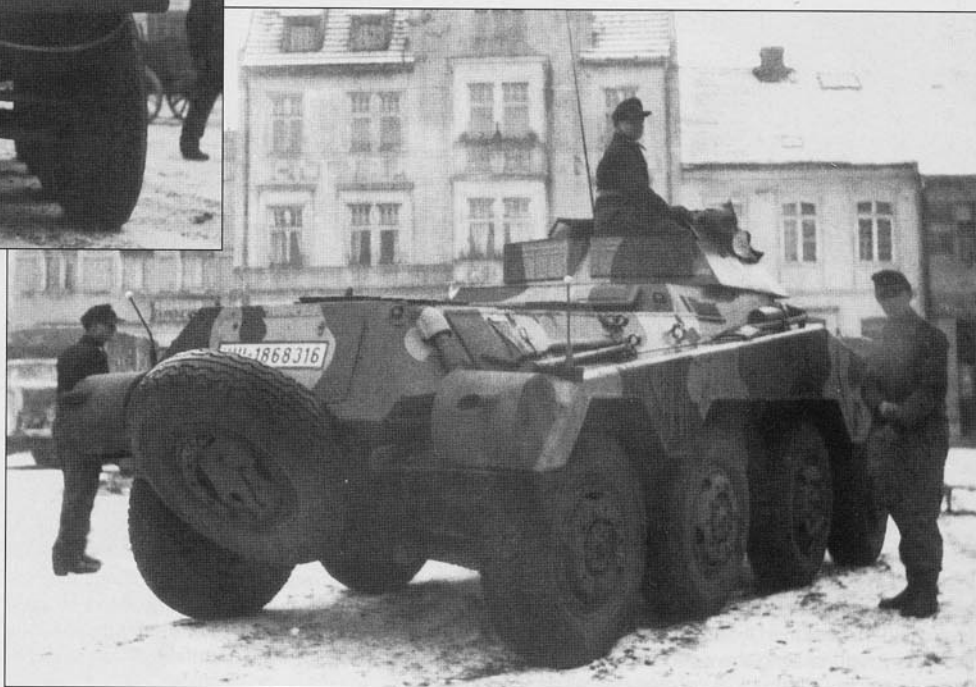
Three views of a new Schwerer Panzerspähwagen (2cm) (Sd.Kfz.234/1), which replaced the Pz.Kpfw.II Ausf.L 'Luchs' as the main combat vehicle of Pz.Aufkl.Abt.4. This photo is taken in January 1945 in the area of Danzig (Gdansk). The vehicle has been painted with a hard edge camouflage scheme of green and brown irregular patches over the dark sand base, applied using a brush. There are no visible markings other than the vehicle license number, WH-1868316, painted on the front and rear plate and a small national cross painted on the side of the turret.
