# ACHTUNG

# PANZER

The German Invasion of  
France and the Low Countries

Jon Feenstra

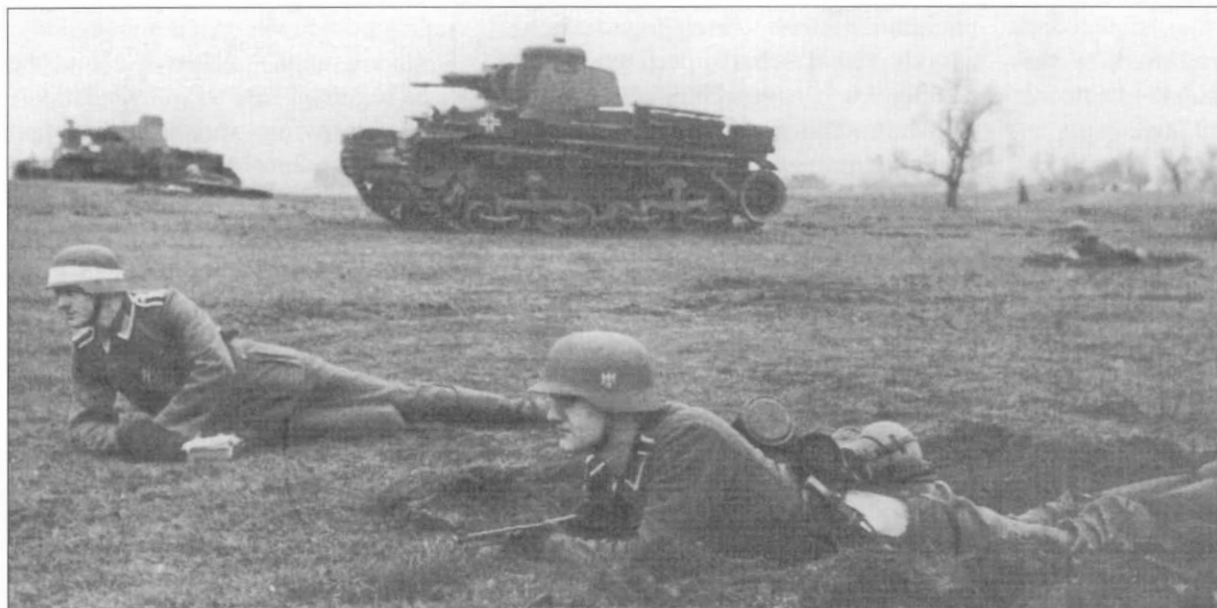
Elements of the 6. Panzer-Division on exercise in early 1940 prior to the attack in the West. The 6. Panzer-Division was the only Wehrmacht unit equipped with the Panzerkampfwagen 35(t), as seen in the foreground, for Fall Gelb and Fall Rot. Moving up in the background is a Pz.Kpfw.IV Ausf.B, C, or D. The soldier with the white helmet band is an exercise umpire.

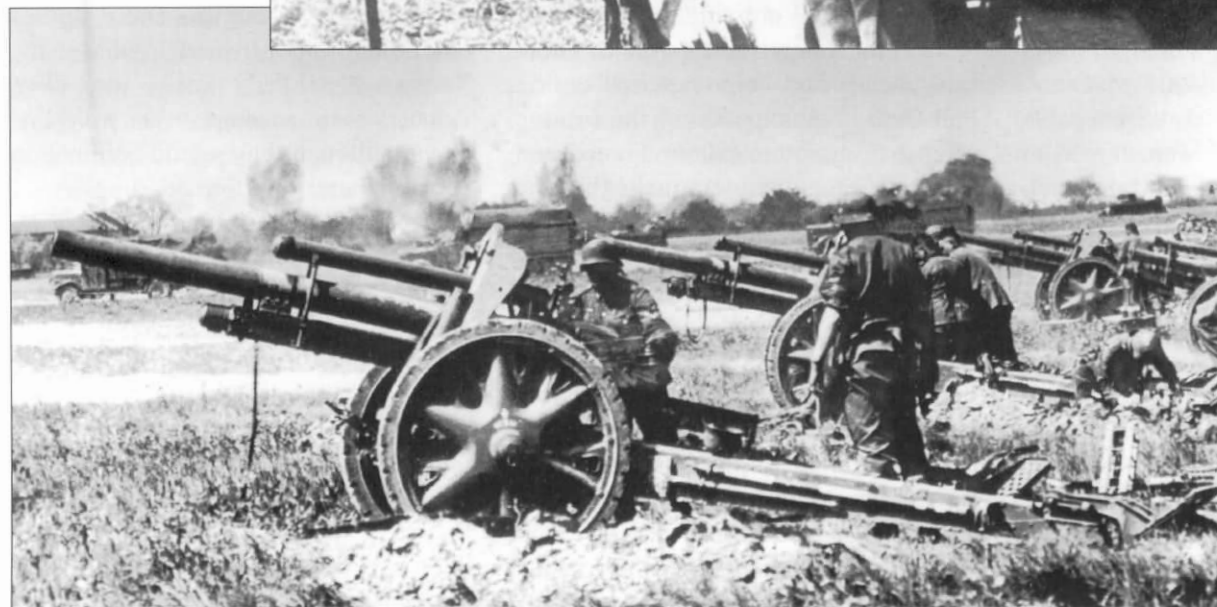
A battery of 10.5cm leFH 18 field guns with their prime movers and ammunition trucks in the background. Each panzer division was authorized one artillery regiment with 3 battalions, two equipped with 10.5cm guns and the other with 15cm guns. A battalion had 3 batteries, each with four guns as seen here. The third leFH 18 appears to have just fired, as the barrel is in full recoil.

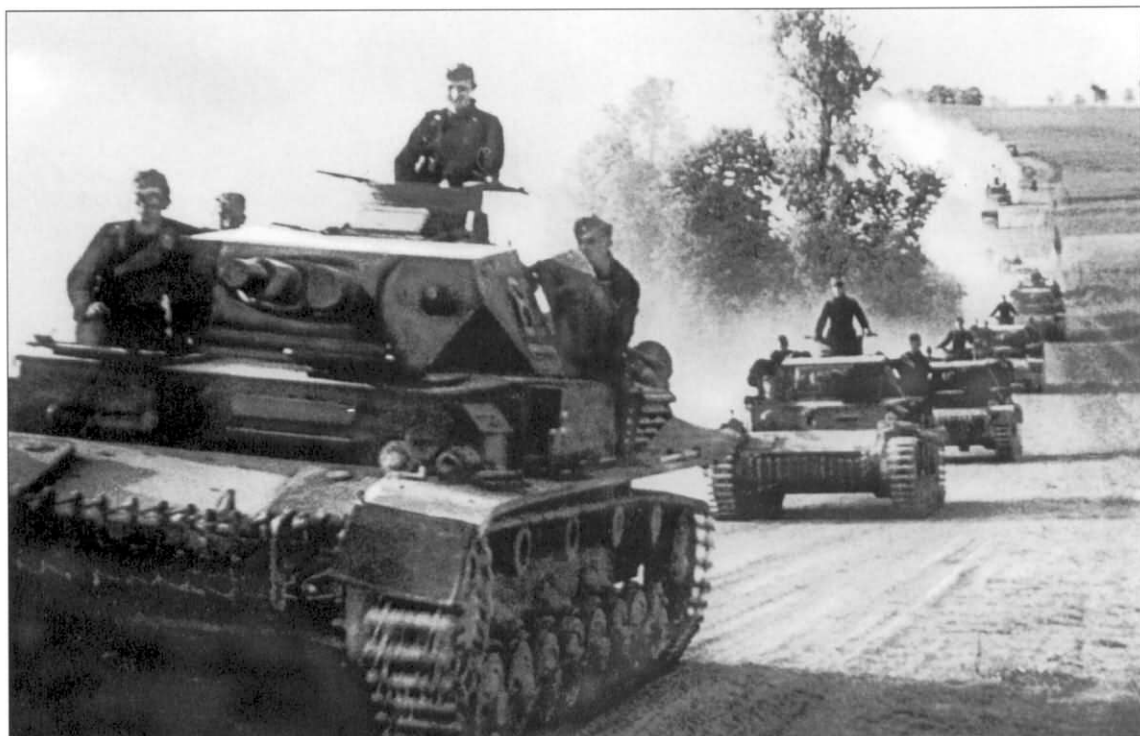
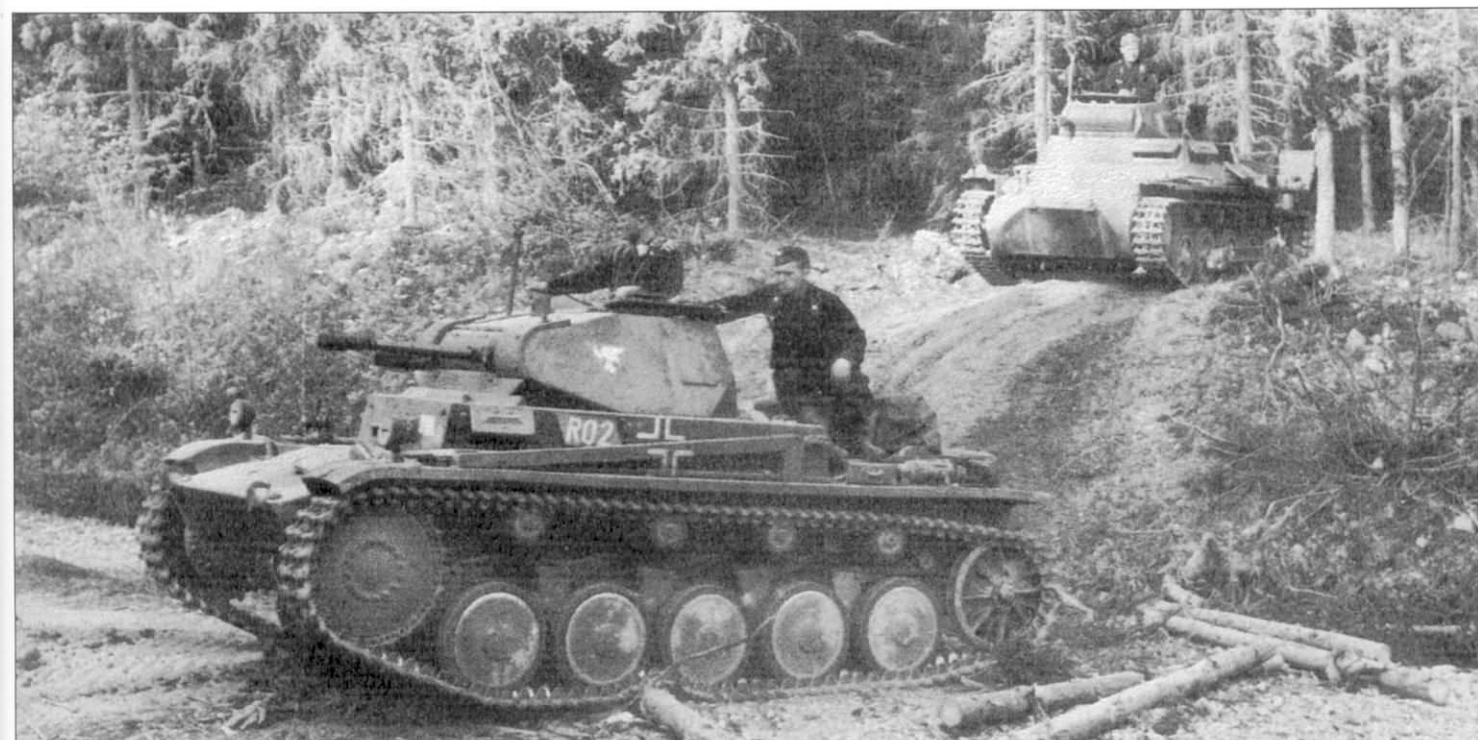
These two photos, although seldom published together, clearly depict the Pz.Rgt.3 or 4 command group of the 2. Panzer-Division moving through the Ardennes in Luxemburg or Belgium late in the day on May 10. In the first photo, the executive officer's Pz.kpfw.II leads a Pz.kpfw.I Ausf.B. The vehicle displays a unique personal emblem on the turret side, a white eagle painted on a dark colored triangle. The divisional insignia of two yellow dots appears between the cross, which has an unusual black outline, and the rhomboid plate. The glacis plate has a white rhomboid with an "R" beside it and the divisional sign is repeated below it. A color plate and different photograph of this tank appears in Concord #7033 "Panzer-Division 1935-1945 Volume (1) The Early Years 1935-1941".

In the second photo a Panzer II with "RN2" in white on its rhomboid plate leads "R01", the regimental commander's Panzer II. RN2 is presumably a vehicle from the regimental signals platoon. Both tanks carry identical markings to those seen on "R02" in the previous photograph, with the exception of the turret emblem.

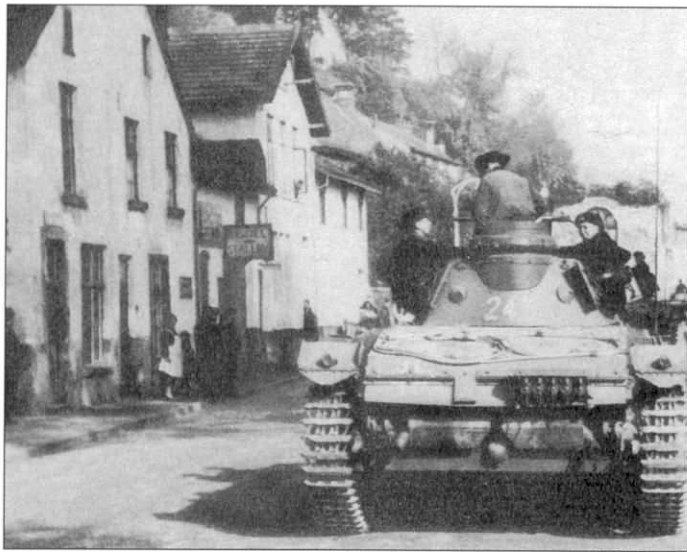
As part of the invasion plan, 6.Armee was tasked with a deception role. Its two divisions, 3. and 4.Panzer-Division, were to convince the Allied forces that their thrust through Holland and into Belgium was the main one while the real effort was made by Heeresgruppe A. This Pz.Kpfw.III Ausf.E or F is seen on the morning of May 10 passing through Valkenburg, roughly in the center of the narrow strip of Dutch land that separates Germany from Belgium and about 10km from Maastricht and its crucial bridges over the Meuse. Although no insignia is visible this vehicle is probably from 4.Panzer-Division and displays tactical number 245 in yellow. It is unclear in the original print if a Pz.Rgt.36 dot is also present.

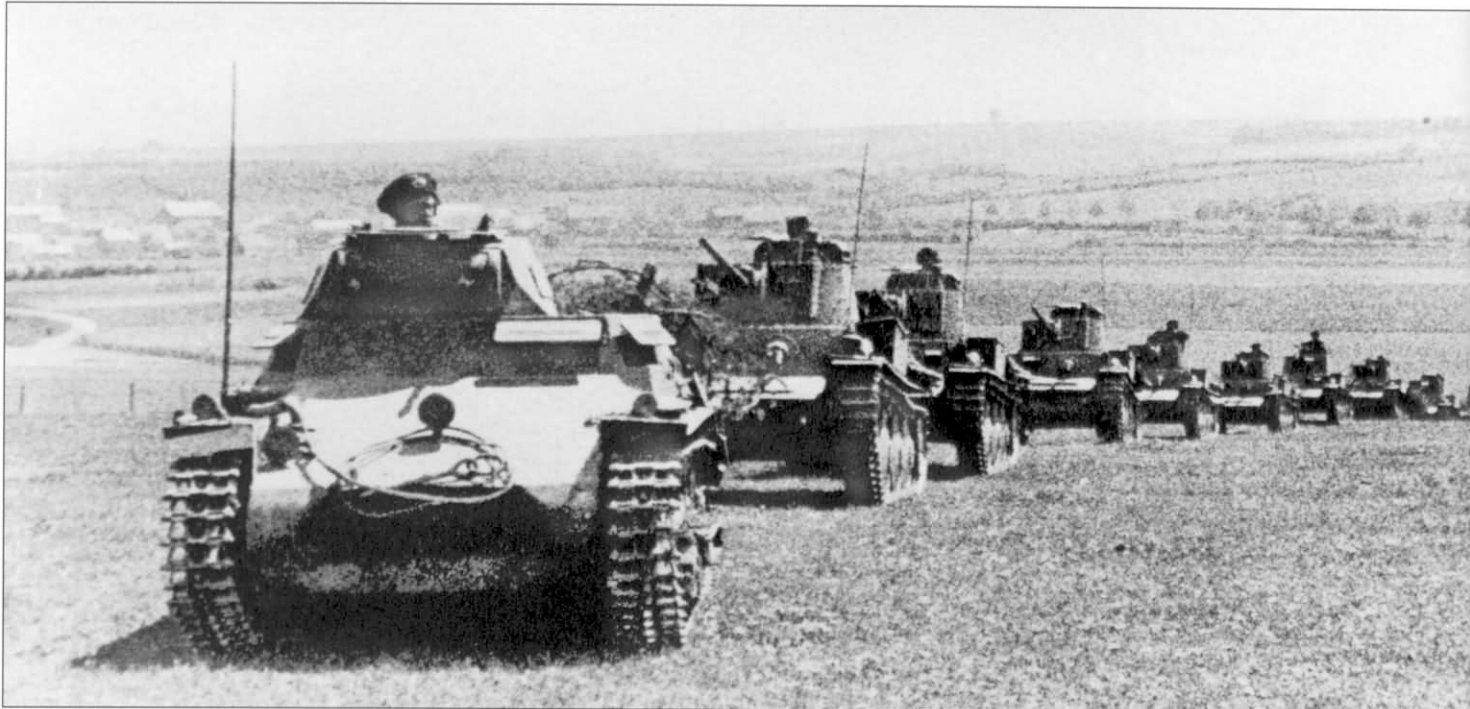
A column of panzers from the 7.Panzer-Division advance across Belgium on May 10 forming the left flank of XV.Armeekorps's drive to the Meuse River. In the lead is a Pz.Kpfw.I followed by Pz.Kpfw.38(t)s. The 7.Panzer-Division was the only division to have both types of panzers on strength at the start of Fall Gelb, with 34 PzI and 91 Pz38(t).

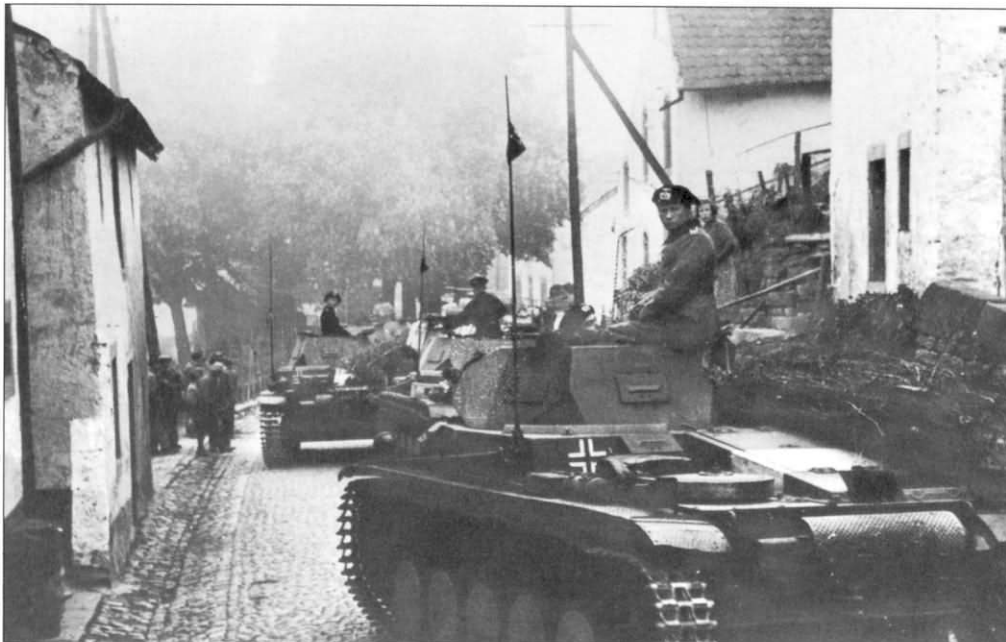
Panzerkampfwagen II from 10.Panzer-Division advance through a Belgian town on the first day of the attack after swiftly driving through Luxemburg. The 10.Panzer Division formed the southernmost flank of the XIX.Armeekorps, part of Pz.Gruppe von Kleist. Barely visible above the rear turret vision flap of both vehicles is the Bison emblem of Pz.Rgt.7. It appears that censors have obliterated the vehicle numbers on the turret side and rhomboid plate above the muffler. A white air recognition rectangle is prominently displayed on the engine deck and a couple of the tanks are flying unidentified banners from their antennae.

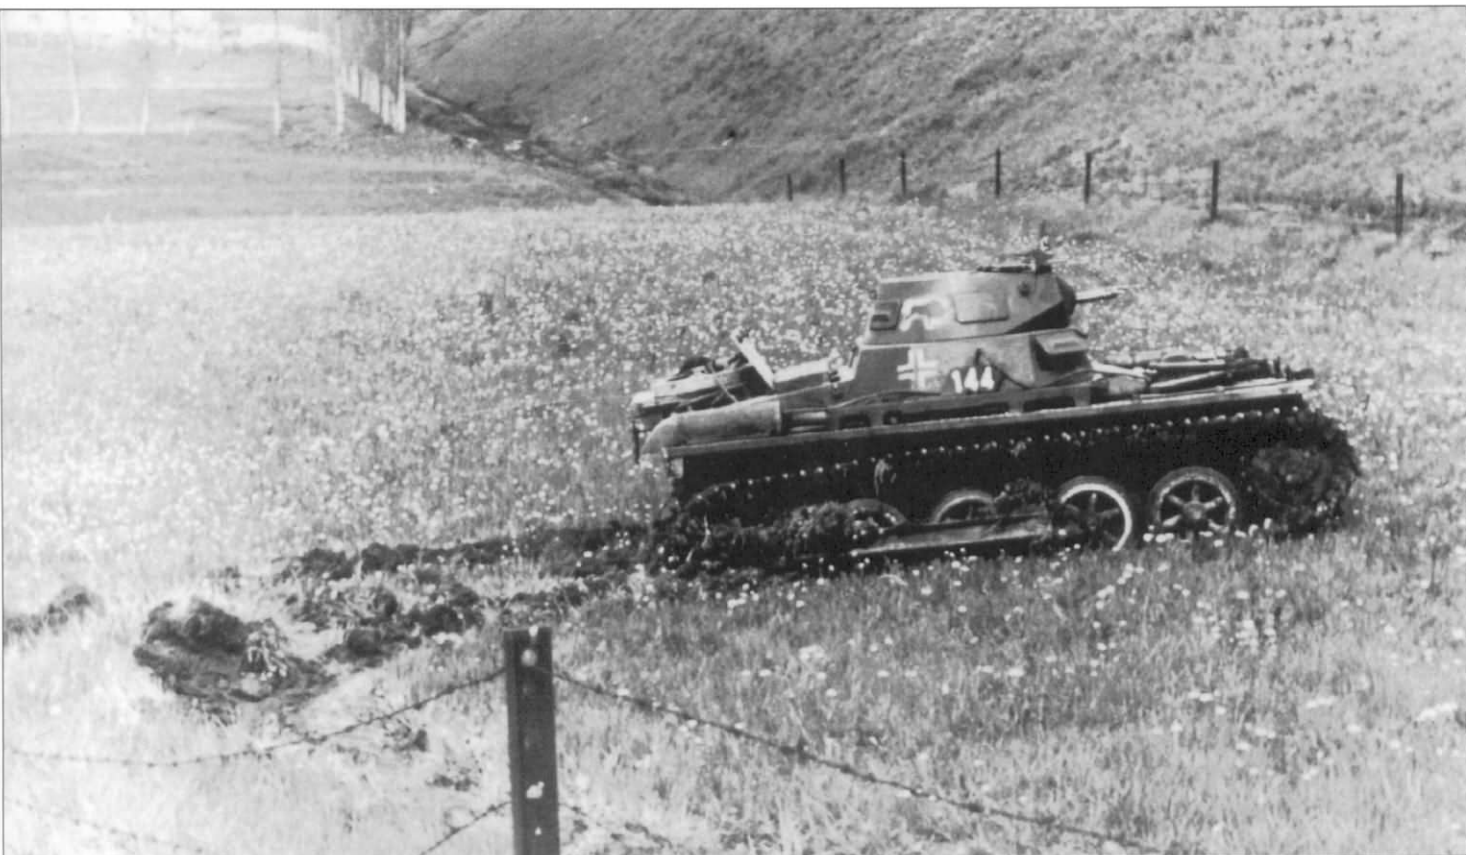
This Pz.Kpfw.I Ausf.A from Pz.Rgt.7, 10.Panzer-Division is in a field near Arlon on the opening day of Fall Gelb, May 10. Arlon was just across the Belgium-Luxembourg border and 10.Panzer-Division encountered its first serious opposition here, the French 2eme D.L.C. (a cavalry unit), and forced them back to the Semois River. The blue-gray outlined bison is clearly visible here, as are the other markings. It appears that one of the engine access hatches is open, probably for cooling, and some unidentified stowage is carried on the engine deck, possibly a spare idler wheel.

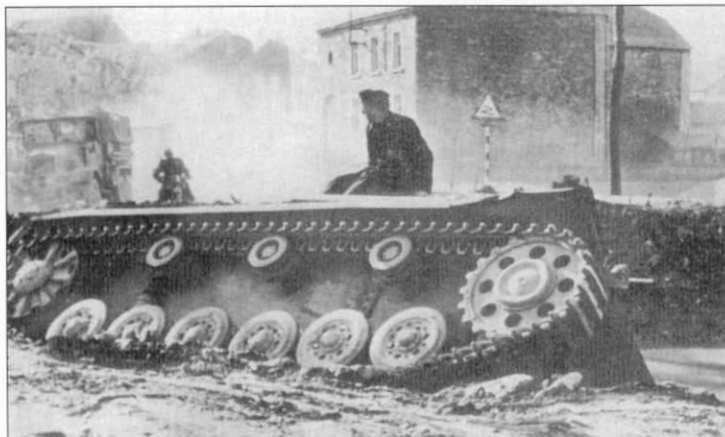
This Panzerbefehlswagen III Ausf.E of 1.Panzer-Division slid into a shell crater in the Belgian town of Bertrix on May 11. Although very little is visible in this photo, a picture from the other side confirms that it is a Pz.Bef.Wg.III with a tactical marking "1101" in white on the turret sides and rear so it was probably the 2nd Abteilung (battalion) commander's personal vehicle. The number is underlined to indicate Pz.Rgt.2. It also carried a unique solid white cross on the turret roof as well as the standard white rectangle on the engine deck for aerial recognition.

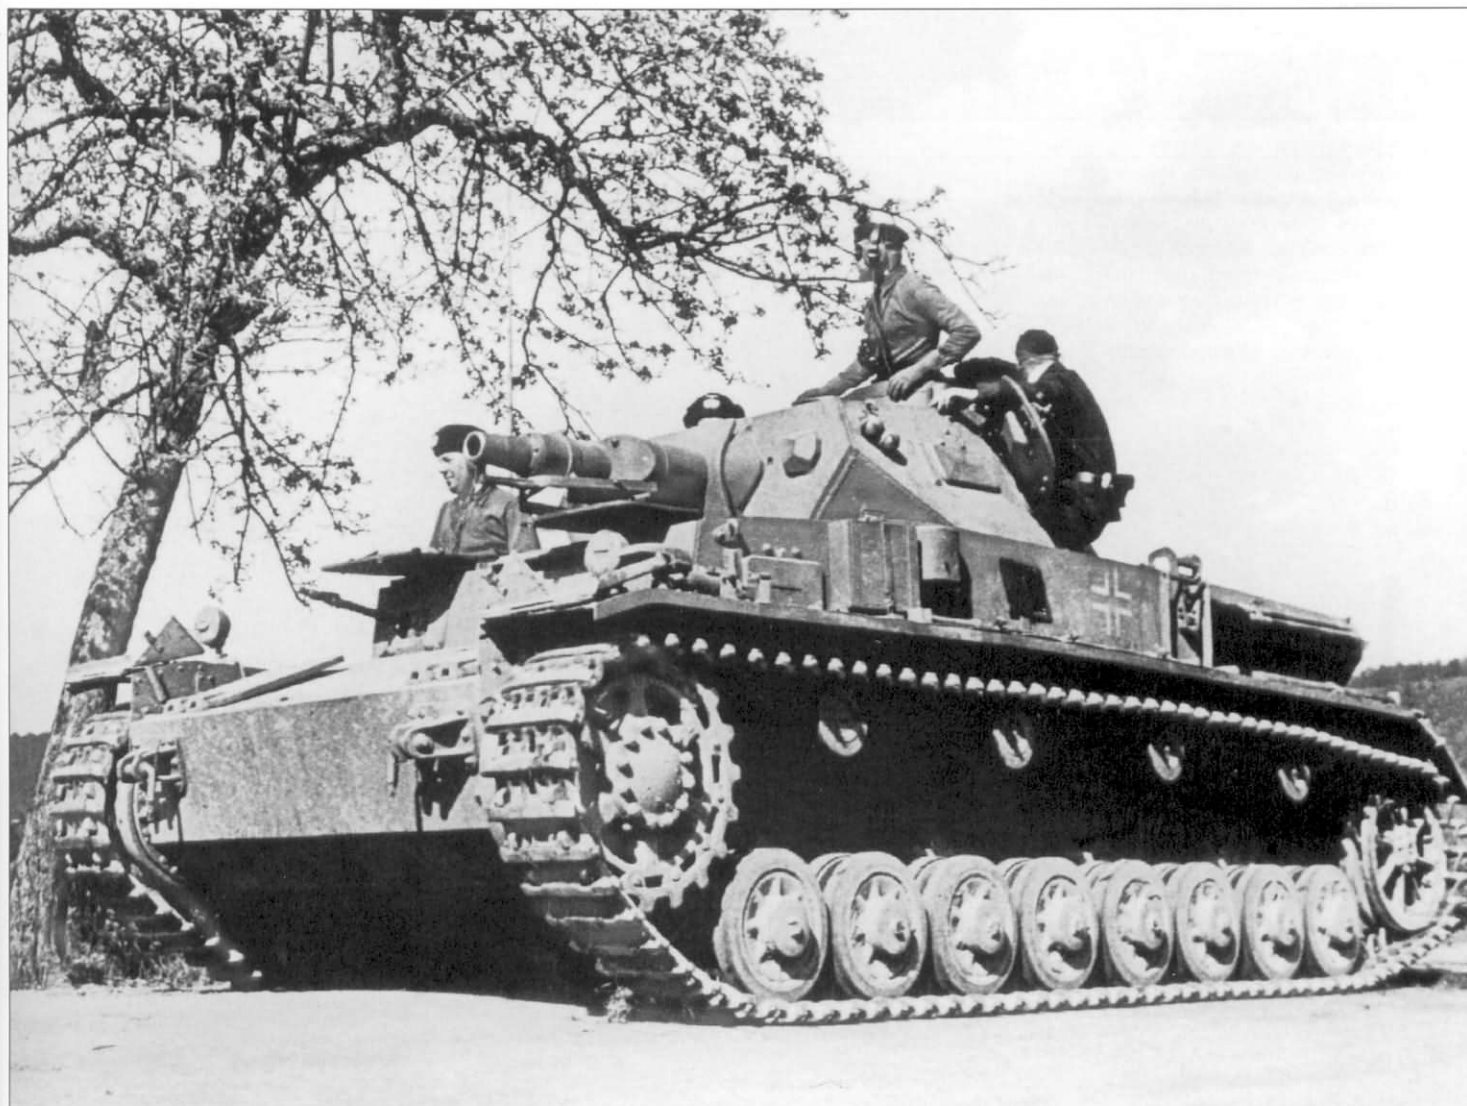
A Pz.Kpfw.IV Ausf.D near the Maas River in Holland. Although the divisional insignia of two yellow "X"s is not visible, this vehicle is from 9.Panzer-Division, which was the only unit equipped with these tanks for the sweep through Holland. After the initial invasion by airborne troops, 9.Panzer-Division performed a crucial role in linking up with the assault troops at the Moerdijk bridgehead. Not surprisingly, the 9th suffered very few losses as the Dutch government capitulated within 5 days.

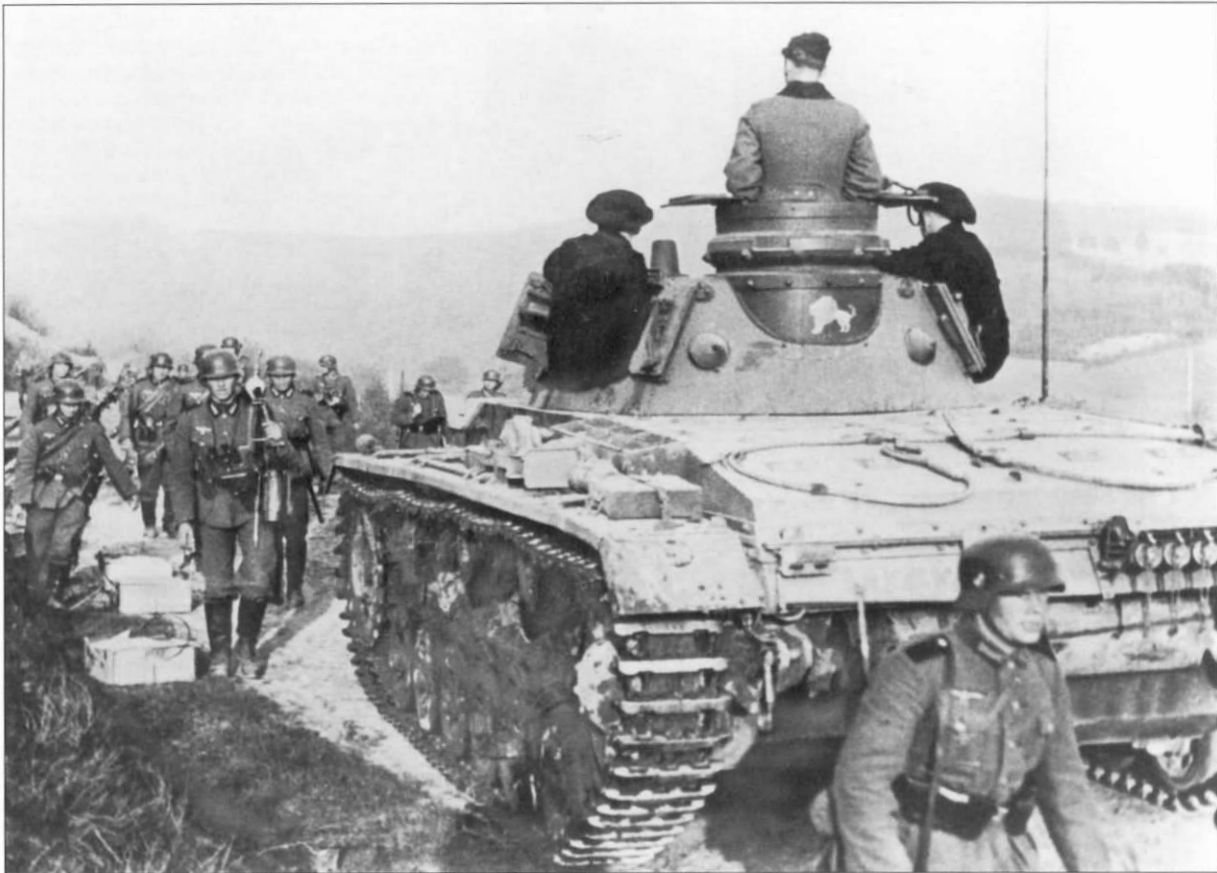
A Panzer III Ausf.E or F halts on a dirt road in the Ardennes on May 12 to allow an infantry section to pass. The detailed lion marking on the cupola bulge is unidentified and appeared on at least one other Panzer III. Just visible on the rear plate beside the helmet of the Schütze (private) in the foreground is the tactical number 232 in yellow alongside a national cross. The convoy light is a field modification as it was not introduced as standard equipment until the Ausf.G and then it was mounted on the left fender in place of the taillight.

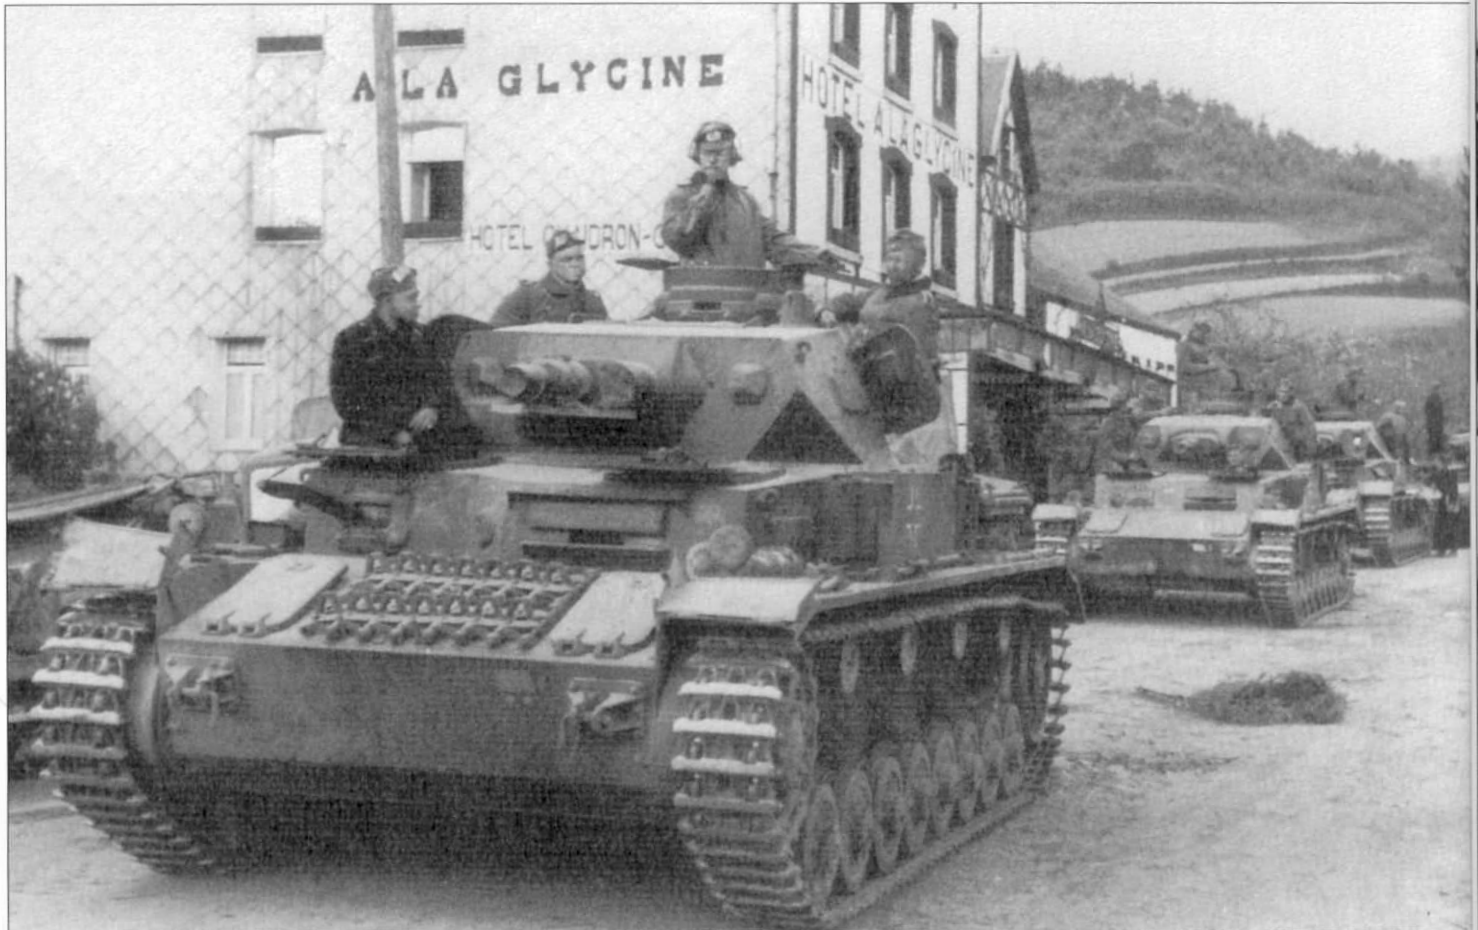
Travelling through the Belgian town of Vresse on May 12, a column of Panzer IVs approach their crossing location over the Semois River. The Semois was the first major river obstacle that Panzergruppe von Kleist had to cross. The lead vehicle is an Ausf.D, while those following are either Ausf.B or C. The 2.Panzer-Division emblem of 2 yellow dots appears below a yellow rhomboid both on the lower hull plate and beside the driver's visor. A small "5" next to the lower one signifies the 5th company. The following vehicle displays similar markings but the divisional sign has been moved to a centralized location on the upper superstructure plate.

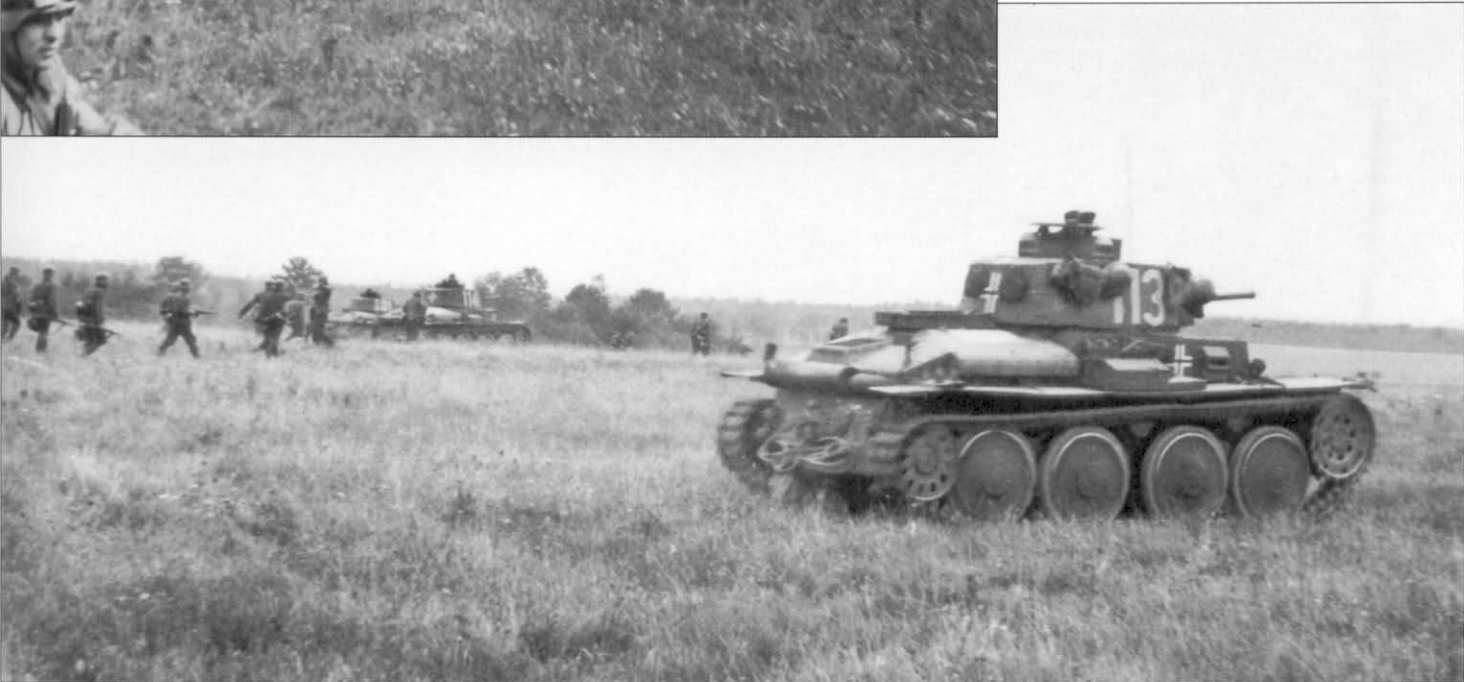
Pz.Kpfw.38(t)s from 7.Panzer-Division advance across a field with infantry support. In the far background can be seen tank "101", the commander's vehicle from the 1st Abteilung (battalion) of Pz.Rgt.25. The two others, "113" and "114", are from the 1st platoon of the 1st company. The roadwheel rims have been worn to a bright bare metal finish due to rubbing the track guide teeth.

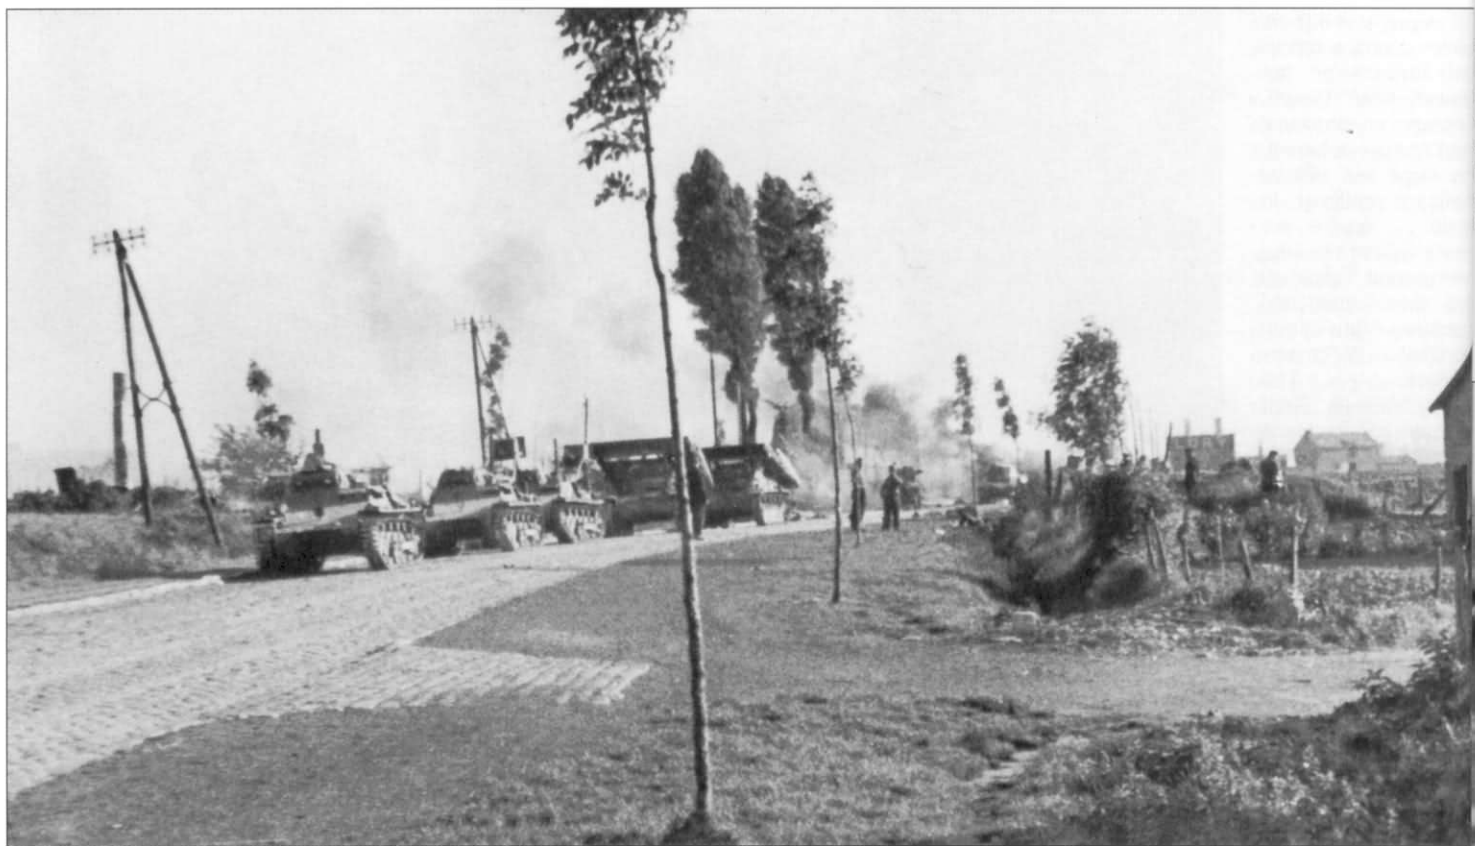
Each panzer-division's third company of its pioneer battalion was to be equipped with four Pz.Kpfw.IV bridgelayers for Fall Gelb. Due to shortages of equipment only half received the allotted numbers and the rest of the battalions were left to deal with the situation on their own. As shown here, Pioneer Bataillon 58 from 7.Panzer-Division equipped at least 2 standard Pz.Kpfw.II with bridges, although it is unclear if these were simply carried on blocks or if an actual launching mechanism was built. Leading the bridgelayers are three Pz.Kpfw.I Ausf.B.

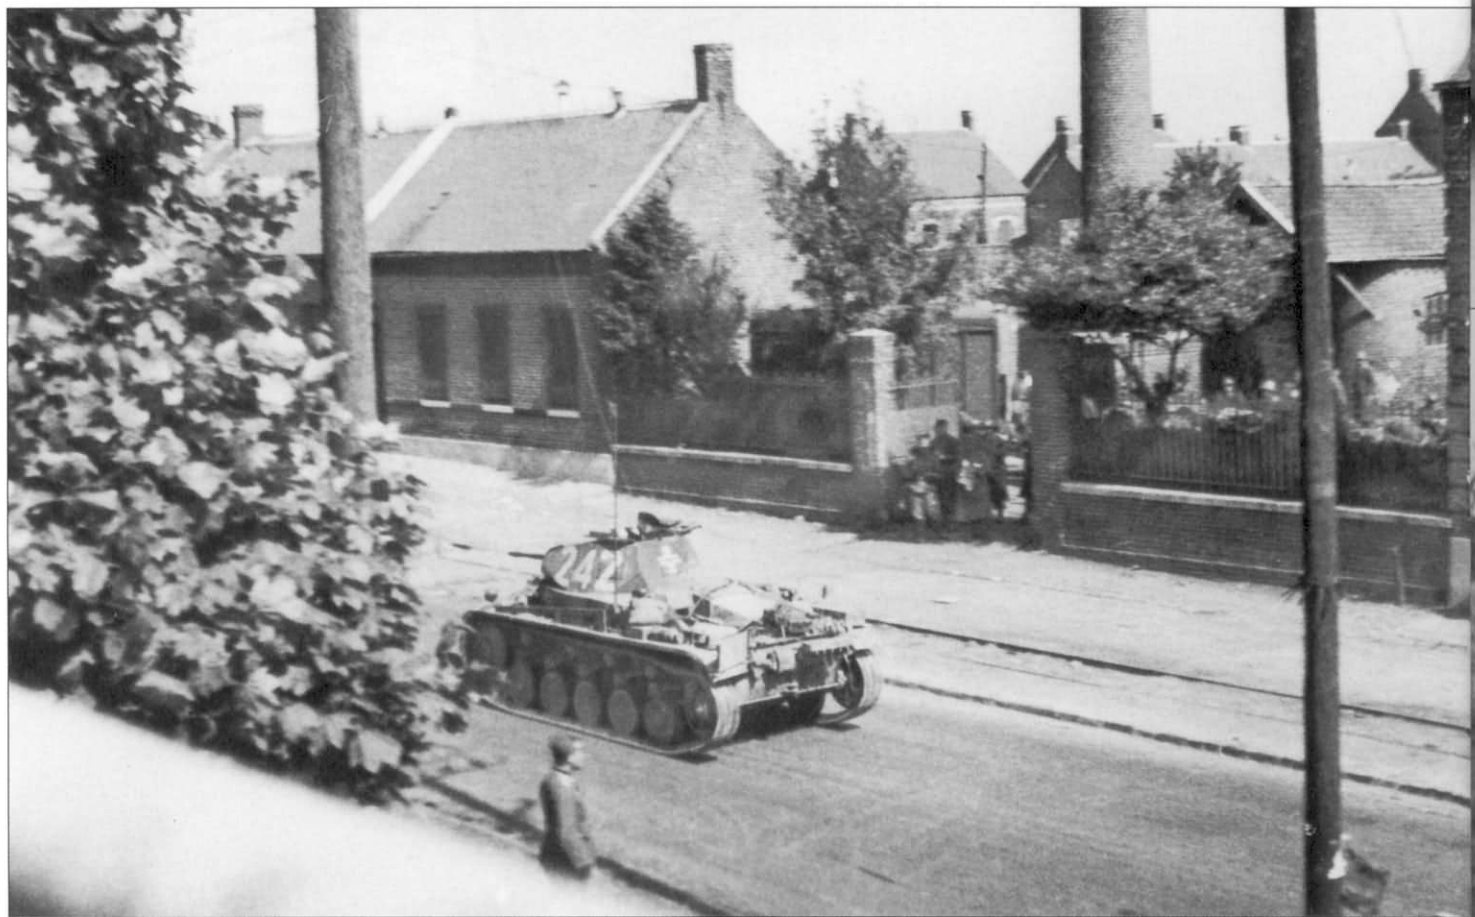
A Pz.Kpfw.II Ausf.A-C moves quickly down a French street in a town that appears untouched by the effects of war. From the style and color of the turret numbers, this vehicle is probably from 7.Panzer-Division as this was one of the only units to display this style. A prominent black and white cross is on the turret rear. Note that the crew has been careful to leave the white aerial recognition rectangle on the engine deck unobstructed.

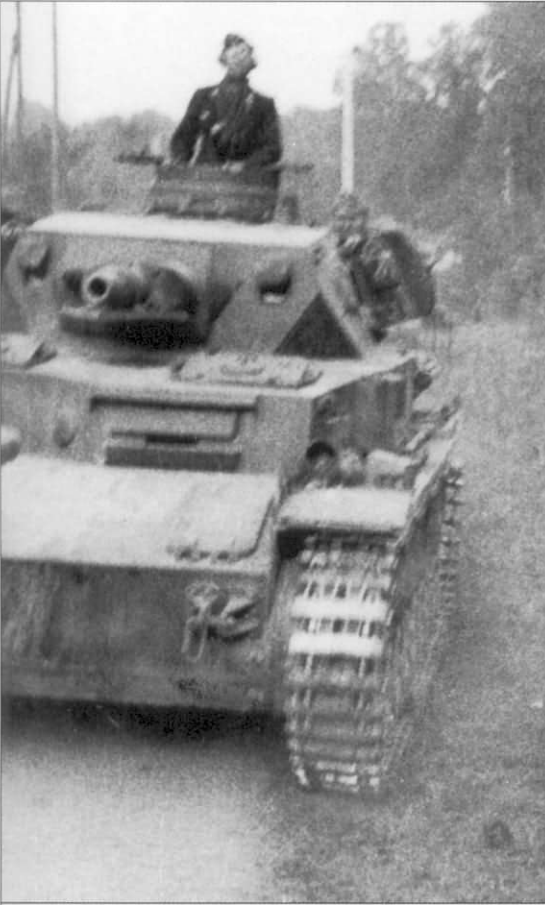
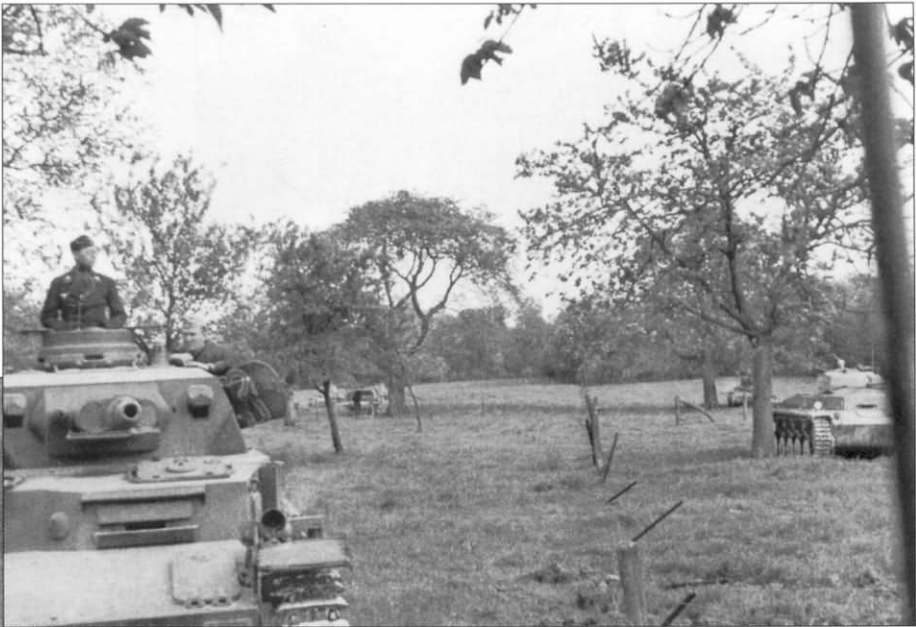
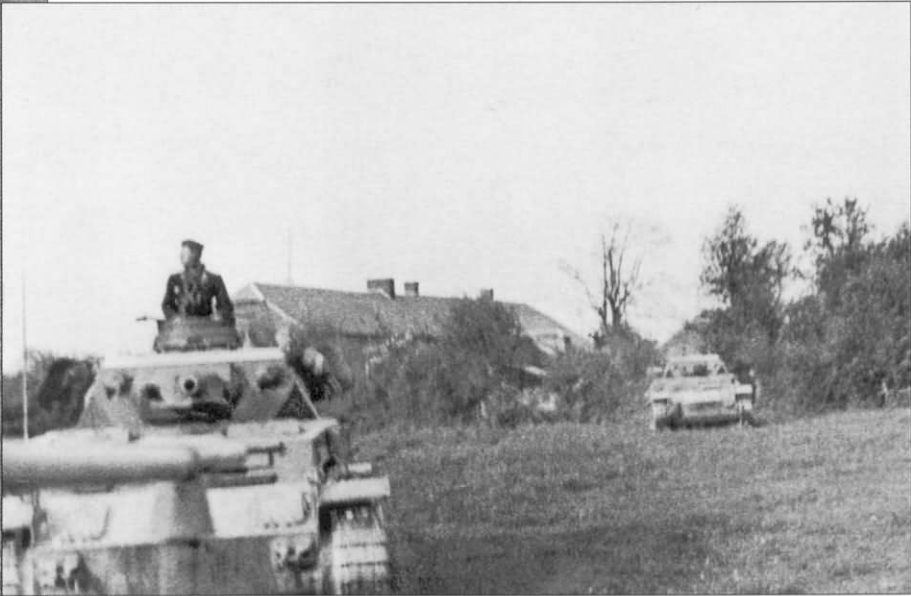
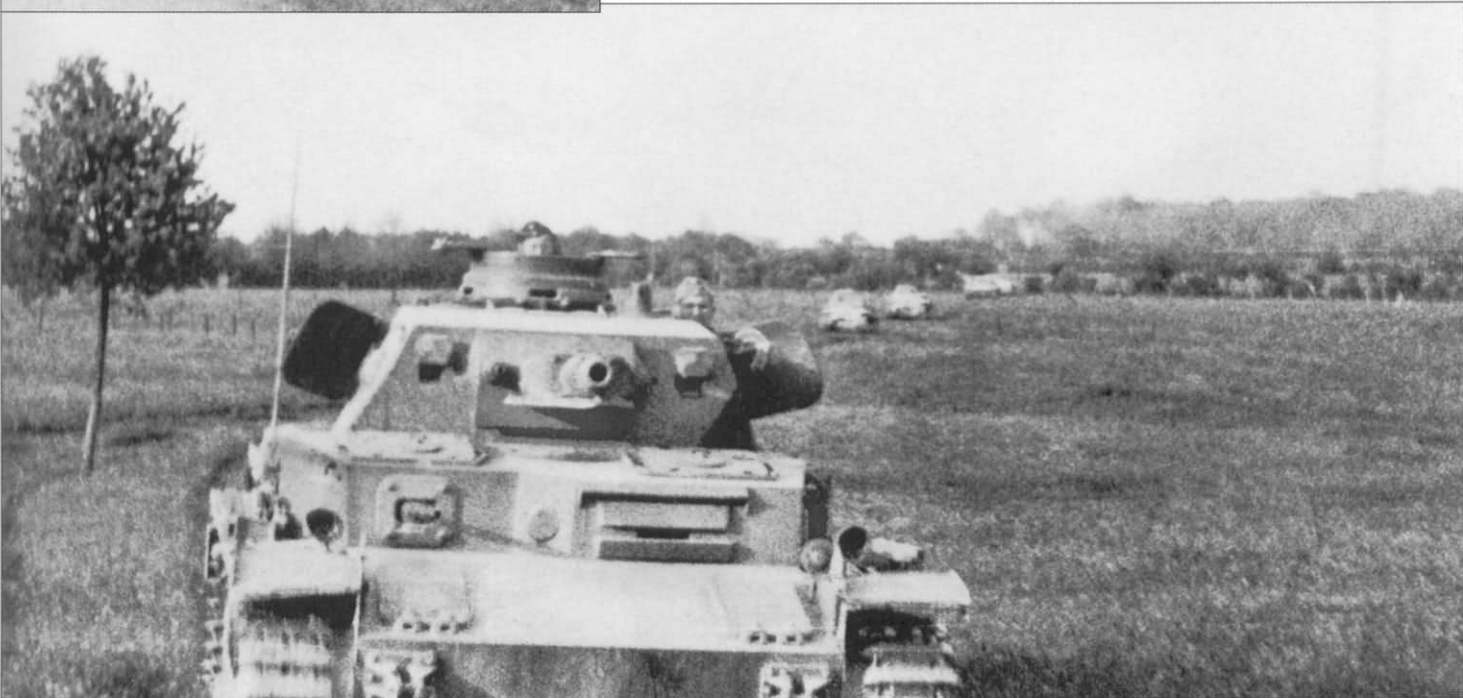
A unique set of four photographs taken roughly in sequence of a Pz.Kpfw.IV Ausf.D from 7.Panzer-Division. The familiar red with thin white outline tactical numbers are apparent from the open turret doors, of which a "3" is visible. In the background can be seen additional Pz.Kpfw.IV, as well as Panzer IIs and 38(t)s. Notice that the turret crewman wears a field gray version of the Feldmutze (sidecap), while the commander's is black.

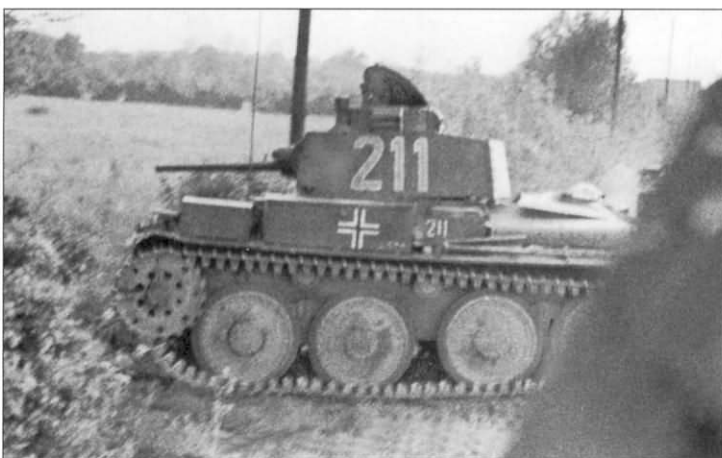
The commander of this Pz.Kpfw.38(t) has propped the cupola hatch open so that only his head is exposed as the tank turns off a French road to traverse a field. Along with the standard pattern of turret numbers, this Pz.Rgt.25 vehicle also has the yellow 7.Panzer-Division insignia just behind the thin national cross, and the tactical number repeated on a fender-mounted rhomboid plate. The additional fender stowage bins were a common modification to these tanks due to the lack of internal space and many were fabricated by the unit workshops and thus quite similar.

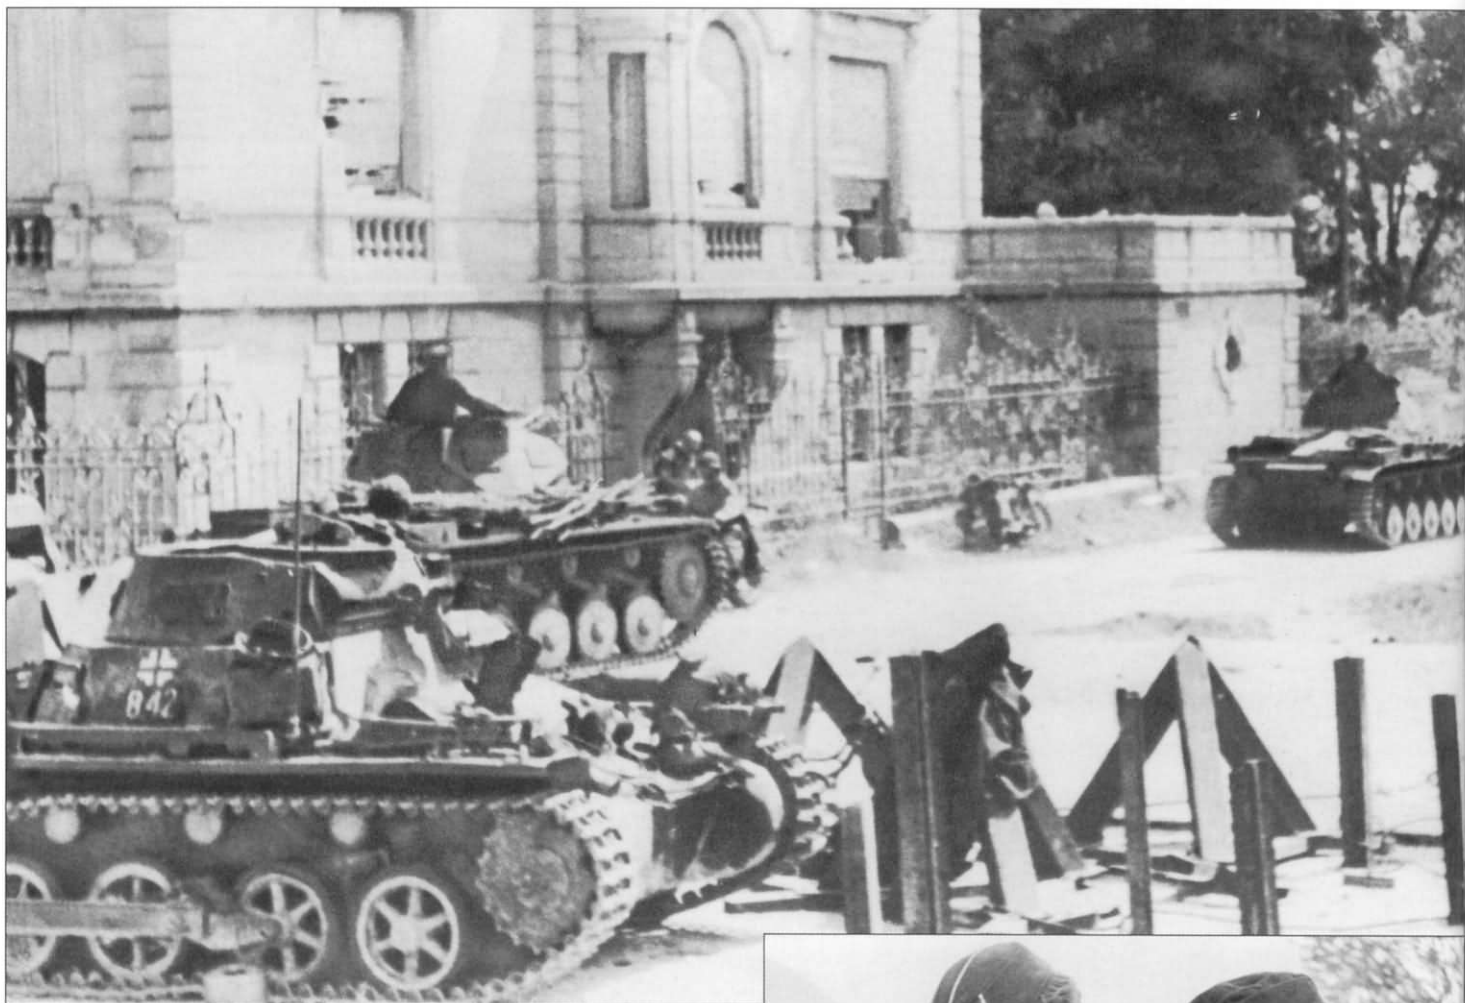
Panzer IIs pass a disabled Pz.Kpfw.I Ausf.A in Sedan after the fighting. The tactical number "842" is seen on a black rhomboid plate. In front of the Panzer I are numerous steel anti-tank obstacles erected by the French. All the vehicles have very light colored roadwheels, invariable due to the dusty conditions.

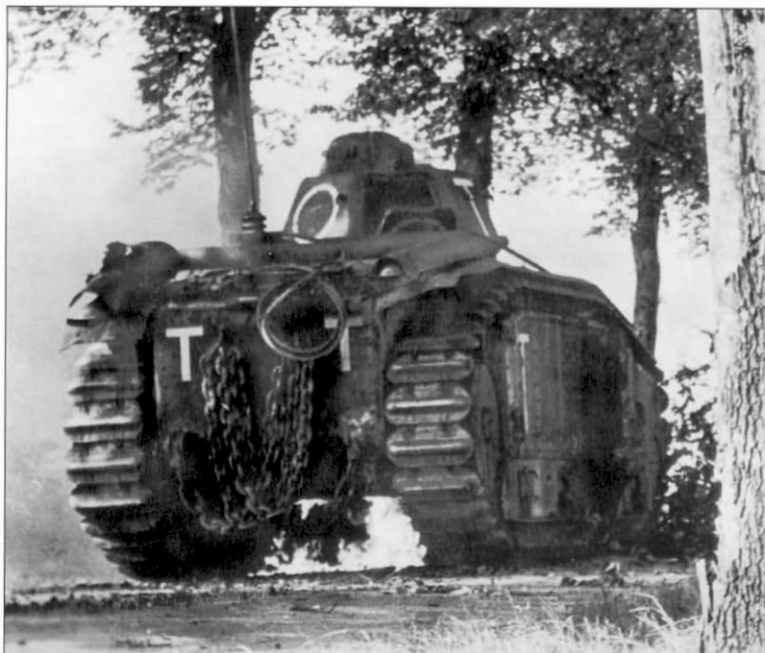
Although the front glacis is not visible, this Renault B1bis is named "Guepratte" and was one of eight tanks decimated by German forces on May 15 near the town of Denee. The tanks were from 37ème B.C.C., this particular one from 3ème Compagnie, 1er Section. Defending against the attack was Inf.Rgt.28 of 8.Infanterie-Division. Since the standard German anti-tank guns could not penetrate the armor of the B1bis, 10.5cm artillery pieces from Art.Rgt.8 were used in this engagement to help stop the French assault.
