# ACHTUNG

# PANZER

The German Invasion of  
France and the Low Countries

Jon Feenstra

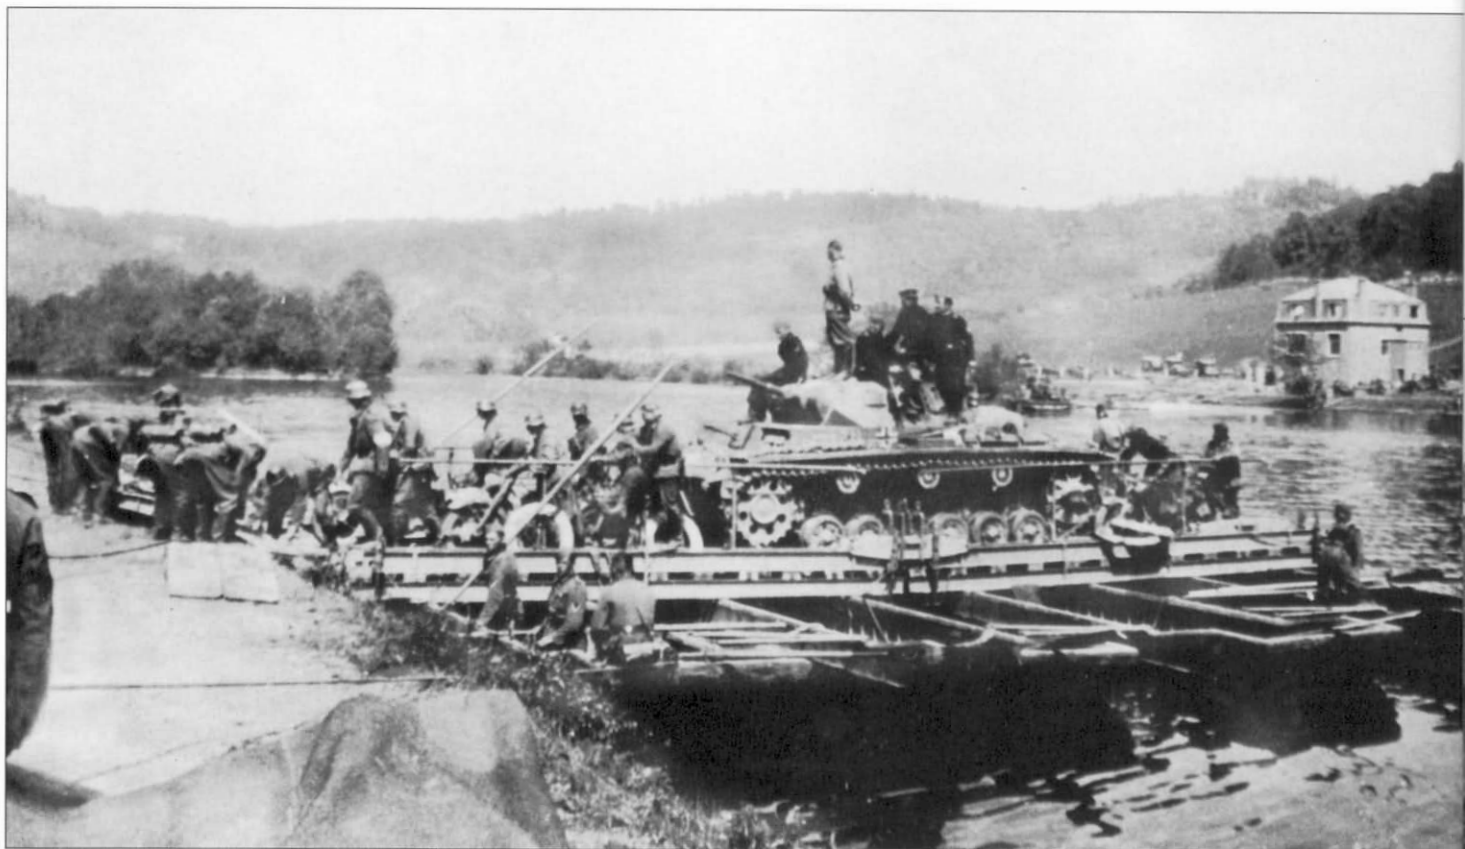
The Meuse was crossed by 5.Panzer-Division on May 13 to the south of Houx. Pontoon barges were used initially to ferry equipment across until the engineers could construct a pontoon bridge. Here, a Pz.Kpfw.III and group of motorcycles have just reached the west bank and are waiting for the offloading ramp to be emplaced. In the background can be seen many more vehicles and equipment waiting to cross.

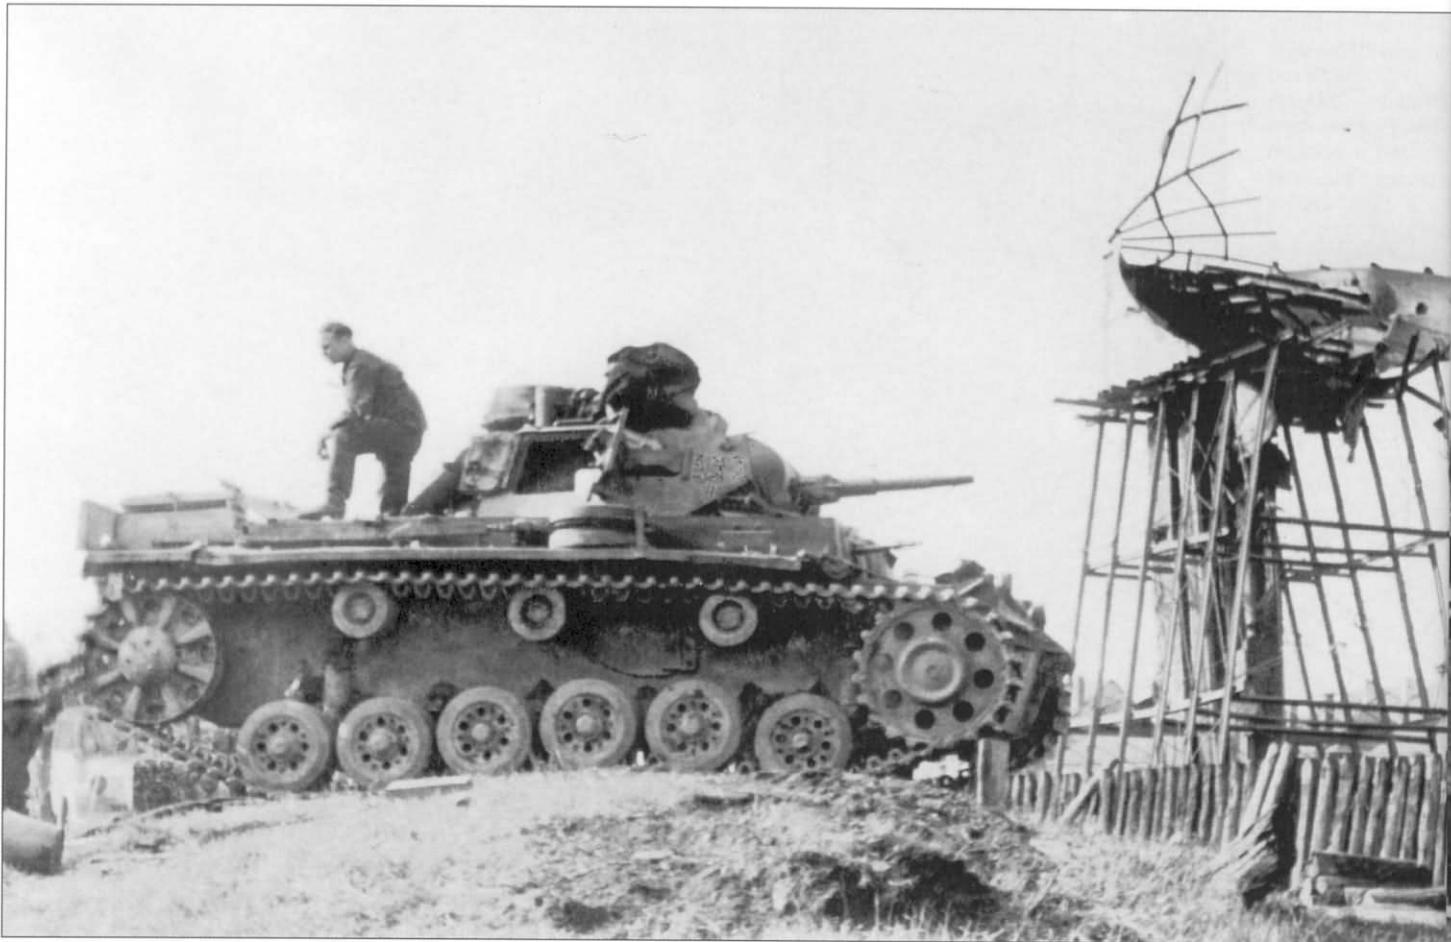
A Pz.Kpfw.III Ausf. F halted outside a town on May 15. The crew is using the opportunity to wash up and most likely perform whatever maintenance they can. Although censors have tried to obliterate the markings, the last two digits of the tactical number in front of the turret view port can be seen, "33" in white outline. Below the turret number is what appears to be the oakleaf emblem of 1.Panzer-Division. The front portion of the fender has been torn off.

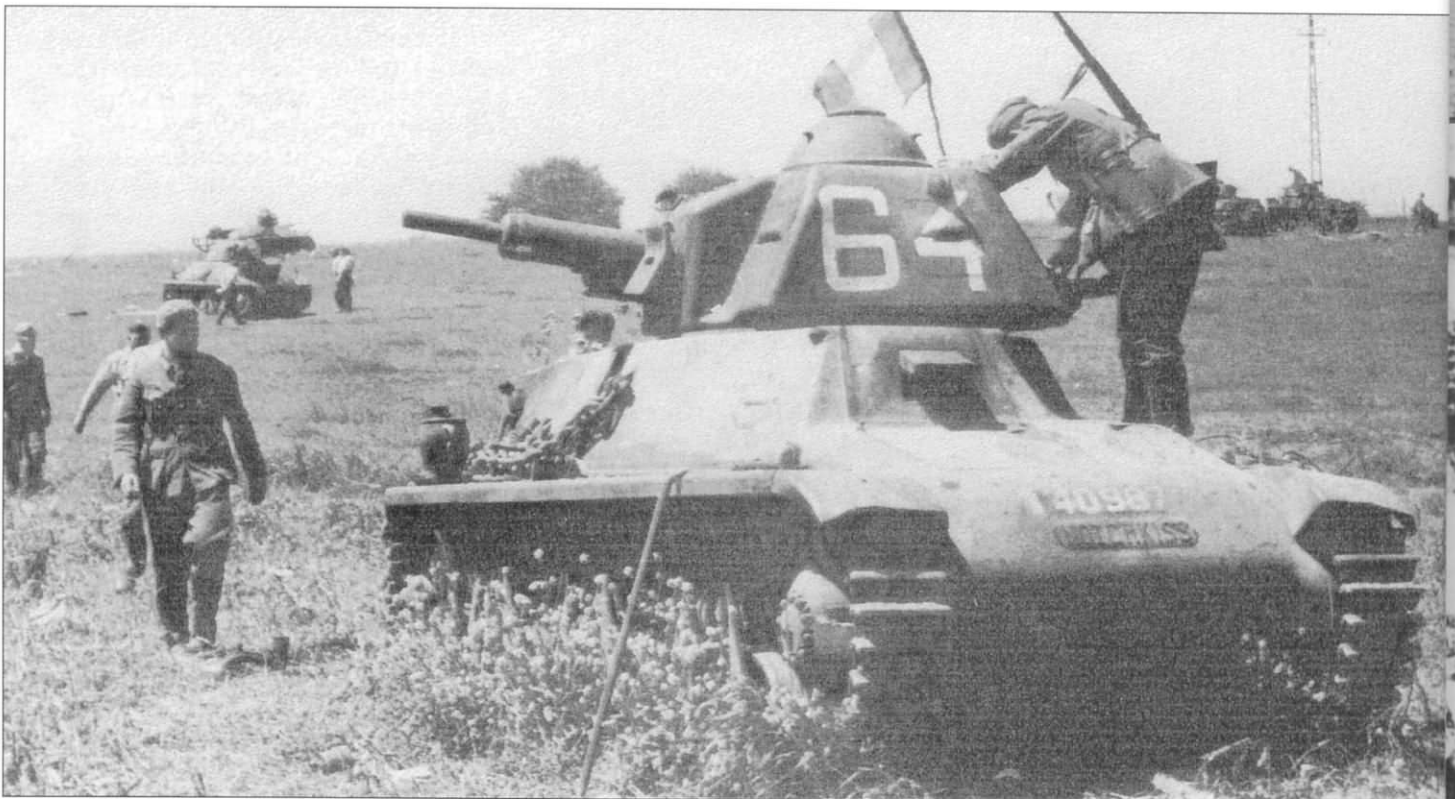
German soldiers examine a field of French tanks destroyed or abandoned during the Battle for the Gembloux Gap. This battle was fought over the course of four days between May 12 and 15 and involved hundreds of tanks from 3. and 4.Panzer-Divisions and the French 2ème and 3ème DLM (Light Mechanized Division). Both sides suffered numerous losses but the French tankers proved they could hold their own against the German panzers. This Hotchkiss H-35 from the 3ème DLM carries the standard national tricolor and matricule (serial) on the front hull and flies a French flag from the turret. This was as per a directive issued May 22 by the French command to provide a quick recognition symbol for friendly forces. In the background are other H-35, H-39 and Somua.

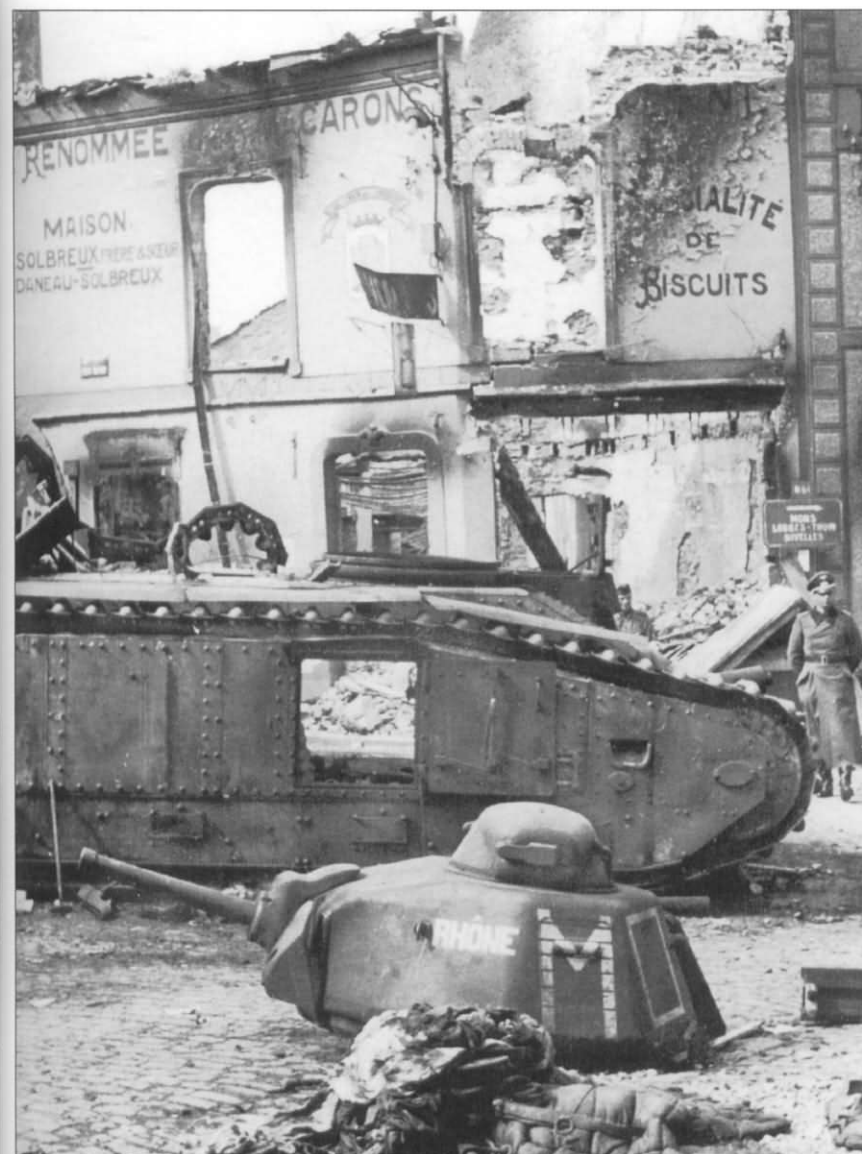
This French Renault B1bis was set on fire by its crew and subsequently exploded, dislodging the turret. "Rhône" was one of five remaining tanks of the 37ème B.C.C. that were destroyed by their crews in the town Beaumont on May 16 after being surrounded by Kampfgruppe Harde of the 5.Panzer-Division and running out of fuel. Unlike their German counterparts, French tanks were usually colorfully painted and marked. In this case the white square denotes 1er Compagnie (1st Company) while a playing card symbol within the square denotes the Section, unfortunately not visible here but probably a red spade for the 1er Section. The "M" is the section code letter. After 3 days, 37ème B.C.C. had lost all 33 of their Renaults to enemy action and fuel shortages.

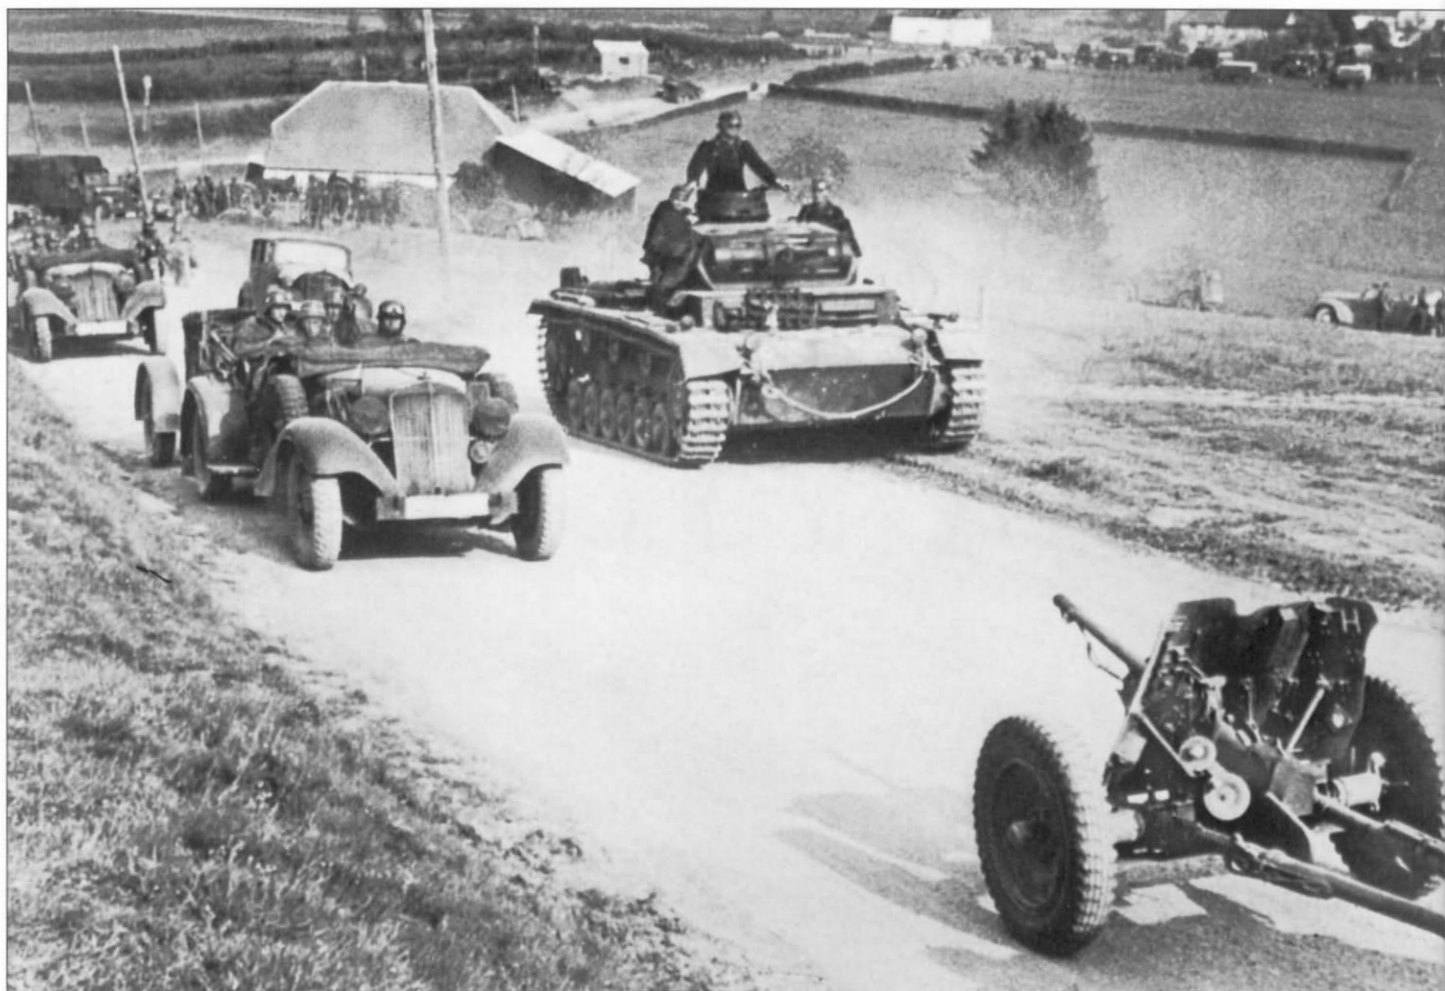
A column of Kfz. 12 (Horch 830 R) towing 3.7cm Pak 35/36 anti-tank guns and trailers passes a Pz.Kpfw. III Ausf. E on a dusty road in Belgium on May 17. The speed of the advance over the previous week left many of the infantry and supporting units far behind. In the background can be seen numerous cars and trucks as they attempt to catch up with the panzer regiments. The letter "H" on the inside of the gun shield probably indicates the individual gun within the company, as the standard anti-tank company at this time was equipped with 9 guns.

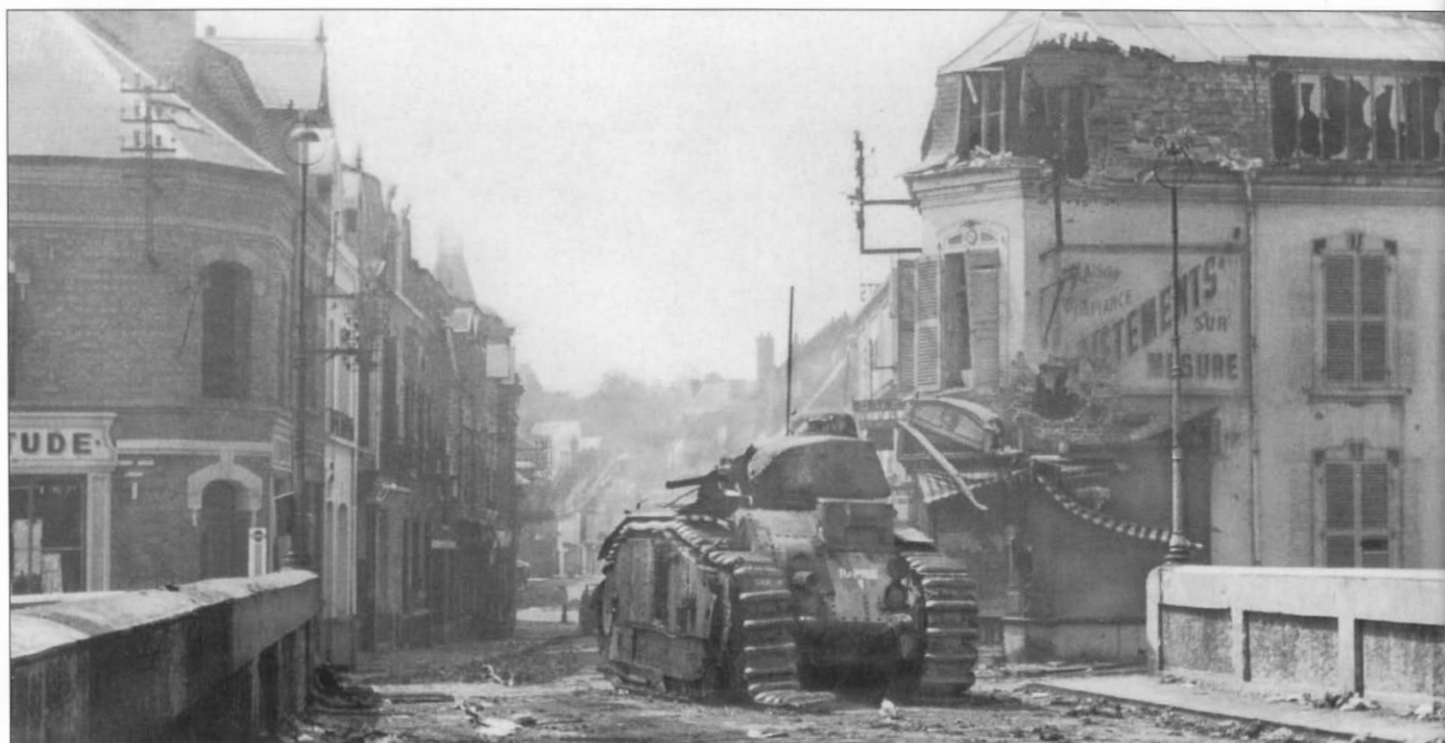
"Rapide", a Renault B1bis from 1er Compagnie, 8ème B.C.C., 2ème D.C.R., was disabled on May 17 by elements of 6. Panzer-Division while defending this bridge across the Oise-Sambre Canal in the town of the Guise. The French commanders continually misused their armored units in situations such as this, committing individual tanks to static defensive positions without any support, instead of using their mobility and large numbers to their advantage. Although the camouflage pattern is not clear in this photo, other tanks in this unit were painted green and ochre with the pattern outlined in black.

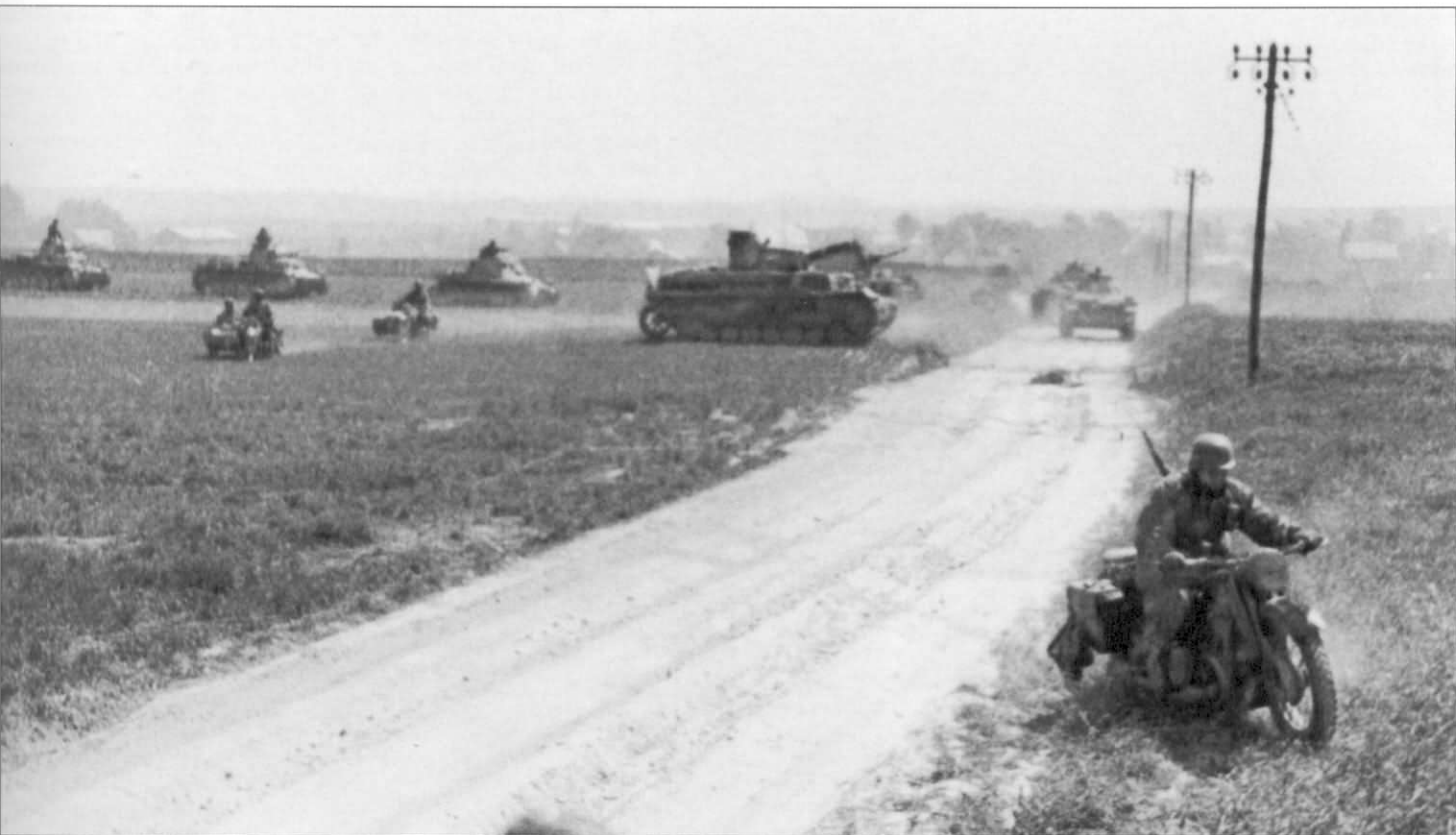
Several types of panzers and motorcycles from 7.Panzer-Division advance across a French field towards a road and village. Nearest to the camera is a Pz.Kpfw.IV, followed by a kl.Pz.Bef.Wg.I Ausf.B and two Pz.Kpfw.II. Immediately behind the Panzer IV is what appears to be Pz.Kpfw.38(t). As seen here, motorcycle mounted infantry was a primary component of the German blitzkrieg and although vulnerable to small arms fire, it allowed the infantry to keep pace with the panzer units during their advances.

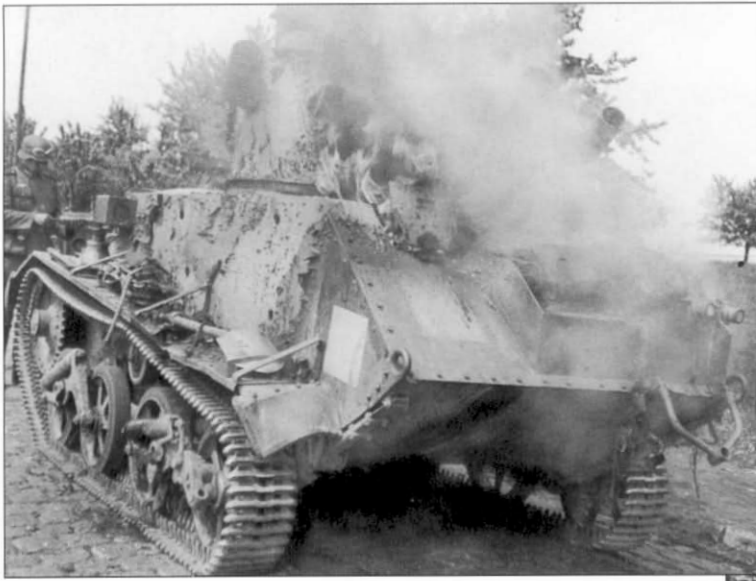
A German soldier examines a burning Mk. VIB of the British Expeditionary Force (BEF). Of the approximately 640 BEF tanks in France, including those of the 1st Armoured Division that arrived between May 15 and 19, over 380 were the Mk. IVB light tank. Unfortunately, it was little more than a fast reconnaissance vehicle, being poorly armed and armored, and no match for most of the German tanks. The white square was a standard identification marking on a BEF tanks.

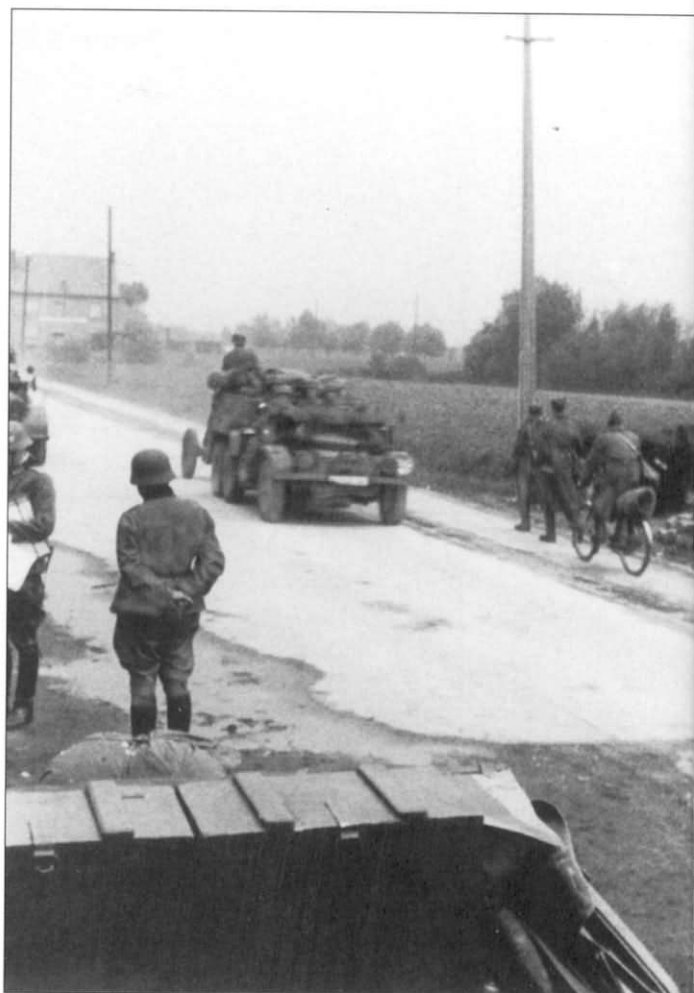
A Krupp Protze Kfz.69 truck pulling a 3.7cm gun on a road in France. This light truck was very common throughout the early battles of WWII and served a variety of roles, particularly as a prime mover for the 2cm Flak 38 and Pak 35/36 seen here.

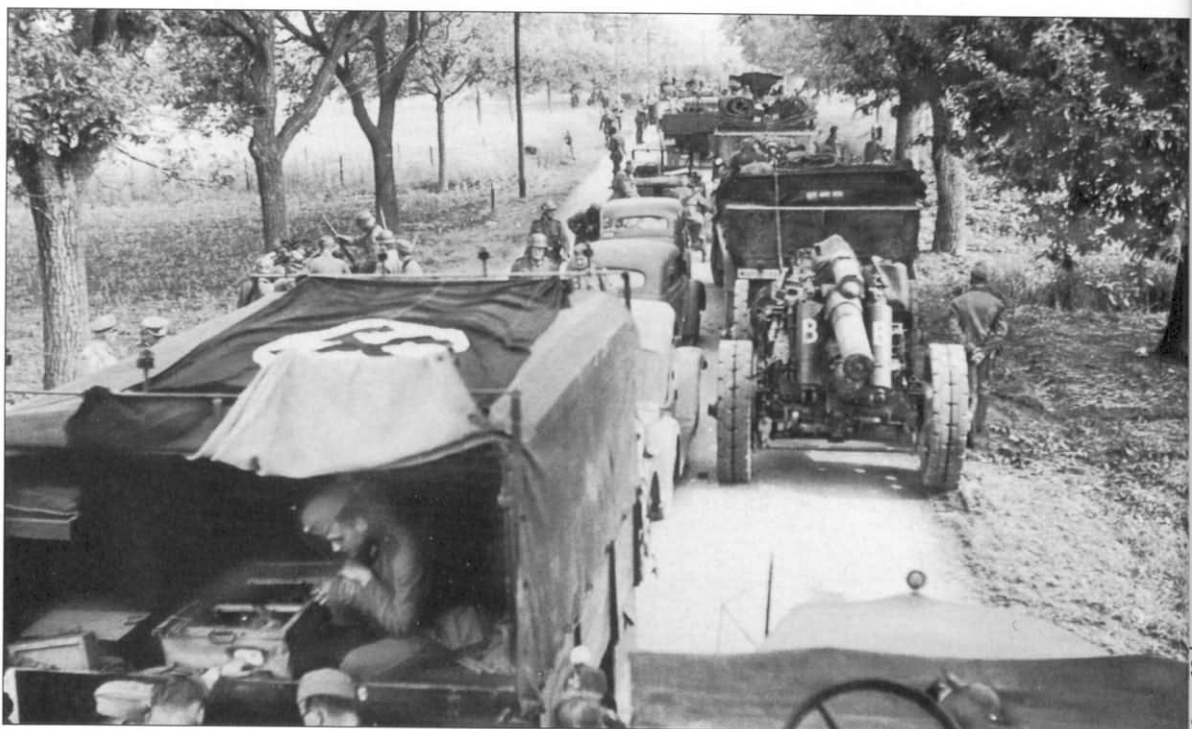
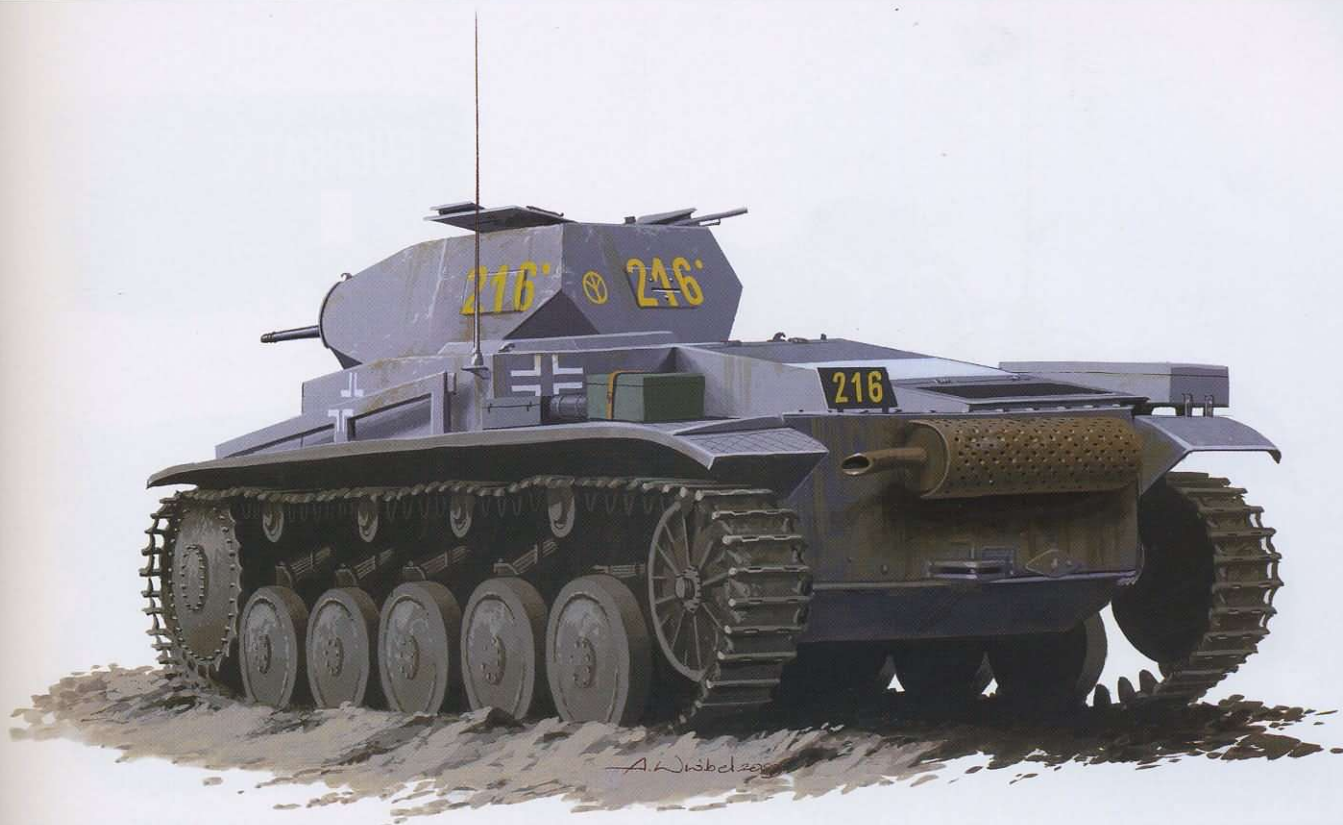
**Pz.Kpfw.II Ausf. A, B or C, Pz.Rgt.36, 4.Panzer-Division, France, May 1940**

Finished in standard Dunkelgrau RAL 7021, this vehicle displays a full set of markings. The divisional insignia is painted in yellow on the turret rear as is the vehicle number "216" on the turret rear and side. The yellow dot behind the turret number signified the regiment, to differentiate it from the other unit in the division, Pz.Rgt.35. The vehicle number also appears in yellow on the black painted rhomboid mounted on the rear plate. White outline crosses appear on both the side and rear superstructure, and a white air recognition rectangle is prominently displayed on the engine deck.

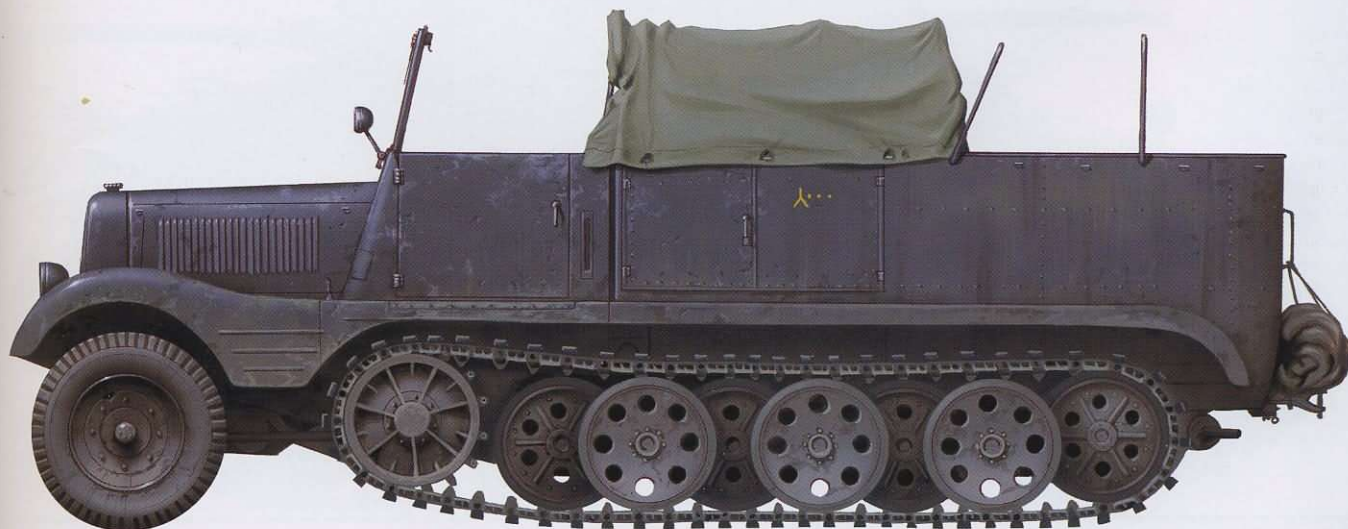
**Sd.Kfz.11, Art.Rgt.78. 7.Panzer-Division, France, May 1940**

A dark gray 3-ton towing tractor with the yellow 7.Panzer-Division insignia on the rear door of the stowage compartment. It is likely that the vehicle had an artillery tactical symbol and battery number in white on the front and rear, along with standard Wehrmacht license plates.

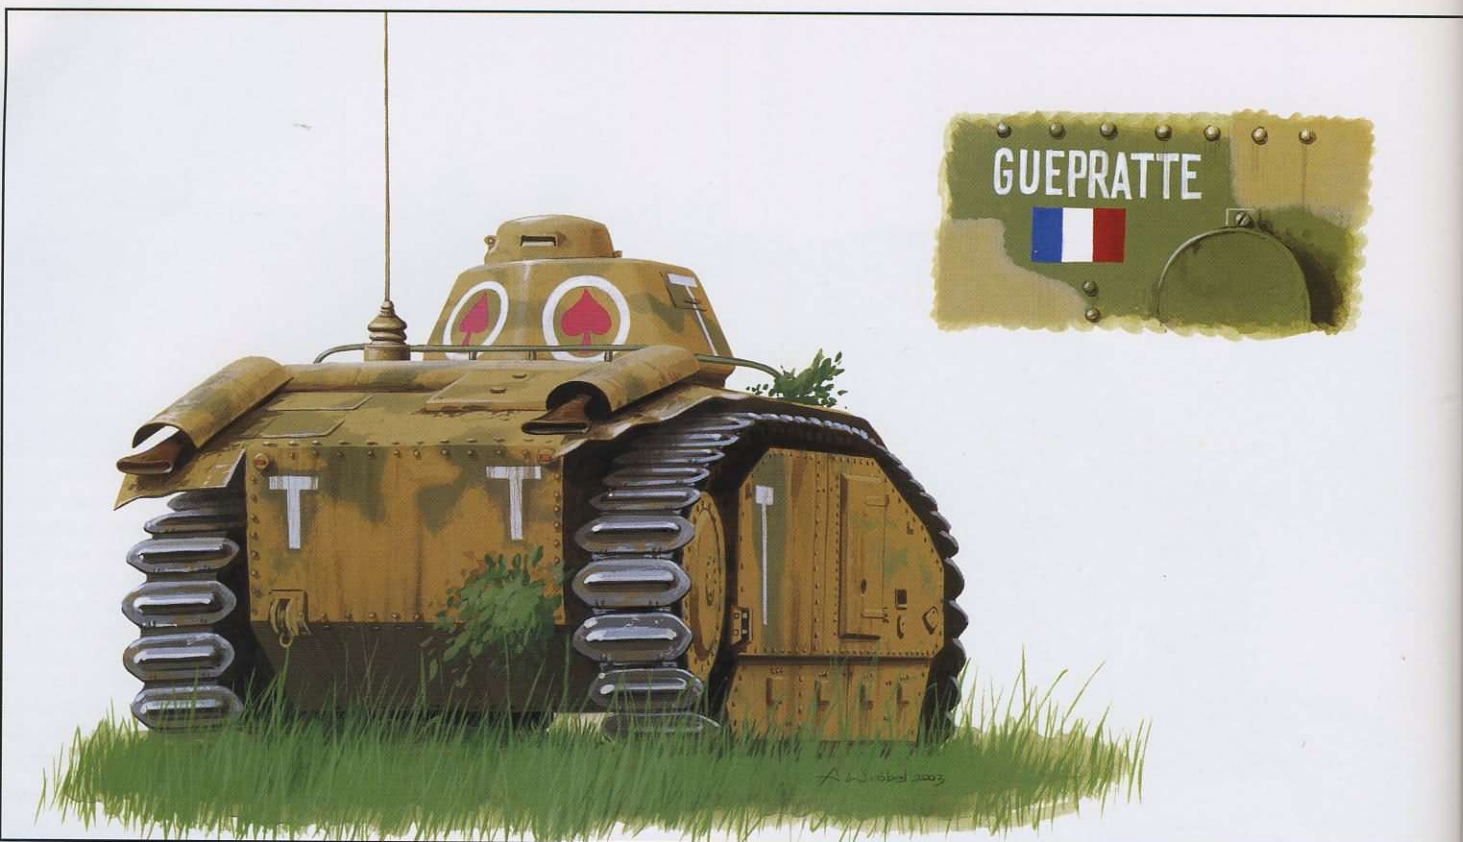
**Renault Char B1bis, 1er Section, 3ème Compagnie, 37ème BCC, May 1940**

The 37e BCC Char B1s were some of the most elaborately marked vehicles of the campaign. "Guepratte" displays a red spade for the 1st Section, within a white circle for the 3rd Company, on both rear turret sides. The white section letter "T" is painted on both sides of the rear hull plate, turret and hull. The vehicle name appears in white on the forward turret sides as well as the front hull, with the French national tricolor painted below. The camouflage pattern of olive green and ochre is speculative and it is possible that some of the B1s in 37e BCC were painted solid olive green.

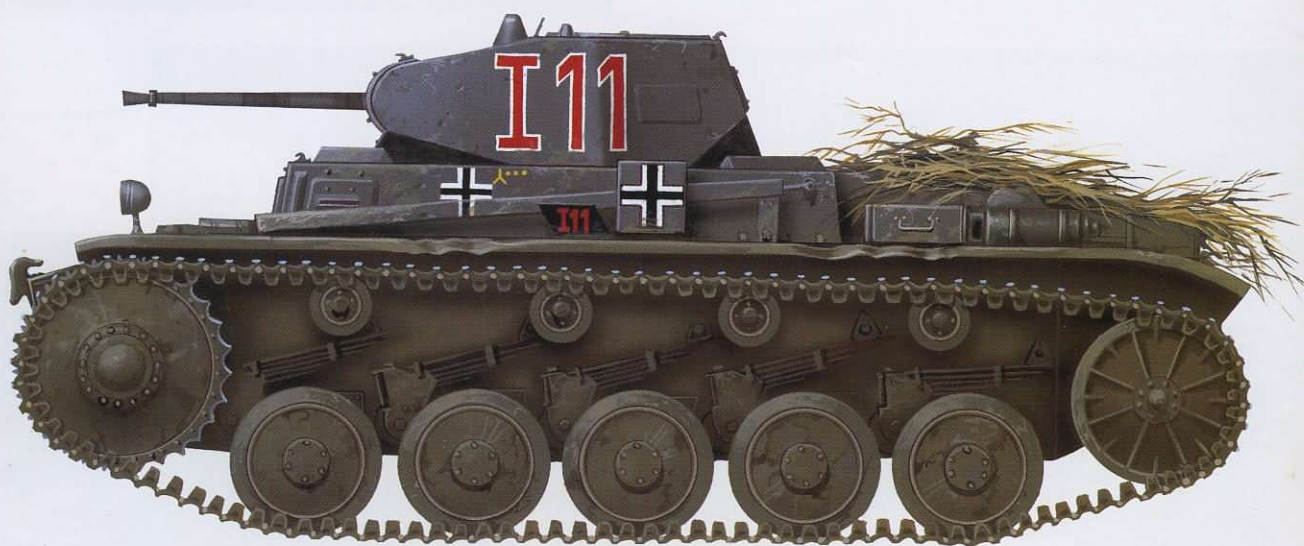
**Pz.Kpfw.II Ausf.A, B or C, Pz.Rgt.25, 7.Panzer-Division, France, May 1940**

Although unconfirmed, this is probably the commander's tank of I.Abteilung, with "I11" painted in red with a white outline, typical for most of the tanks in 7.Panzer-Division. A black and white national cross appears on the hull side, followed by the divisional insignia in yellow. Similar crosses were also applied on the upper right corner of the turret rear and left corner of the rear superstructure. The black painted rhomboid plate is still mounted on the fender with the tactical number uncommonly applied in a dark color, probably red. An additional cross with a thin black outline has been painted on a sheet metal plate attached to the antenna trough.

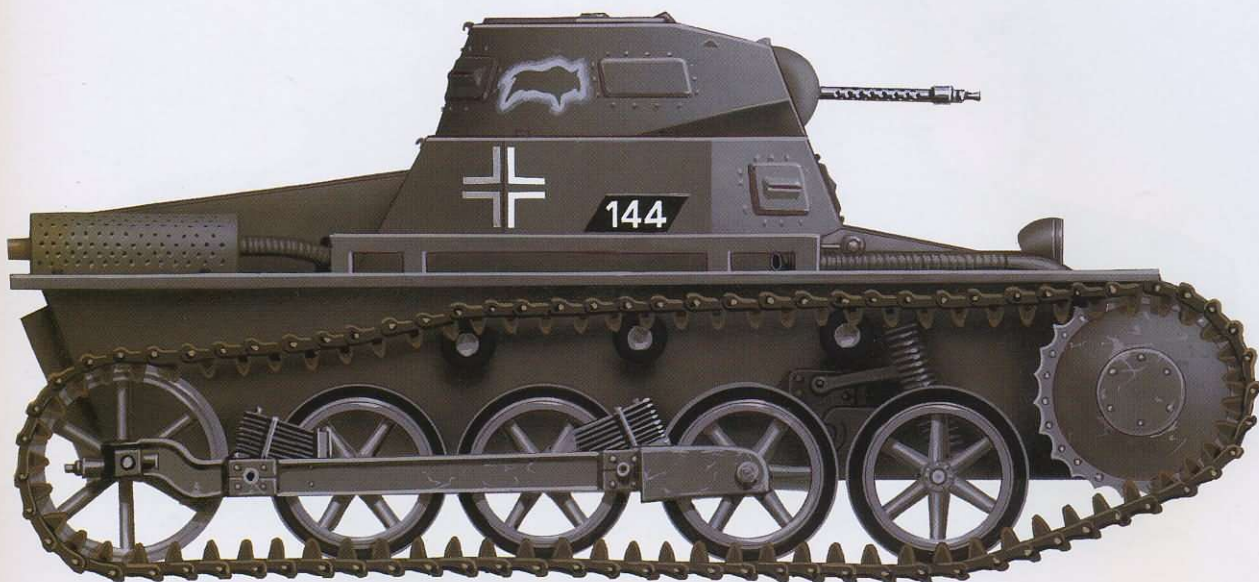
**Pz.Kpfw.I Ausf.A, Pz.Rgt.7, 10.Panzer-Division, France, 1940**

This dark gray Panzerkampfwagen I has the familiar Panzer-Regiment 7 bison insignia on its turret side, sprayed through a stencil with light blue-gray paint. On the hull side is a white outline cross that has been uniquely applied at the joint in the superstructure, invariably to ensure it is not obscured by the black painted rhomboid mounted on the fender, with the tactical number "144" in white.

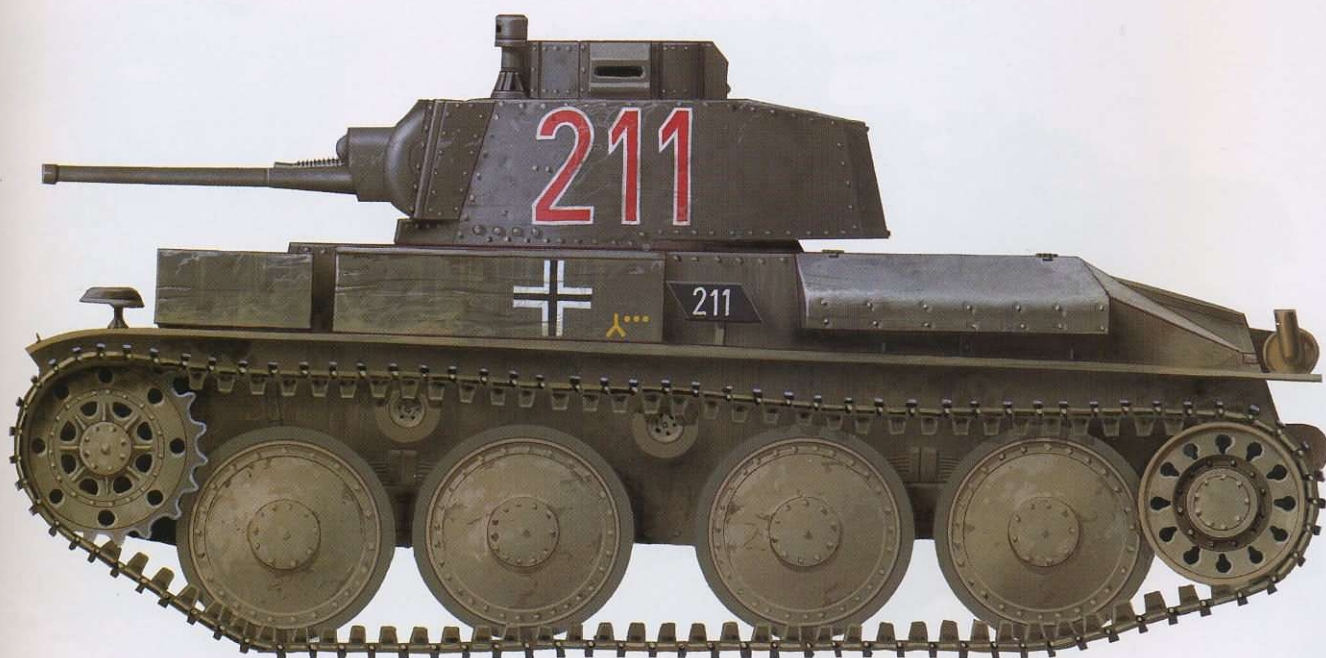
**Pz.Kpfw.38(t) Ausf.B or C, Pz.Rgt.25, 7.Panzer-Division, France, 1940**

Another 7.Panzer-Division vehicle, this tank displays the typical style of red and white turret number seen on most of the 38(t)s in this unit. The tactical number is repeated in white on the black rhomboid plate attached to the fender. Two additional stowage bins have been mounted on the fender, with a thin black and white national cross and yellow divisional marking painted on the rearmost one.

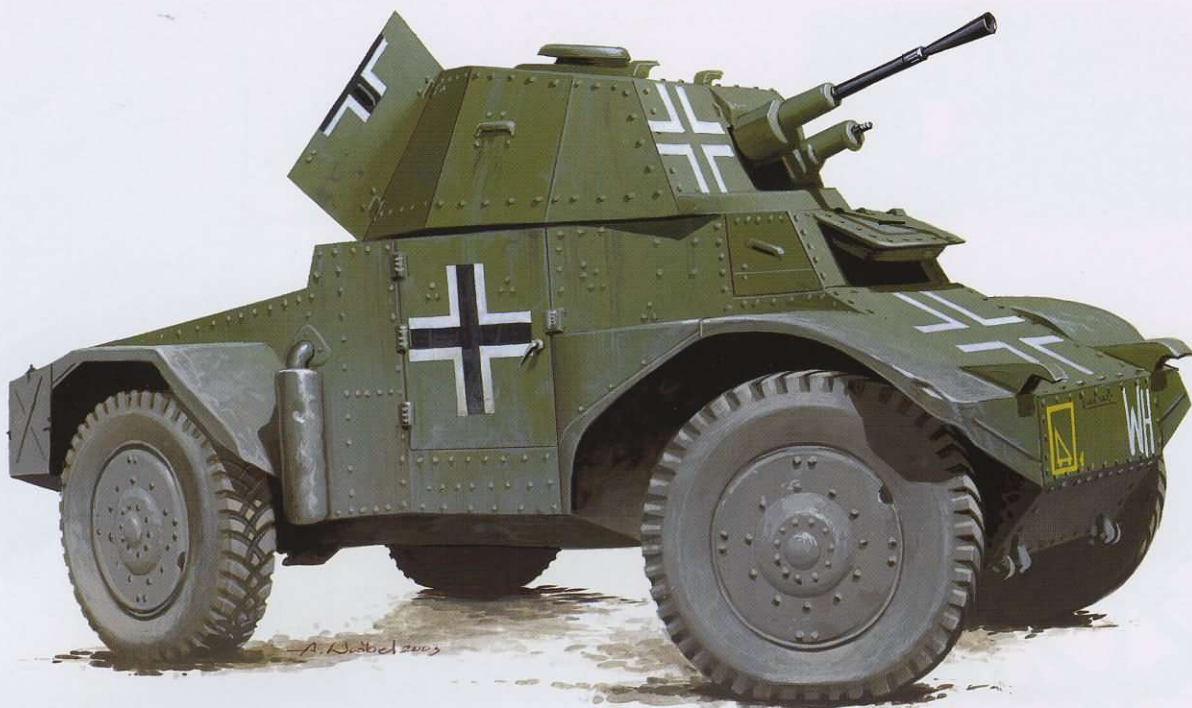
#### AMD 35 Panhard 178, Pz.Jäg.Abt.5, France, June 1940

Based on the tactical marking, this captured armored car was being used by the first company of a towed anti-tank gun unit, possibly Panzerjäger Abteilung 5. The tactical marking appears to be painted in yellow on both sides of the rear plate and to the right on the front plate. "WH" (Wehrmacht) has also been added in white. As with most captured equipment, it has been prominently marked with no less than three national crosses to avoid friendly fire. The turret front and glacis plate are in white outline only, while the sides, rear and turret rear are black and white. The Panhard is still in its original French olive green.

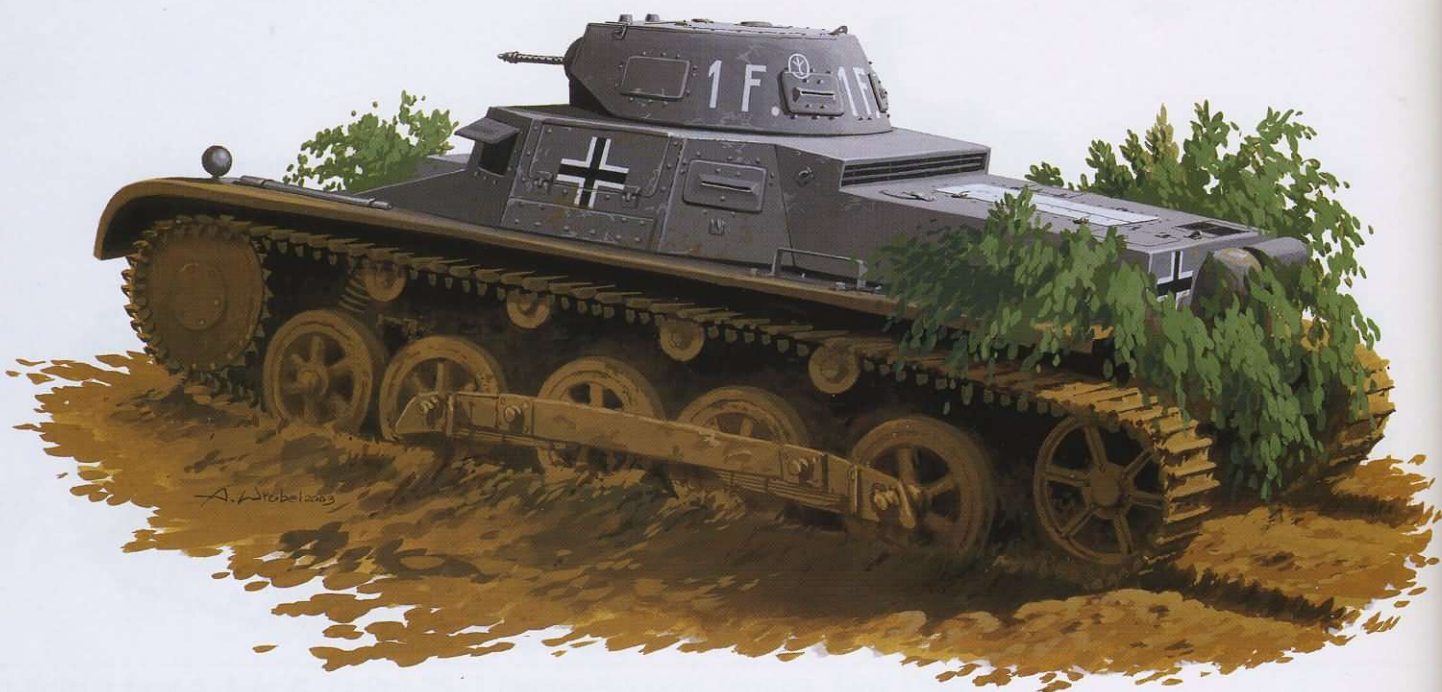
#### Pz.Kpfw.I Ausf.B, Pz.Rgt.36, 4.Panzer-Division, France, 1940

This Panzer I has been assigned to a Propaganda Kompanie film crew attached to Panzer-Regiment 36. The divisional insignia and regimental "dot" appear on the turret with the code "1F", likely indicating 1st film crew vehicle. A white air recognition rectangle is painted on the engine deck. The existence and position of the national cross on the hull side is speculative based on other 4.Panzer-Division vehicles.

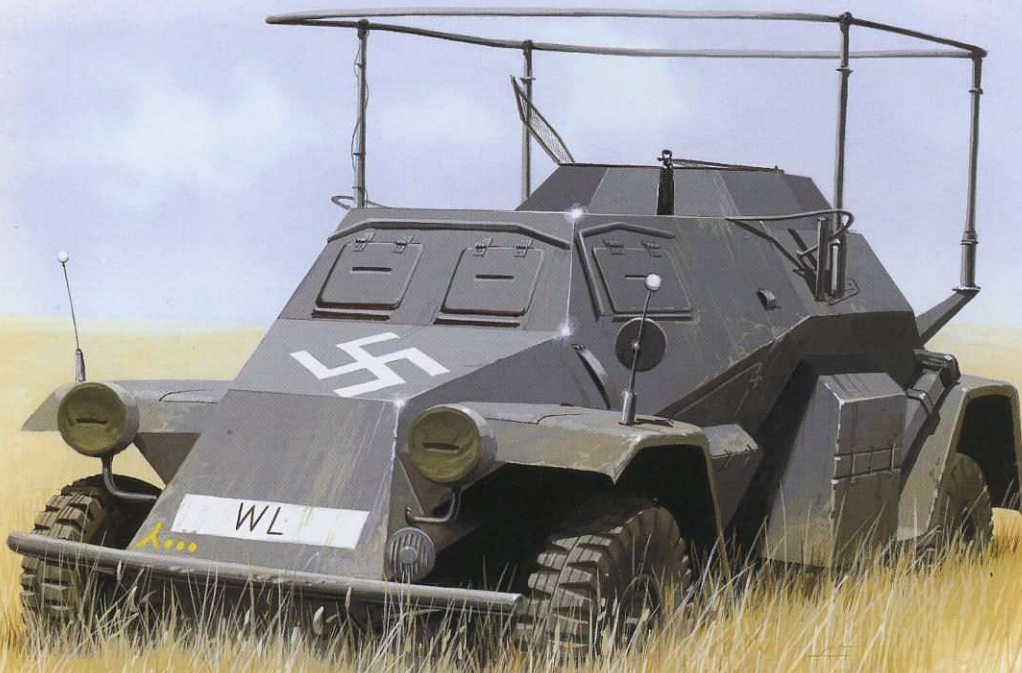
#### **Sd.Kfz.223, assigned to 7.Panzer-Division, France, 1940**

This dark gray Sd.Kfz.223 is a Luftwaffe vehicle being used by an aircraft communications officer assigned to the 7.Panzer-Division. A standard white license plate has been applied with only "WL" in black and no number. The yellow divisional sign is below it and a prominent white swastika has been painted on the glacis plate for aerial recognition.

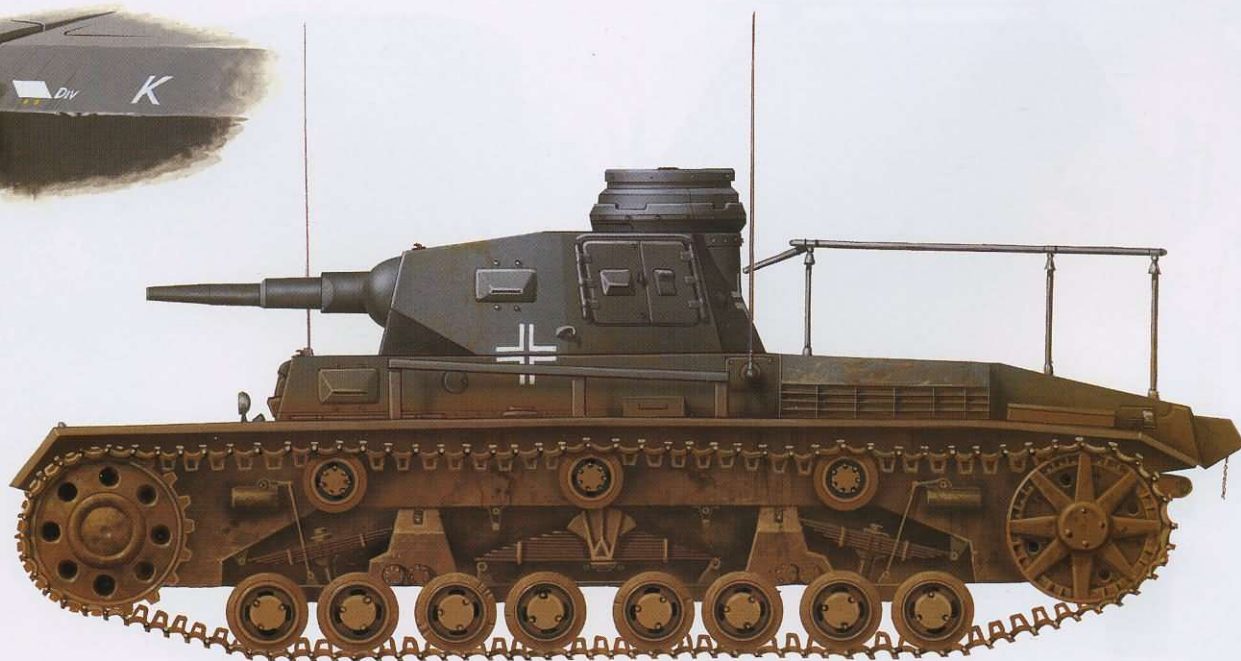
#### **Pz.Bef.Wg.III Ausf.D1, 2.Panzer-Division, Belgium, May 1940**

This rare Panzerbefehlswagen III Ausf.D1 is part of the divisional headquarters as indicated by the "Div" notation next to the panzer rhomboid, both in white. The divisional insignia of two yellow dots is below it and as part of Gruppe von Kleist, a white "K" has also been applied. White outline crosses appear on the side and turret rear. Interestingly, since the turret was fixed in place, the cross has been split between turret and hull.
