# ACHTUNG

# PANZER

The German Invasion of  
France and the Low Countries

Jon Feenstra

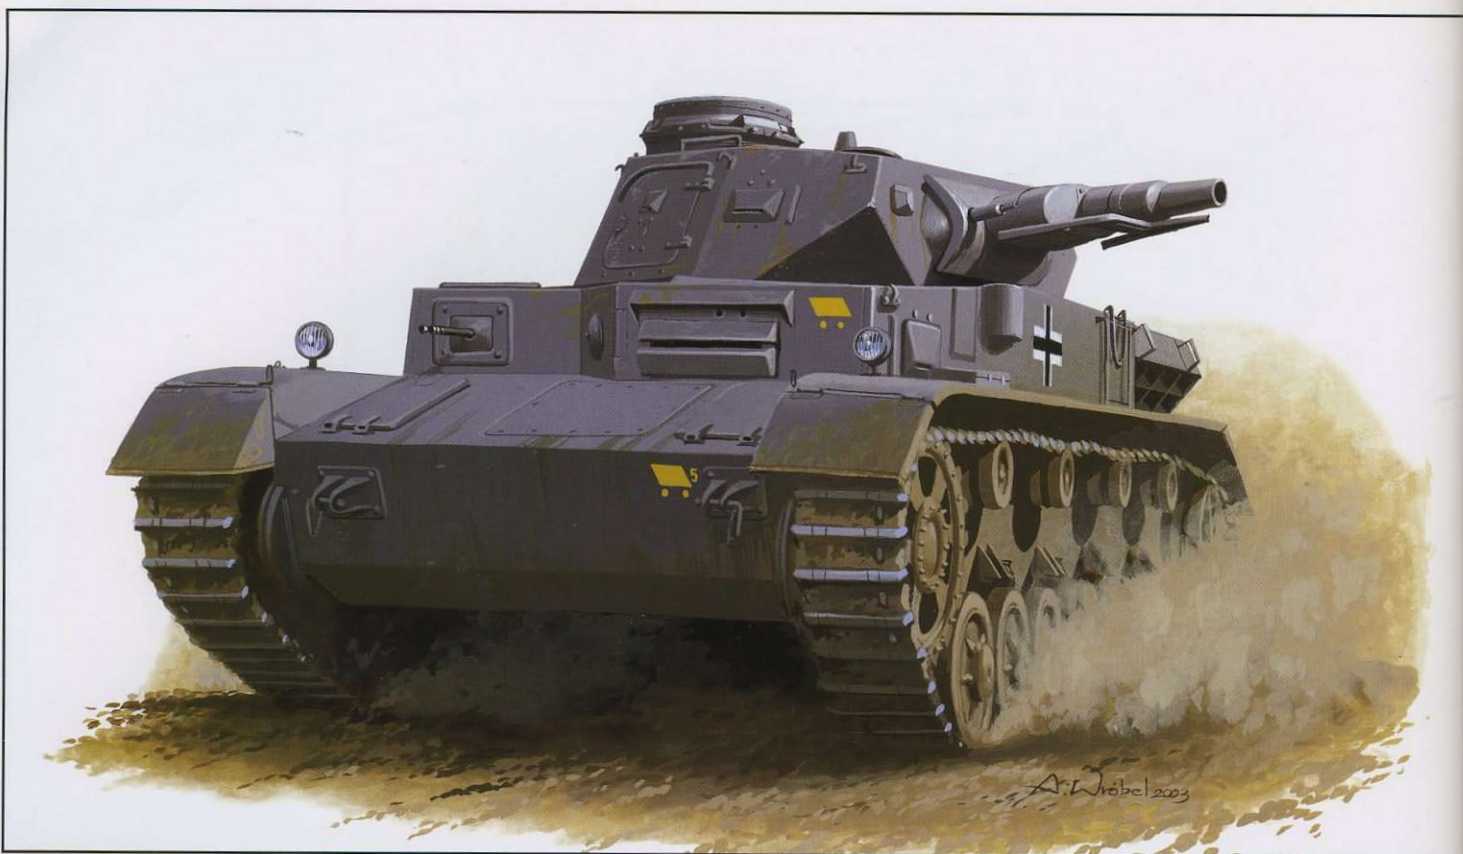
#### **Pz.Kpfw.IV Ausf.D, 2.Panzer-Division, Belgium, May 1940**

Another 2.Panzer-Division vehicle during the first days of the invasion. It is in typical overall dark gray, with a black and white national cross on the hull side. Yellow rhomboids appear on the upper glacis and lower hull plate with the division insignia directly below. A small yellow 5, for 5th Company, appears beside the lower rhomboid only.

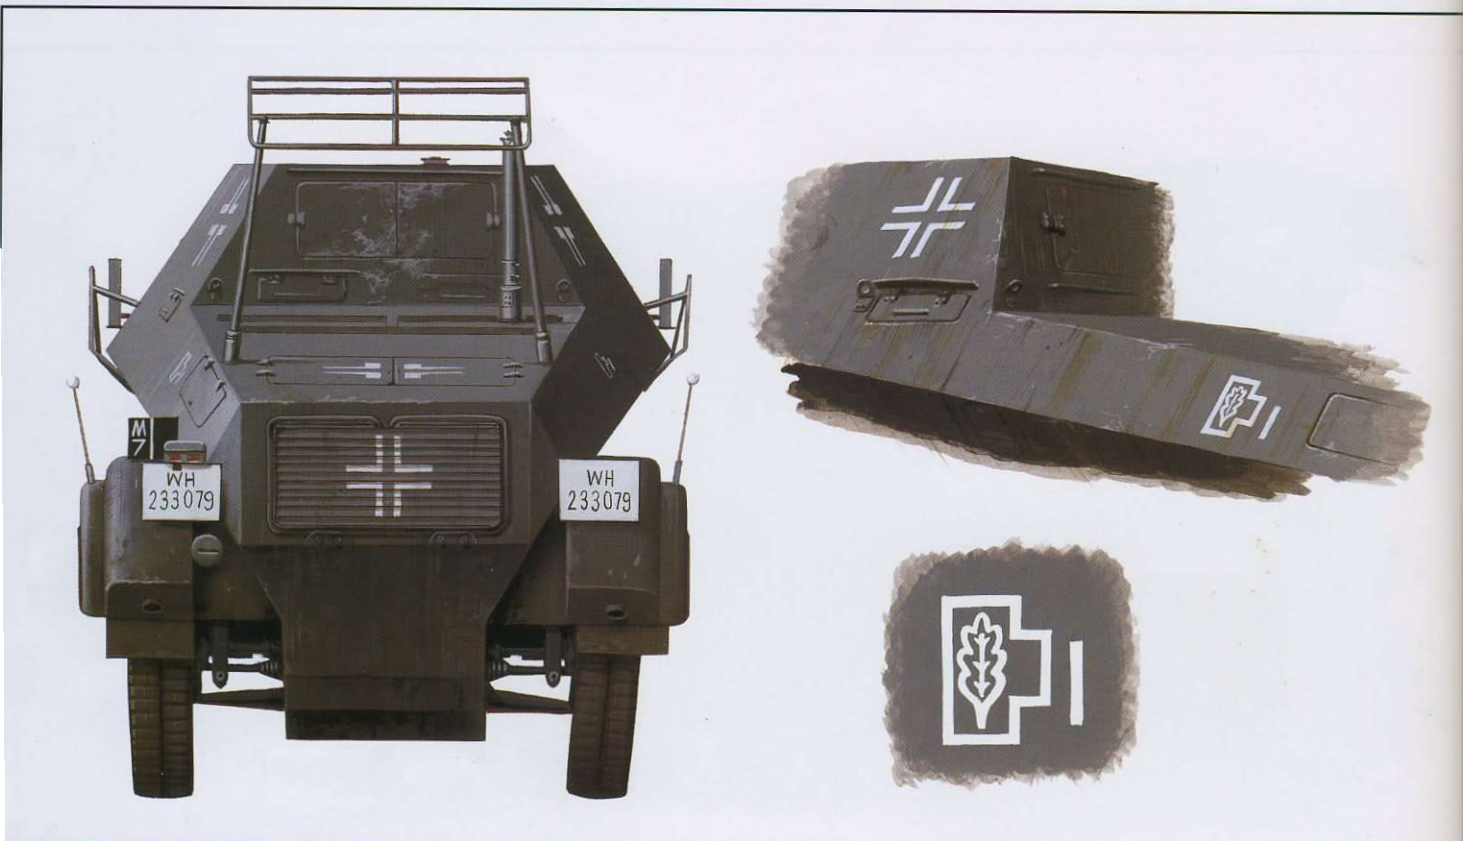
#### **Sd.Kfz.263, 1.Panzer-Division, France 1940**

This armored radio car displays the divisional oak leaf emblem inside the tactical symbol for a signals unit. The exact meaning of the "1" is unknown, and could signify Pz.Rgt.1 or perhaps Abteilung 1 in either of the regiments. White outline national crosses are painted on the upper superstructure sides, engine deck access doors and rear ventilation flaps. A sheet metal plate has been attached to the muffler guard with an unidentified marking and standard license plates are mounted on both sides, typical for armored cars.

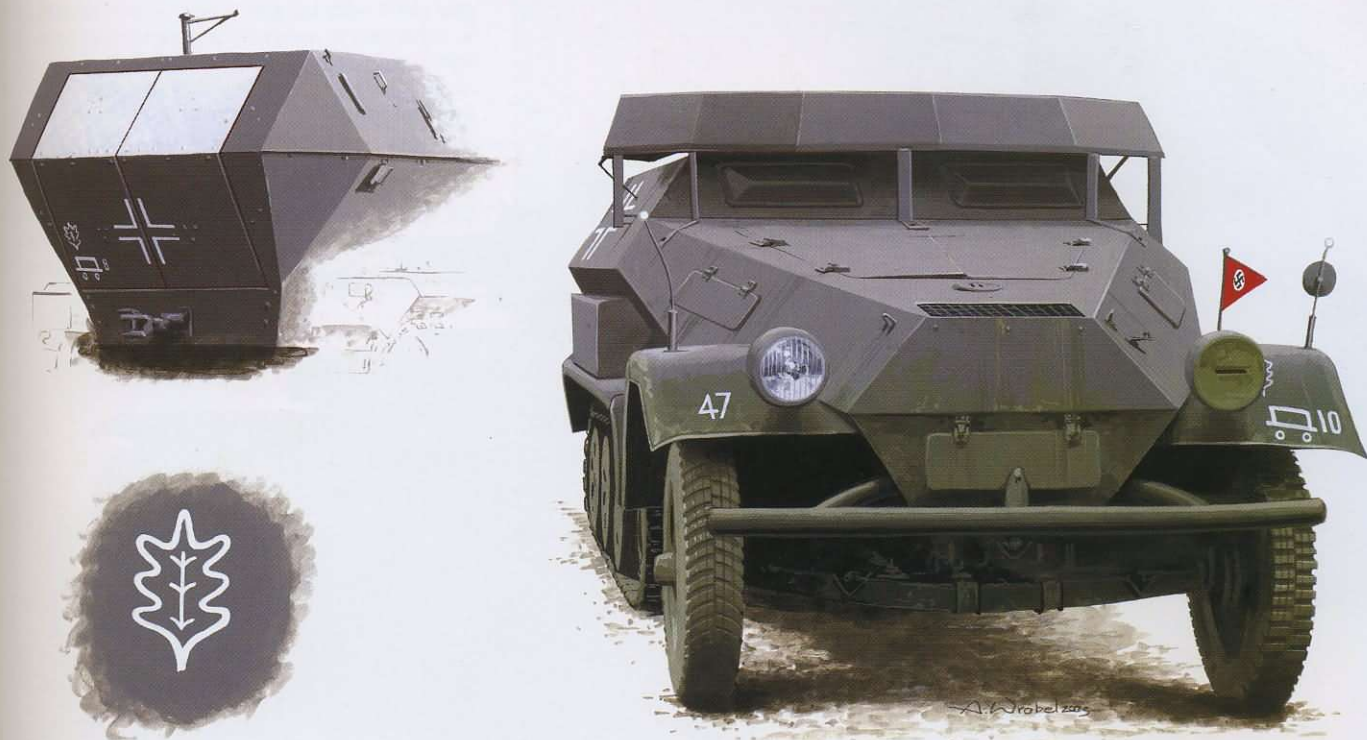
#### **Sd.Kfz. 251/18 Ausf. B, Schützen-Regiment 1, 1. Panzer-Division, France 1940**

This command half-track is from 10. Kompanie as evidenced by the numeral "10" next to the tactical insignia for motorized infantry. The 1. Panzer-Division oak leaf appears above and a command pennant is mounted as well. On the opposite fender is the number "47", which may be an individual vehicle tactical number as other half-tracks in the unit displayed different numbers. All markings are in white. The rear view is of a half-track from 8. Kompanie and is representative of the rear markings that were generally carried by many Sd.Kfz. 251 in Schützen-Regiment 1. The top half of the doors have been painted white for aerial recognition.

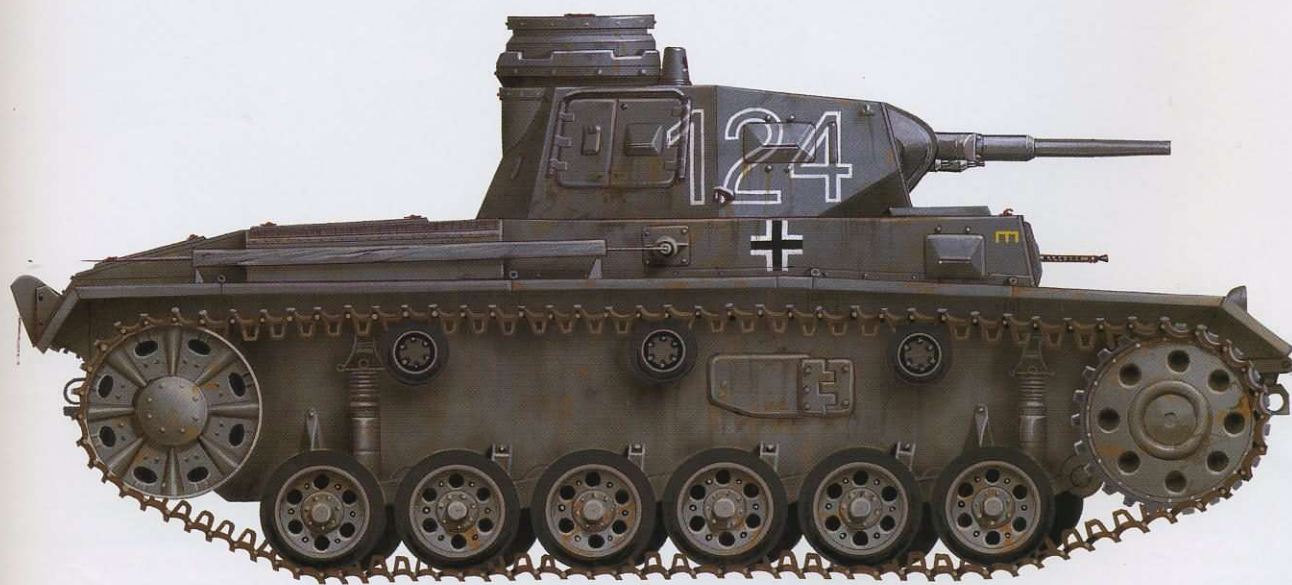
#### **Pz.Kpfw. III Ausf. F, 3. Panzer-Division, France, May 1940**

3. Panzer-Division Pz.Kpfw. III and IV typically had large tactical numbers in white outline on the turret sides and rear. This Panzer III has the divisional emblem, a sideways "E", painted in yellow at the front edge of the side hull plate. A prominent black and white national cross has also been applied.

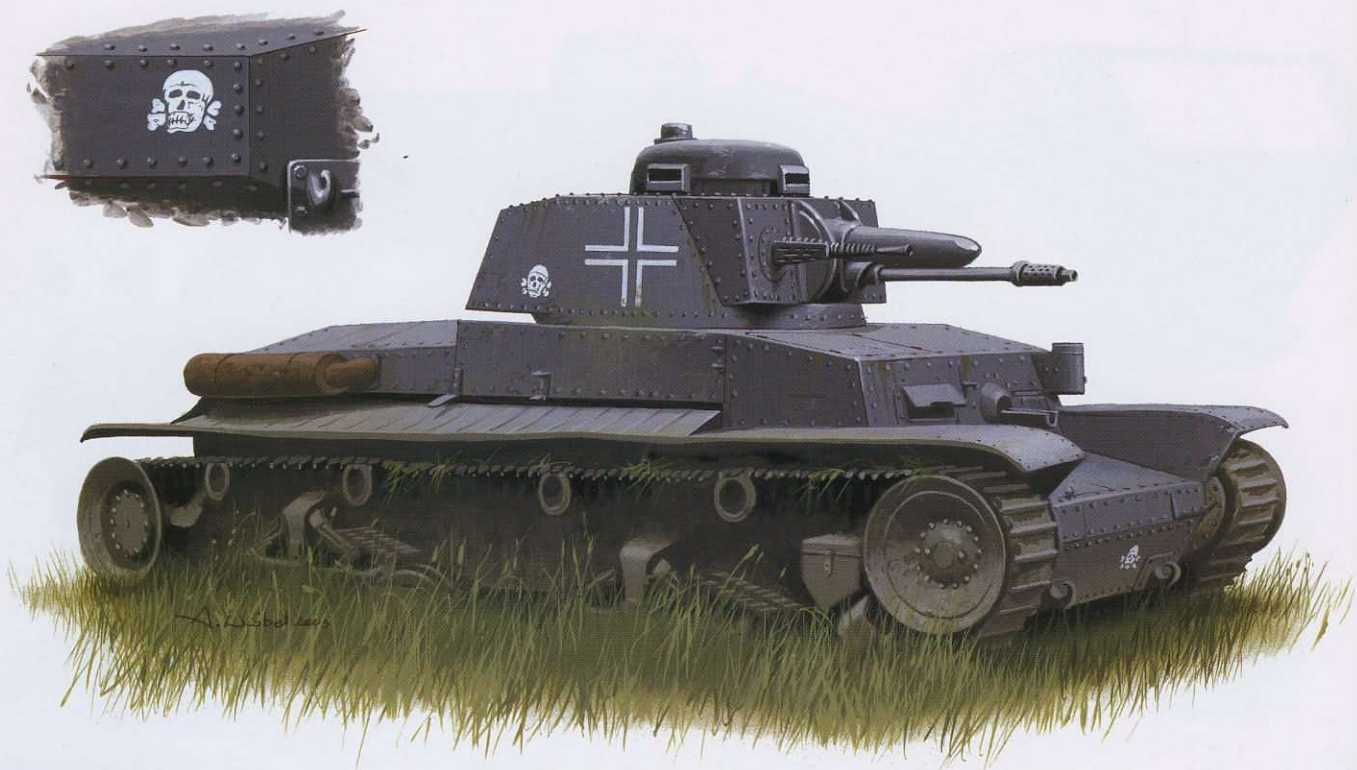
#### **Pz.Kpfw.35(t), Aufkl.Abt., SS-Totenkopf-Division, France, May 1940**

Although not an armored division, Totenkopf's reconnaissance battalion (official designation 3.(s)/SS-T.-AA) was equipped with six 35(t) armored cars. Although armored cars were not available and the division already had a preponderance of Czech weapons. The dark gray tanks were simply marked with thin white outline national crosses and the divisional emblem on the turret sides. The "Death's Head" insignia also appeared on the lower front and rear hull plates. All six tanks were lost by the end of May.

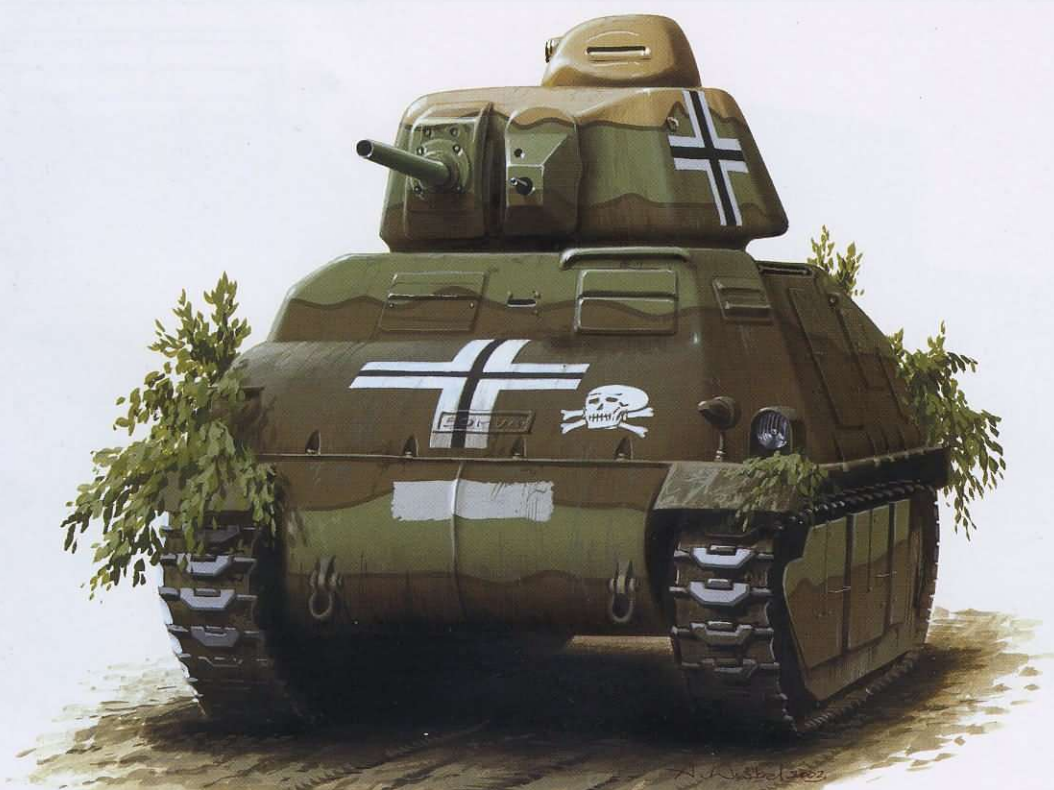
#### **Somua S 35, Aufkl.Abt., SS-Totenkopf-Division, France, May 1940**

At least one captured French Somua was used by Totenkopf to replace lost Pz.Kpfw.35(t). Prominent national crosses were applied to the hull front and turret sides, with the glacis plate cross having different lengths of horizontal legs. The divisional emblem was painted on the glacis much larger than those applied to the Czech tanks. The French serial number has been painted over on the hull front, presumably with the same white paint used to apply the new markings.

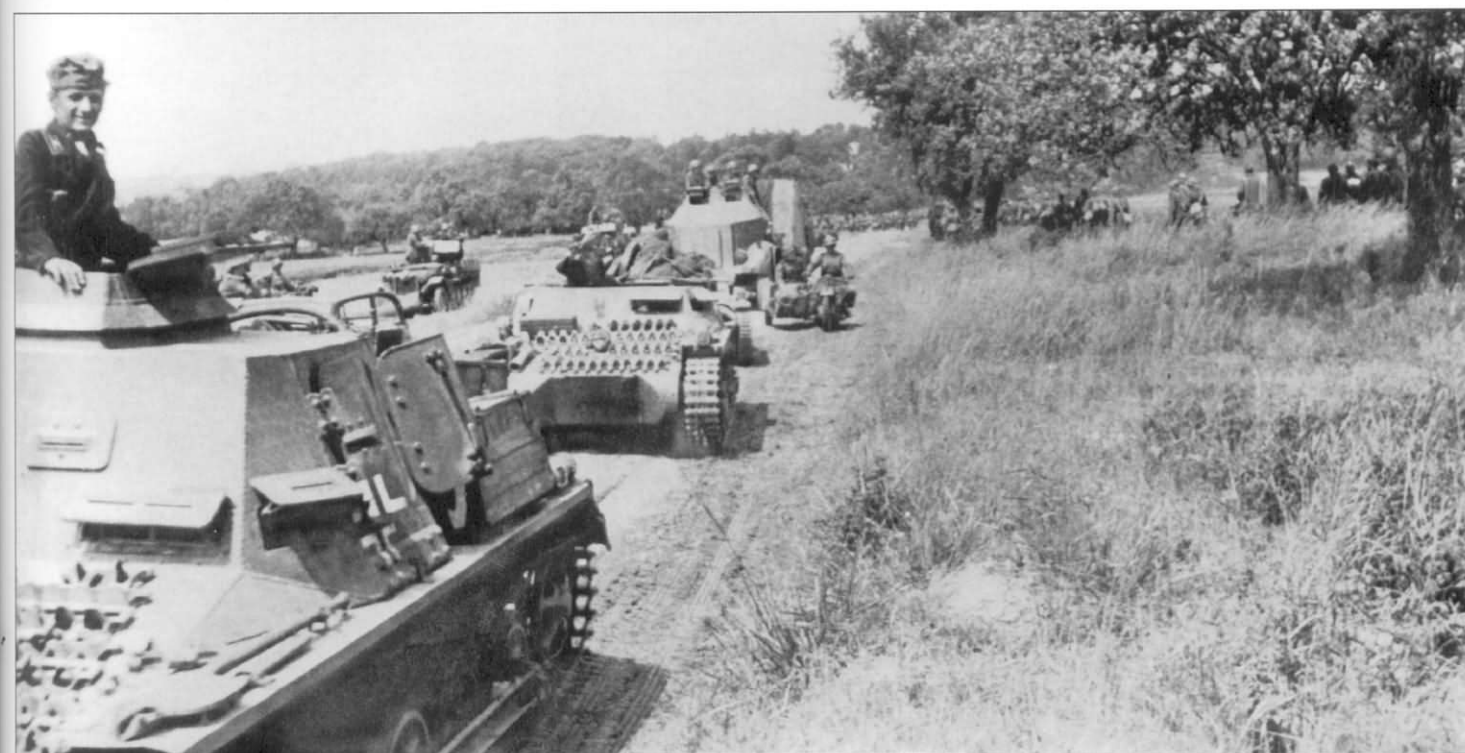
A very unique mix of vehicles move along a road while rows of prisoners are taken into captivity in the background. In the lead is a kl.Bef.Pz.Wg.I Ausf.B, followed by a Munitionsschlepper auf Pz.Kpfw.I Ausf.A, which was basically a turretless tank with the opening plated over. These were used as armored supply vehicles or as workshop vehicles. In the background is one of the massive gepanzerte 8 ton Zugkraftwagen towing a modified 8.8cm Flak 18 auf Sd.Ah.201. These were specially built 8-ton halftracks equipped with fully armored bodies and ammunition bins towing Flak 18 guns modified with ready round ammunition bins and large armored shields. Developed specifically for the engagement of ground targets, only 33 were issued to Panzer-Jäger-Abteilung 525, 560, and 605 for Fall Gelb and Fall Rot. To the left is an Sd.Kfz.10/4 halftrack with Flak 30, while just visible beside the motorcycle-sidecar combination is what appears to be a captured French Renault UE tractor, which were used extensively by the Germans throughout WW2 as a tracked carrier and prime mover.

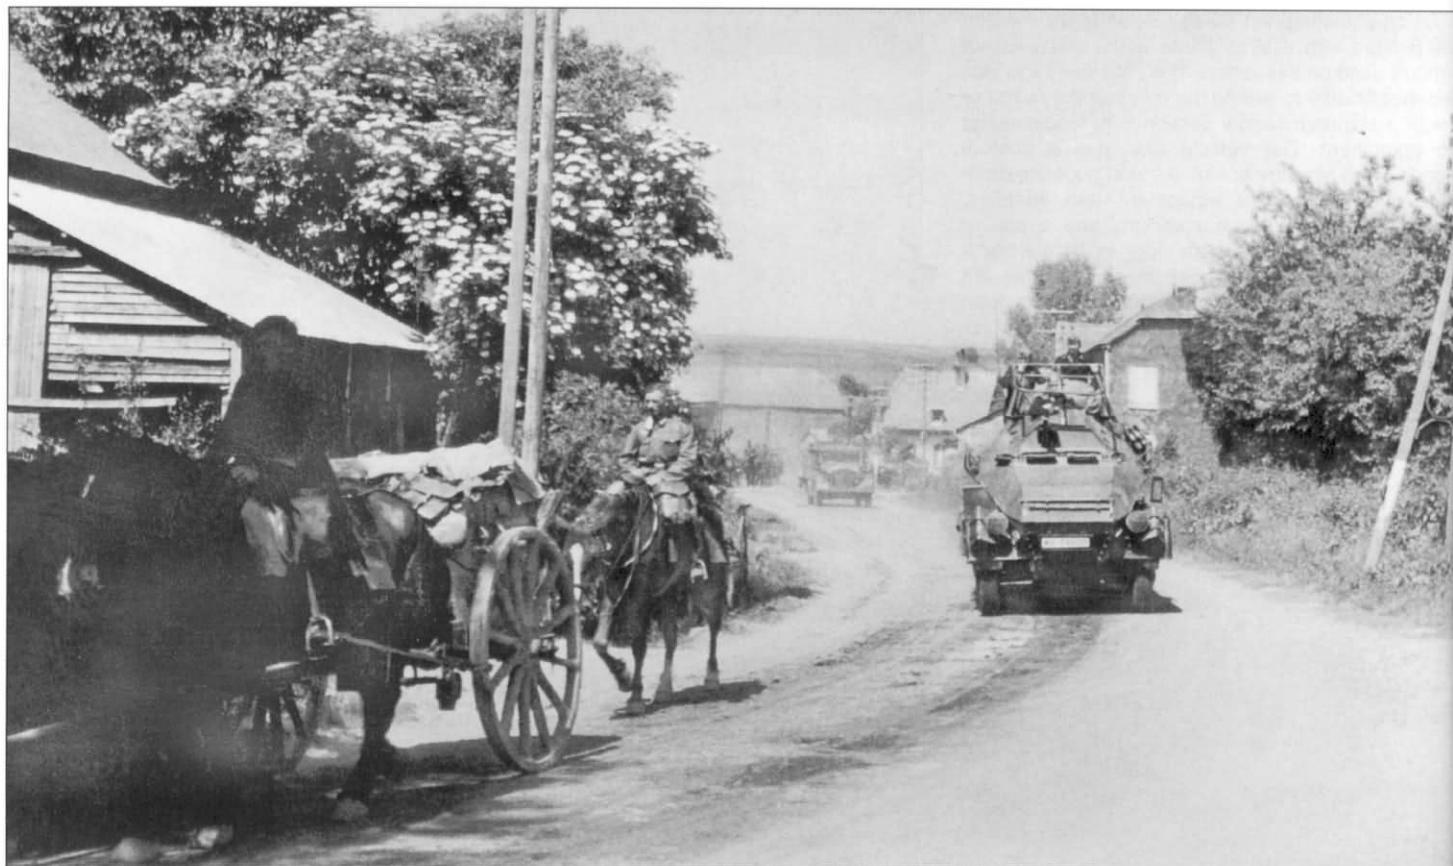
An Sd.Kfz.263 8-wheeled armored radio car travels around a bend on a French road past a horse-drawn unit. The Sd.Kfz.263 was a valuable asset for the signals platoons by providing long range radio communications. It was equipped with a high-powered wireless set, large frame antenna, and a 9 meter telescoping rod aerial for use when halted. Rommel also used one as a command vehicle during the 1940 campaign.

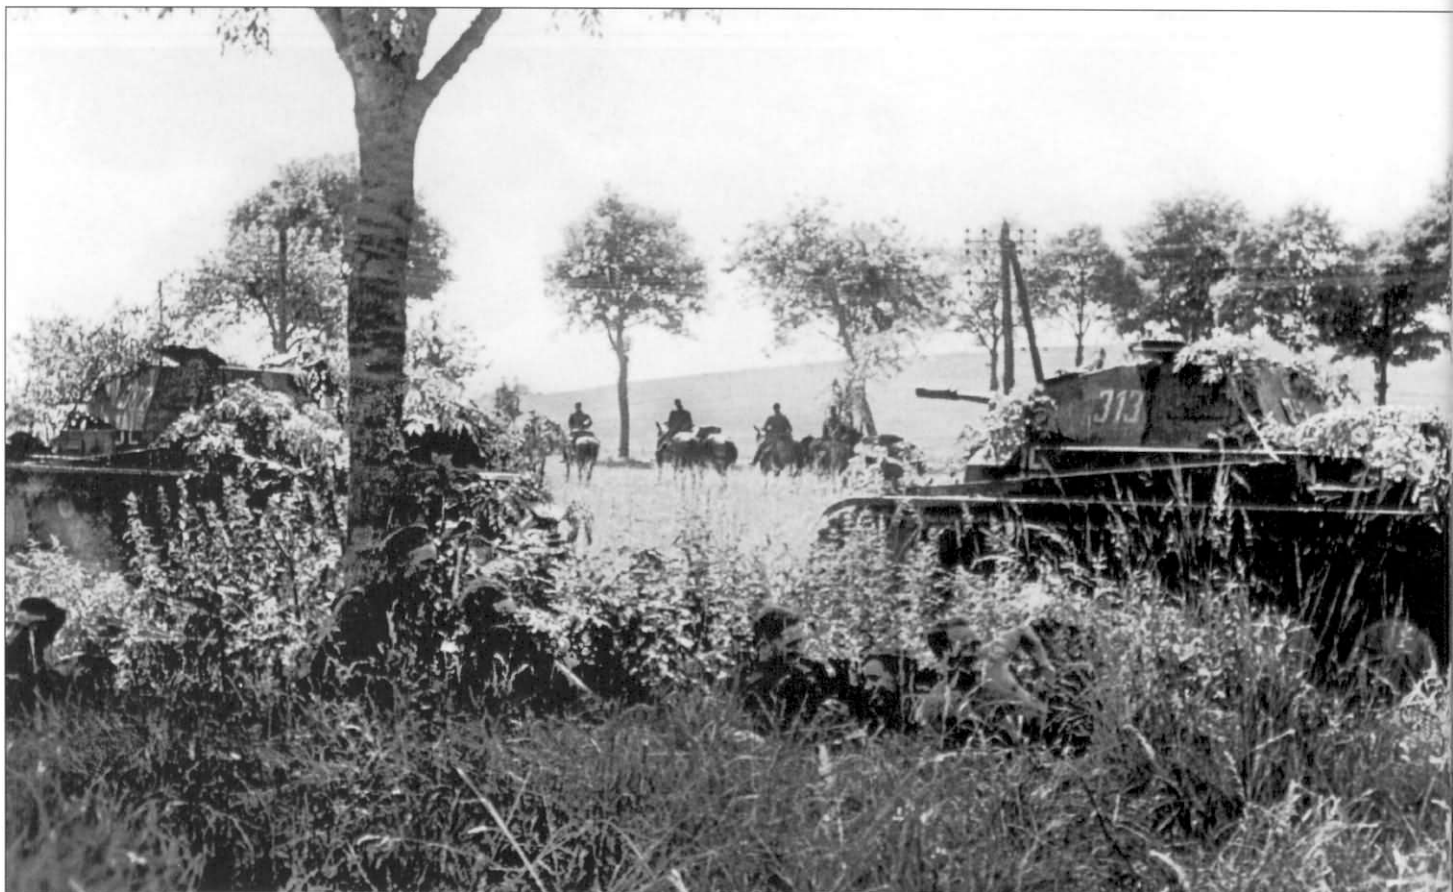
A pair of Pz.Kpfw.IIs stopped along a tree line as cavalry troops pass in the background. These are from 1.Panzer-Division, with the oakleaf insignia visible on the turret rear. The first tank is numbered "302", while the nearest one is "313". The use of foliage as camouflage was not common during the battle for France and the Low Countries, invariably because the Wehrmacht typically had air superiority and were on the offensive. It appears to be quite effective here though.

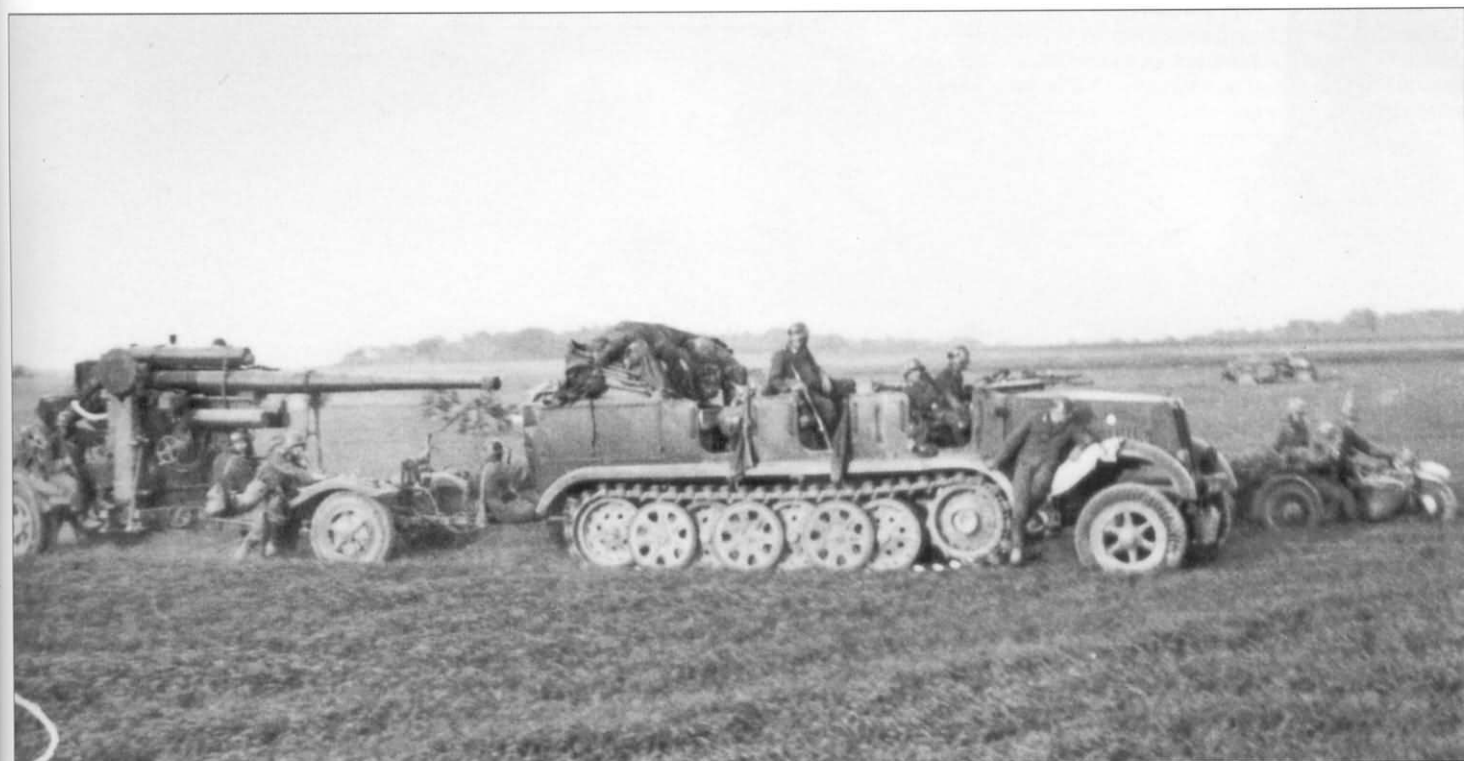
An Sd.Kfz.7 8-ton halftrack towing an 8.8cm Flak 18 on an Sd.Ah.201 sits in a field in France while its crew takes a much needed break. This gun invariably belongs to a Luftwaffe Flak unit as the few Panzer-Jäger-Abteilung equipped with 88s in the Battle of France used the modified guns with large shields. Although the Flakartillerie was employed against French tanks in some instances, this was not a common occurrence and many more enemy aircraft were destroyed than tanks.

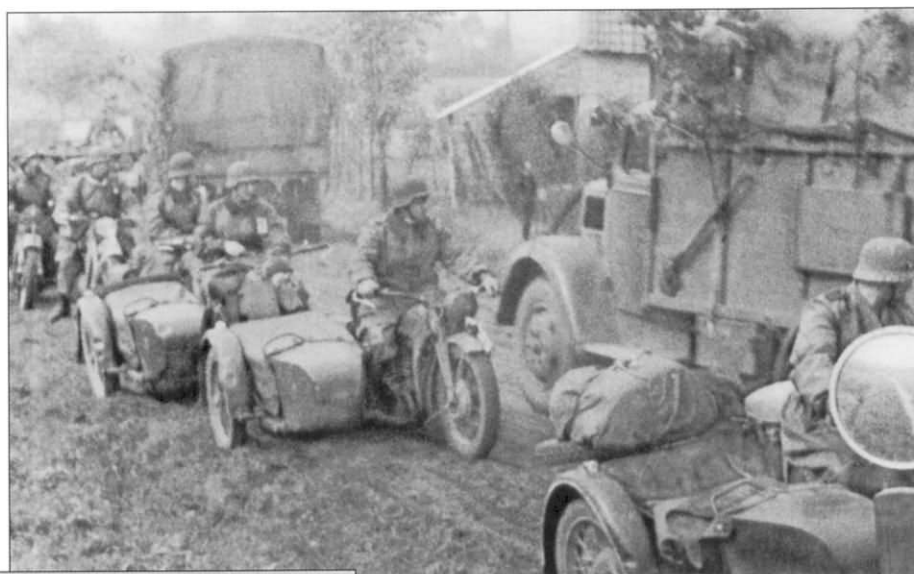
Another group of motorcyclists, this time lead by three Zündapp KS600 combinations. Motorcycles were widely used by the Wehrmacht in the early stages of WW2 not only for reconnaissance and dispatch work, but also to mobilize many infantry units. This was beneficial to allow the infantry to keep pace with the panzer units but was useless once Germany was on the defensive.

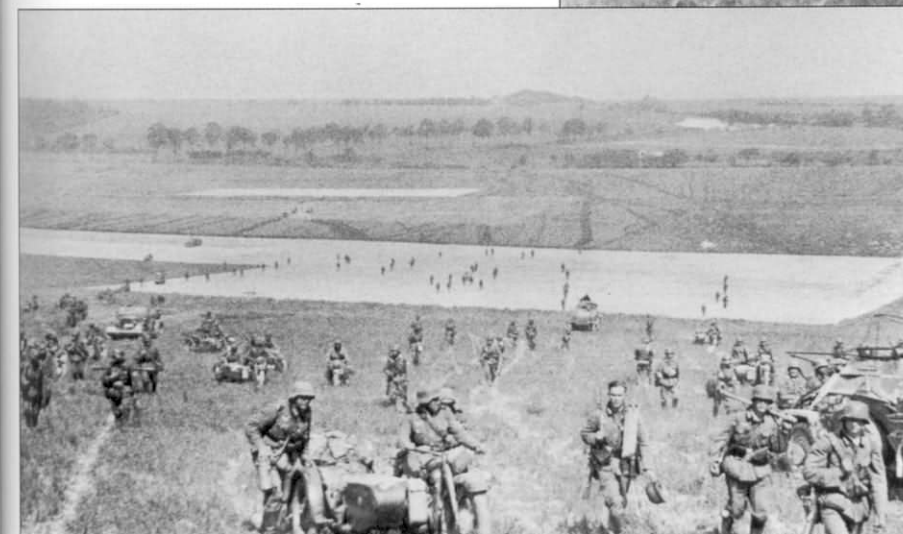
A unique photograph of men and machines advancing across a plain in France. Amongst the hundreds of infantrymen are BMW R35 motorcycle sidecar combinations, a Kfz.15 medium Pkw. and what appears to be an Sd.Kfz.231 (8 rad) in the distance. To the right is a Sd.Kfz.222 armored car with a tactical number "122" in white on the turret side. Use of tactical numbers on armored cars was somewhat uncommon in the French campaign.

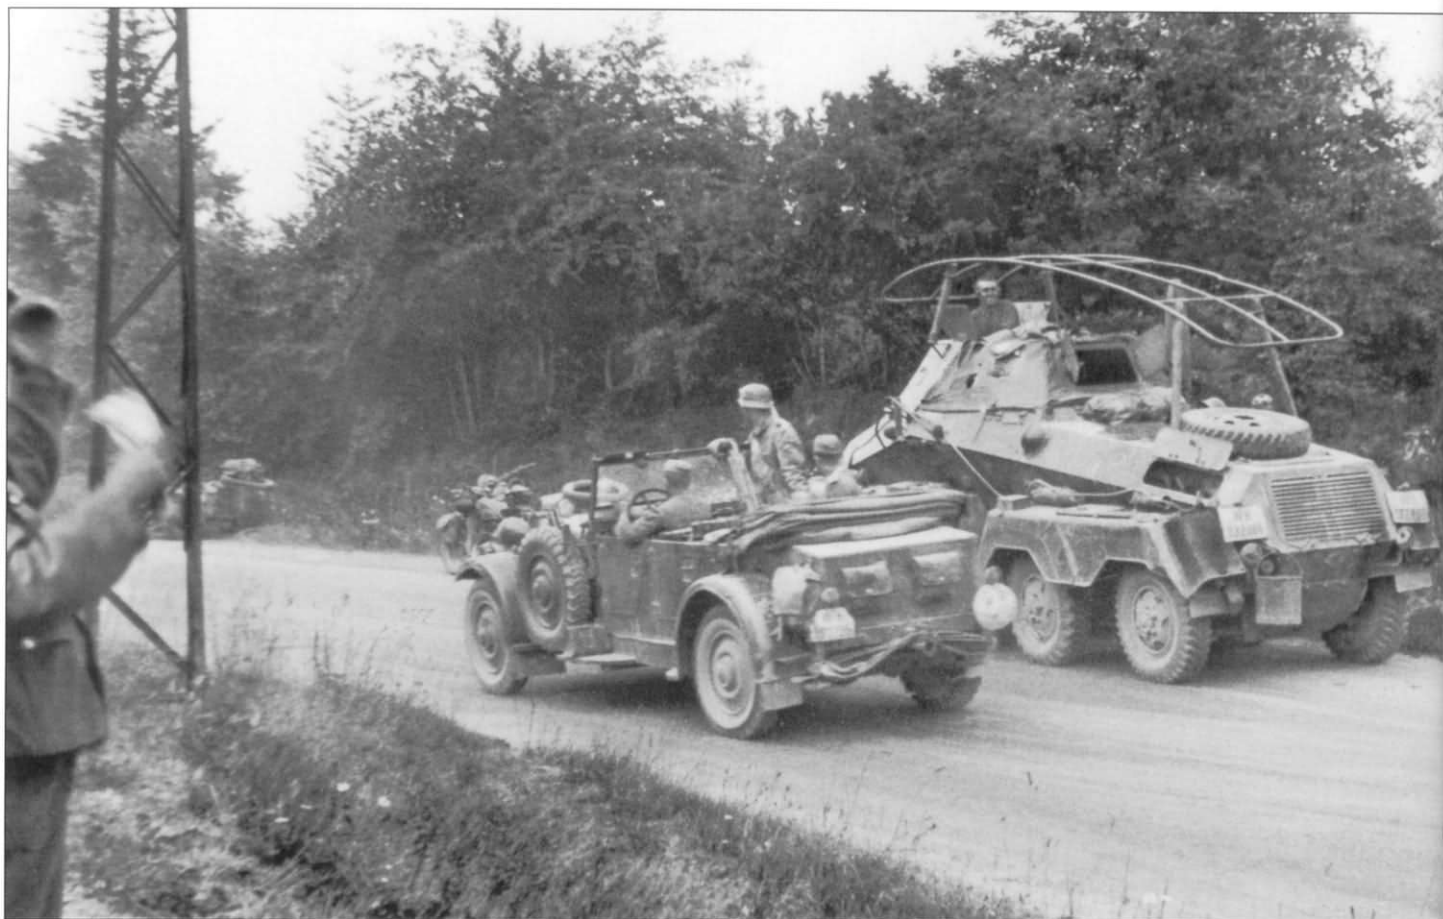
An Adler Type 3 GD passenger car passes an Sd.Kfz. 263 Panzerfunkwagen stopped on a road with some motorcycle combinations. The Adler was one of a multitude of makes and models of automobiles that were used by the Germans in many roles, including command and radio cars, prime movers, infantry transport, and reconnaissance. The armored car has a national cross on its rear ventilation grille.

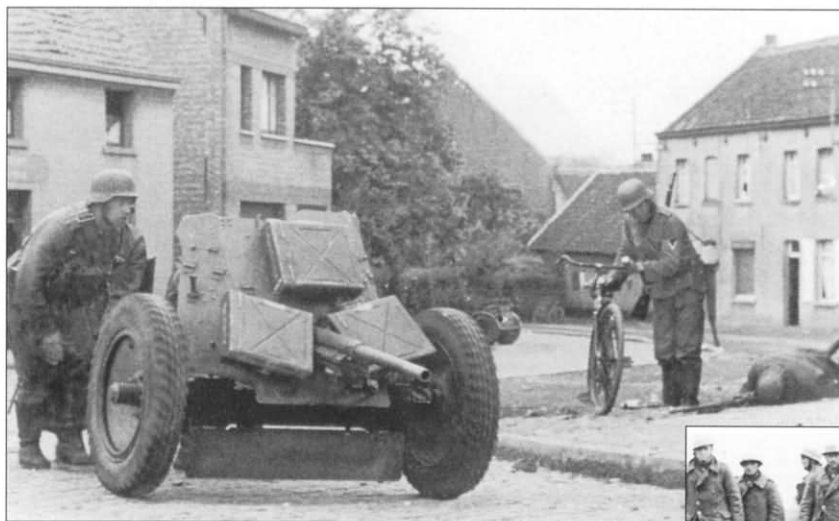
A 3.7cm Pak 35/36 antitank gun is manhandled into position by its crew. This was the only dedicated towed antitank gun in service with the Wehrmacht at this time and it proved to be very ineffective against most French tanks, except at extremely close range. Ammunition boxes have been hung from the front shield for easy access and transportation. The bicycle-mounted Gefreiter to the right appears to be looking at a dead or wounded comrade lying on the ground.

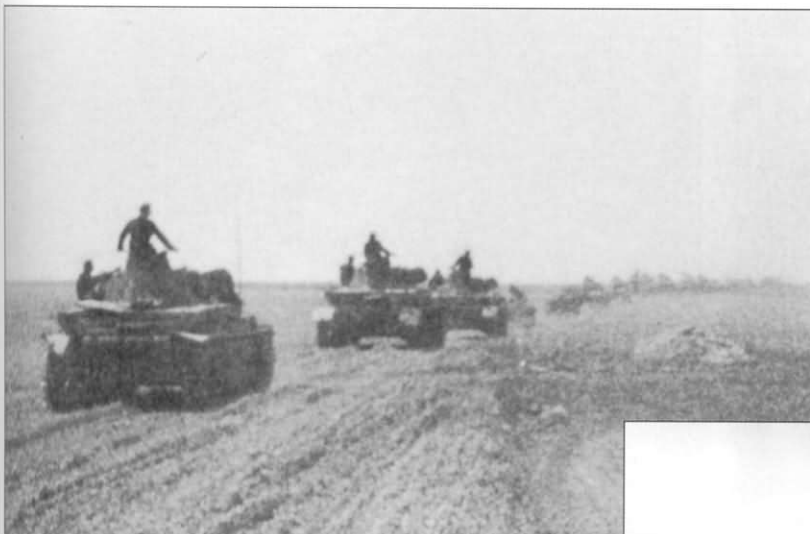
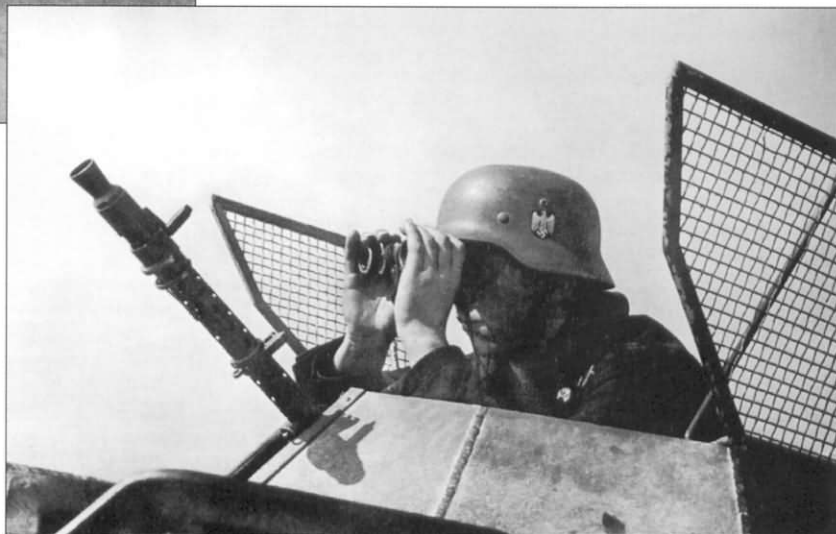
An interesting close-up of the turret of an Sd.Kfz.221 armored car as the vehicle commander peers through his binoculars at something in the distance. The barrel of the 7.92mm MG34 main armament is visible, as are the wire mesh anti-grenade screens that covered the open turret when folded down. For additional protection he wears an M1935 steel helmet with the standard silver-white Wehrmacht eagle marking, and visible on the collar is the death's head insignia of the panzertruppen.

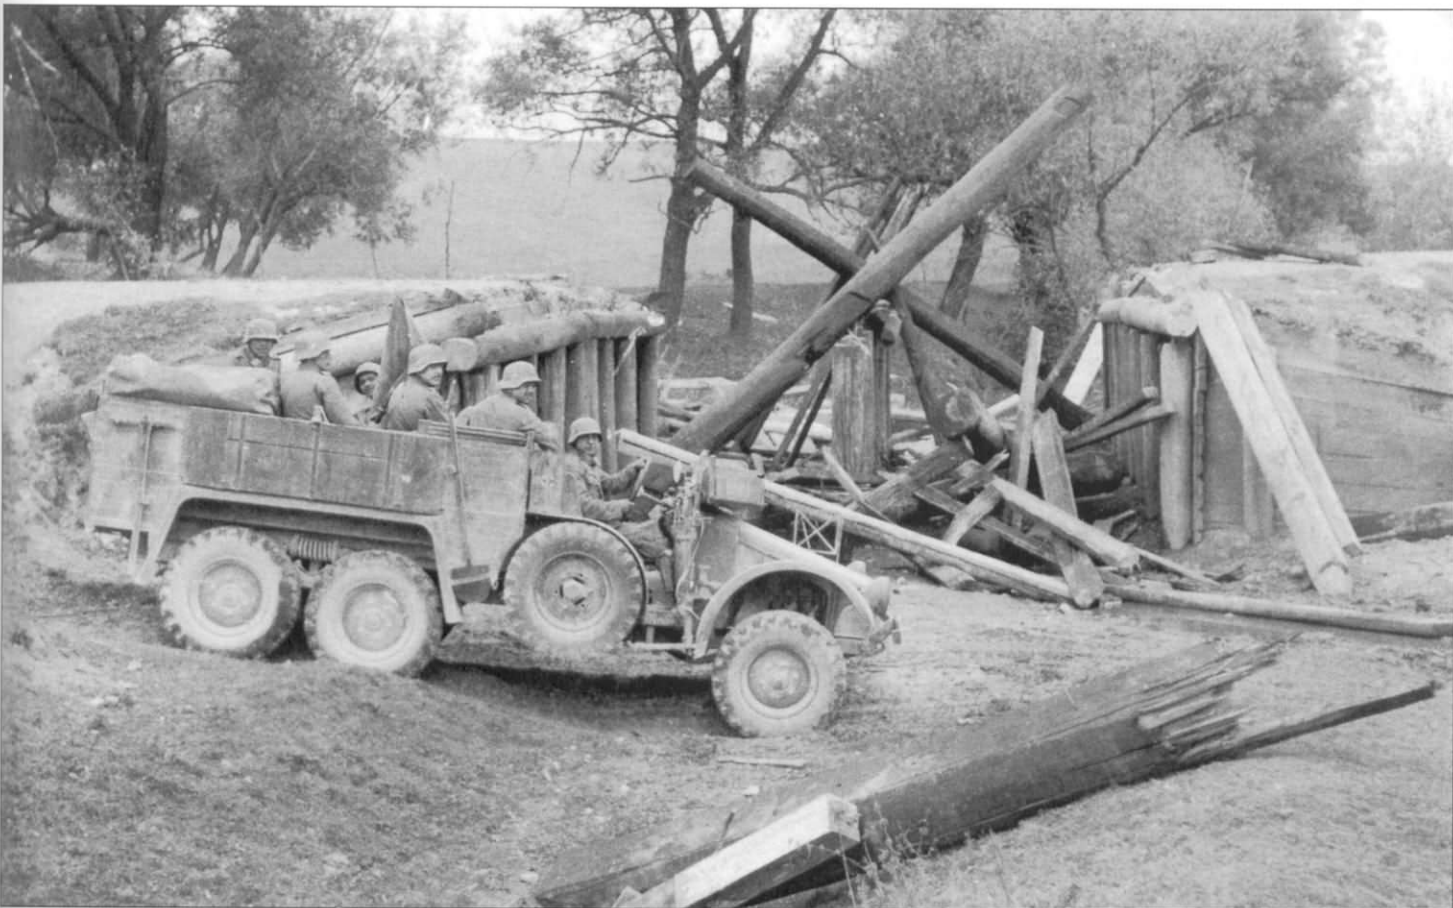
A truck load of infantry passes a destroyed bridge or barricade. The Krupp Protze Kfz.69 was the most common light truck in service with the Wehrmacht at this time and they were used as personnel carriers, prime movers, supply vehicles and even self-propelled anti-aircraft guns. This 6x4 had a 1.5ton payload capacity and a very distinctive sloping hood, which is clearly seen here.

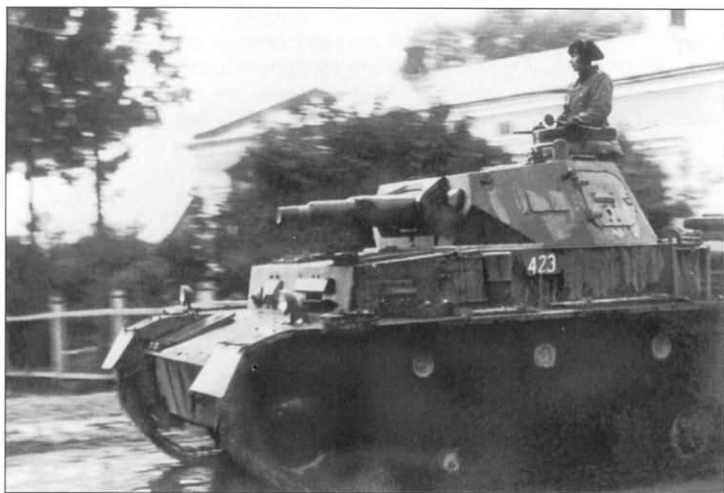
A speeding Pz.Kpfw.IV Ausf.B moves through a French town. The commander has donned his M1935 pattern greatcoat to protect himself from the rain and wears the M1934 padded beret. Unusually, he carries a signal-baton, which were normally issued only to military police traffic controllers. It is most likely that this tank is the lead vehicle in a column and therefore the baton would be useful for signaling the other vehicles.

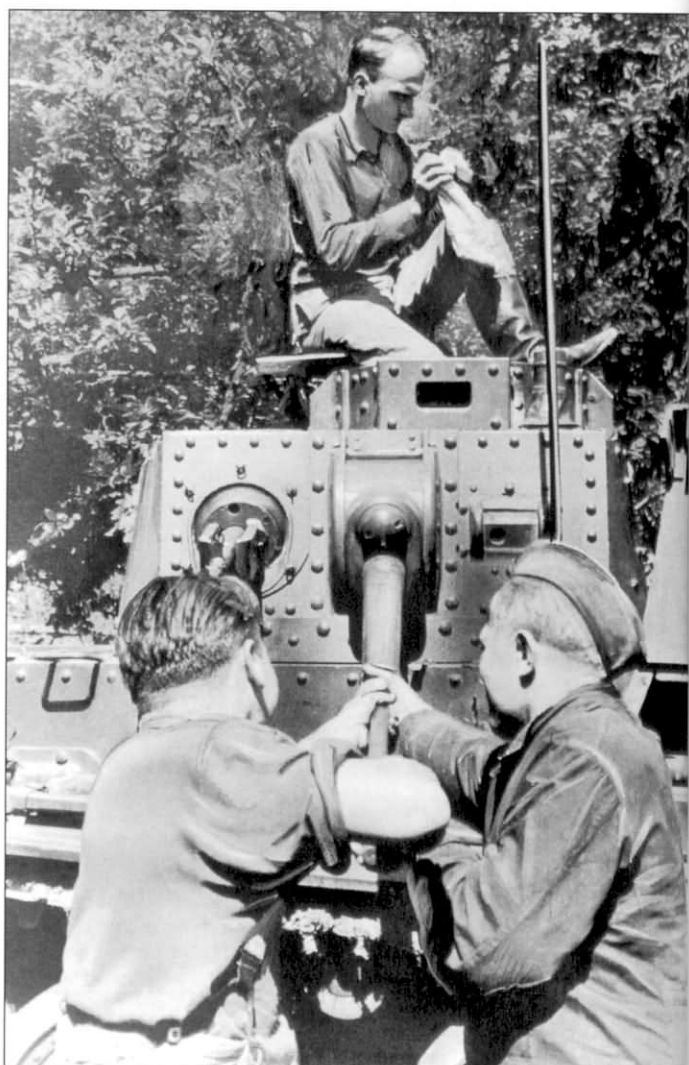
In this heavily re-touched photograph, crewmen clean the 3.7cm gun barrel of a Panzerbefehlswagen 38(t) Ausf.A. Instead of a frame aerial over the engine compartment, this vehicle mounts an additional rod aerial, visible to the right of the turret gun sight above the crewman's head. Notice that the door to the engine compartment has also been opened, undoubtedly for other maintenance work.

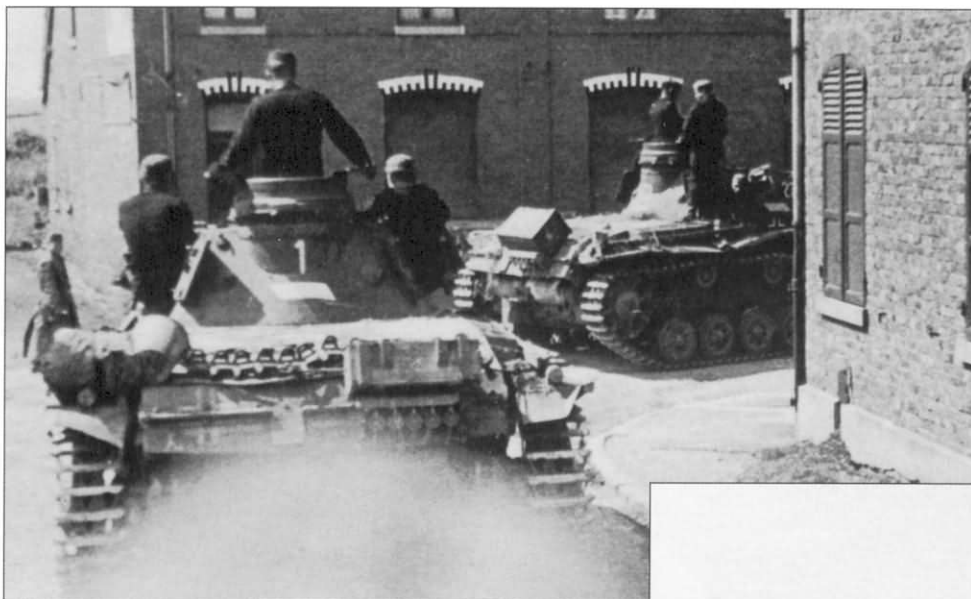
A clear photograph of 5. Panzer-Division markings on a pair of Pz.Kpfw.III Ausf.E/F. The white elongated rhomboid was a unique marking that may have distinguished between the two regiments and very few tanks carried 3 digit tactical numbers, opting instead for two or single digit as seen here. To further confirm the identity, the divisional insignia adopted for the French campaign, an inverted "Y" with a single dot in yellow, is visible on the rear plate beside the national cross.

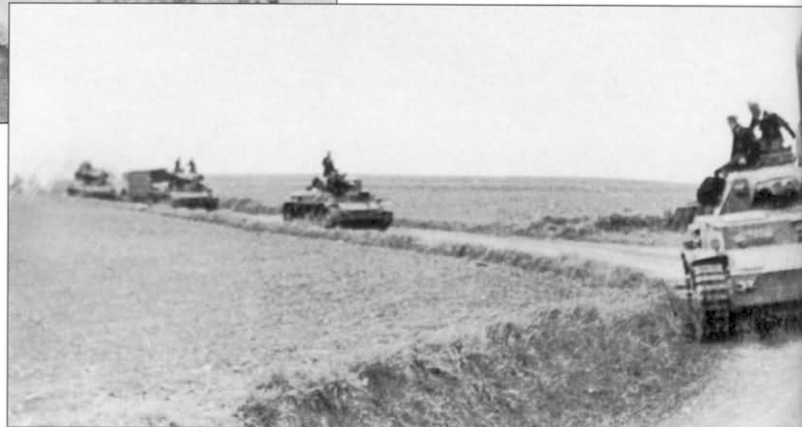
Pz.Kpfw.IV move along a track in France, with an Ausf.C leading the column. For the French campaign, each panzer abteilung (battalion) typically consisted of two light and one medium panzer company. Pz.Kpfw.IV were the primary component of the medium companies, although one zug (platoon) was equipped with Pz.Kpfw.IIs for support. Unfortunately, many of the regiments did not receive their full complement of Pz.Kpfw.IVs, so lighter tanks had to be substituted.

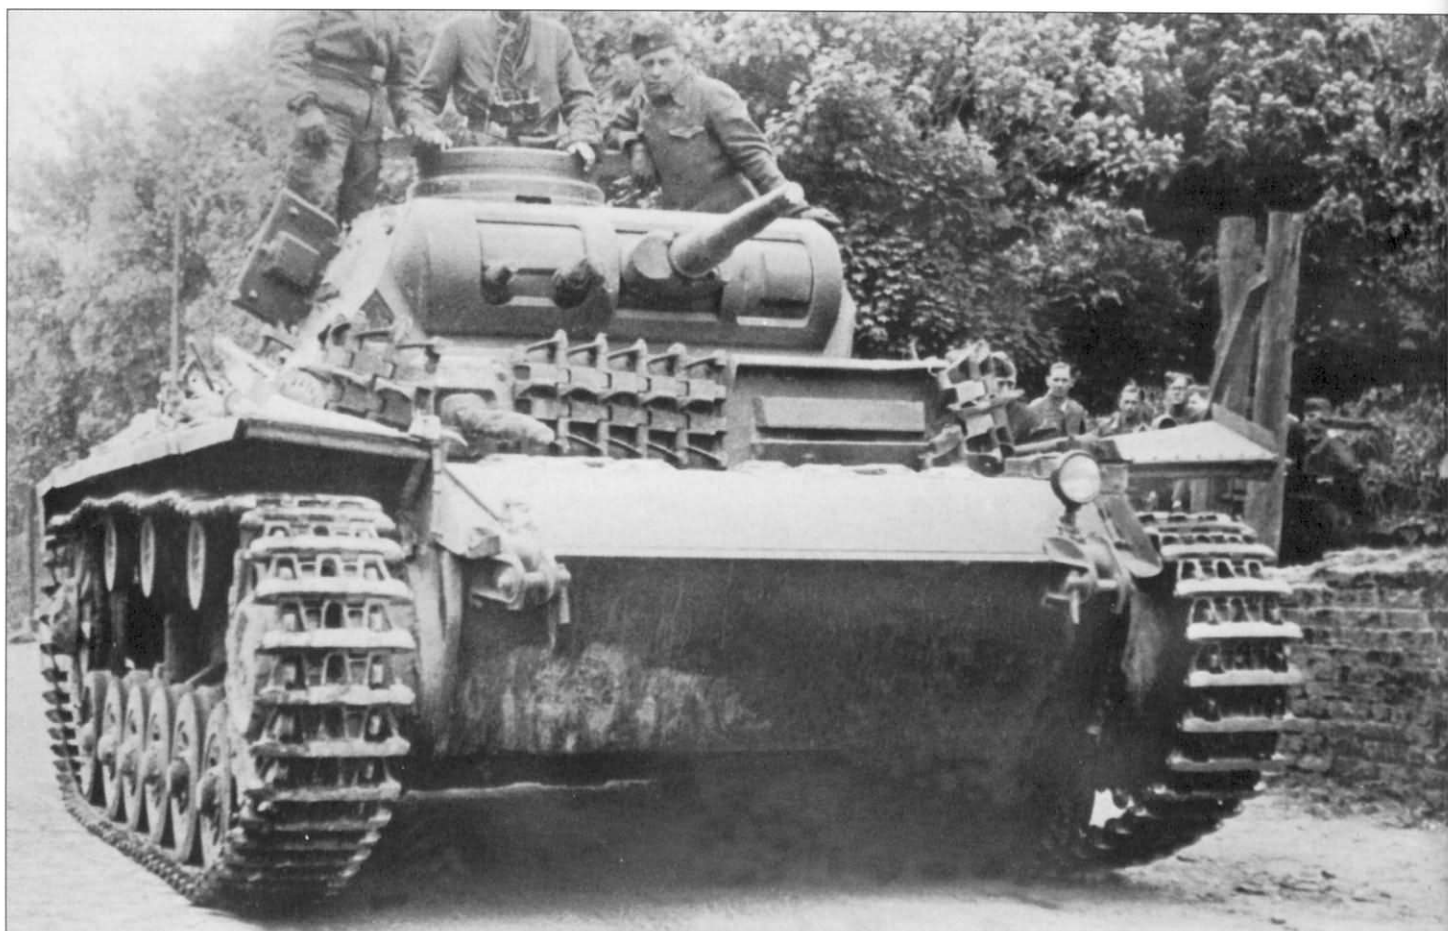
The Pz.Kpfw.III, along with the Czech produced Pz.Kpfw.35(t) and 38(t), were the only tanks carrying an effective anti-tank weapon, the 3.7cm gun. Unfortunately, they accounted for less than one quarter of the total inventory of tanks available for the invasion. Once fighting began, it was discovered that the 3.7cm was ineffective against many of the Allies' more heavily armored tanks. The Pz.Kpfw.III Ausf.E shown here has dust covers over all the armaments and the crew has placed spare track sections over the glacis plate for additional protection.
