# ACHTUNG

# PANZER

The German Invasion of  
France and the Low Countries

Jon Feenstra

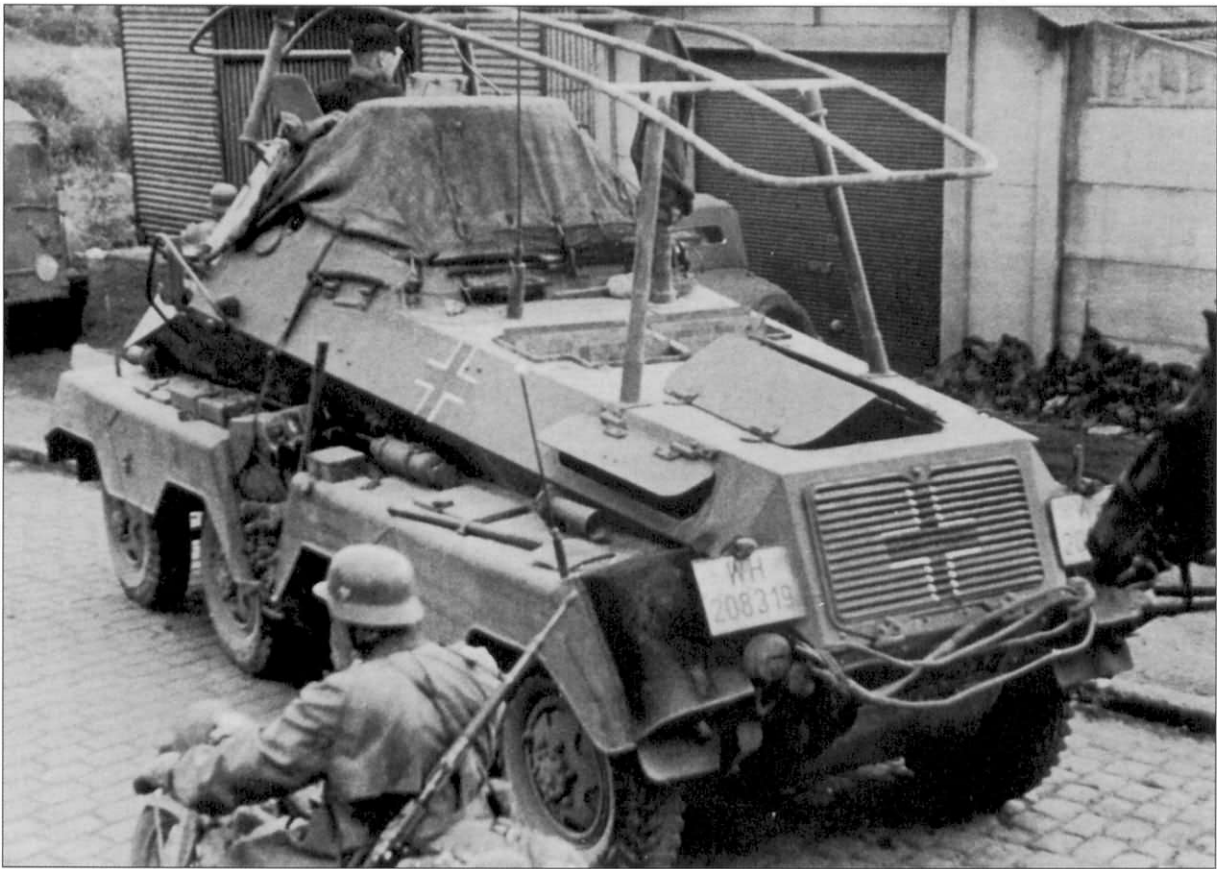
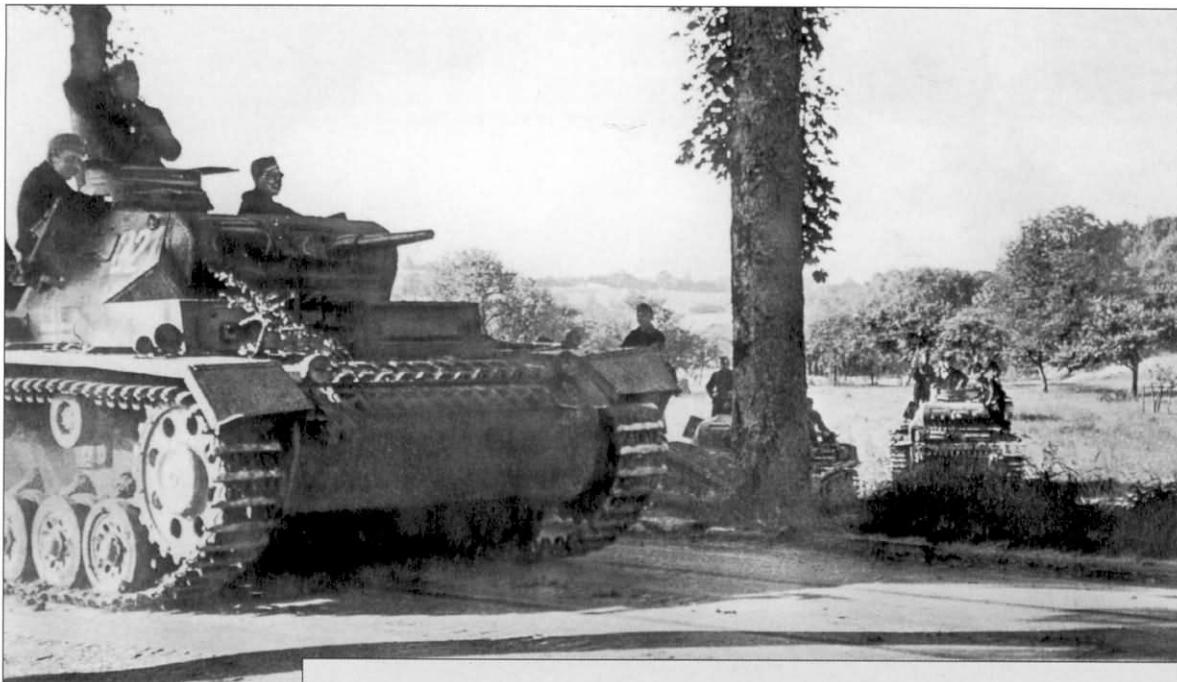
An array of vehicles move through a shallow valley, with a Zündapp KS600 motorcycle combination in the foreground, equipped with an MG34 mounted on the sidecar. The Sd.Kfz.223 (WH82875) has its frame aerial folded down and the white aerial recognition rectangle can be seen painted across the top of the stowage box and down either side onto the hull. It is missing the rear ventilation grille, most likely removed due to irreparable damage. Further up the road is a Henschel Type 33 D1 6x4 truck towing a compressor or generator.

An Sd.Kfz.263 parked on the roadside with its engine access doors propped open to assist in engine cooling. In addition to the standard frame aerial and telescoping mast, this vehicle also has a third rod aerial, which was not a standard fitting and probably indicates that additional radio equipment has been installed. A tire is carried under the roof tarpaulin, which was a common place to stow the spare.

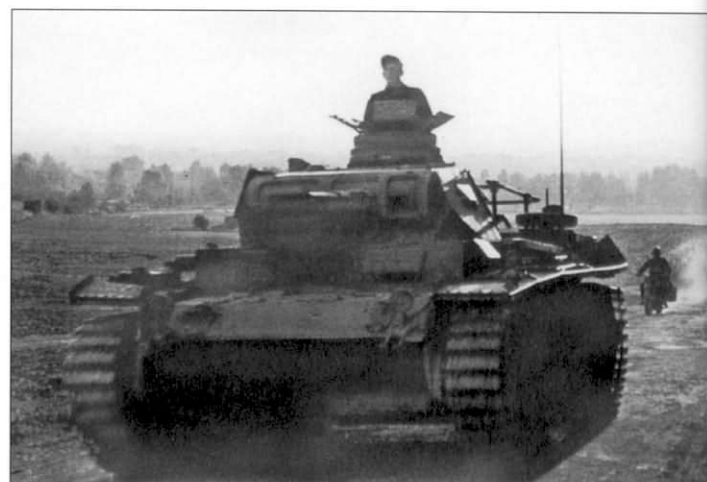
With its large frame antenna visible over the engine deck, a Panzerbefehlswagen III Ausf.E command tank is seen near Peronne, France, during Fall Rot. No markings are visible and this vehicle has what appears to be a Panzerkampfwagen II style armored visor cover over the driver's viewport instead of the standard Pz.Kpfw.III vision block.

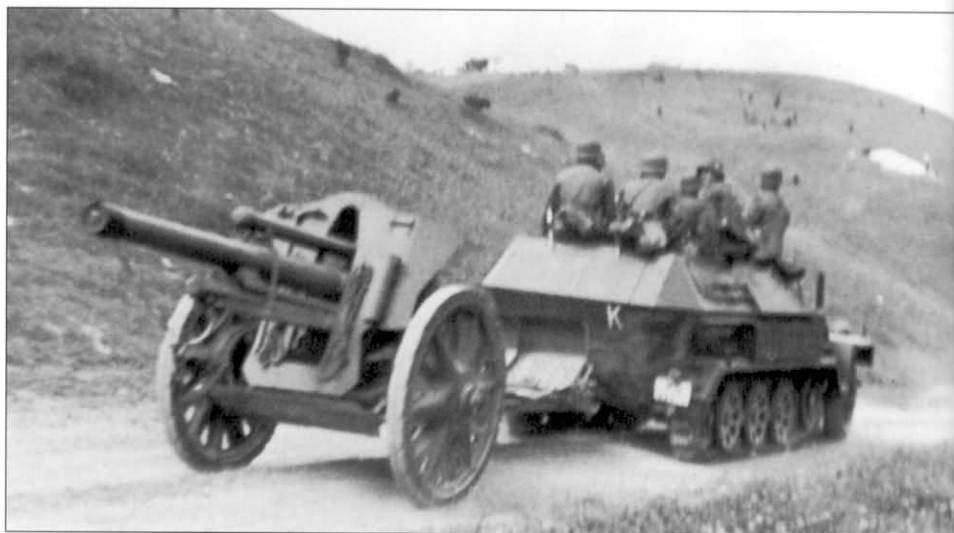
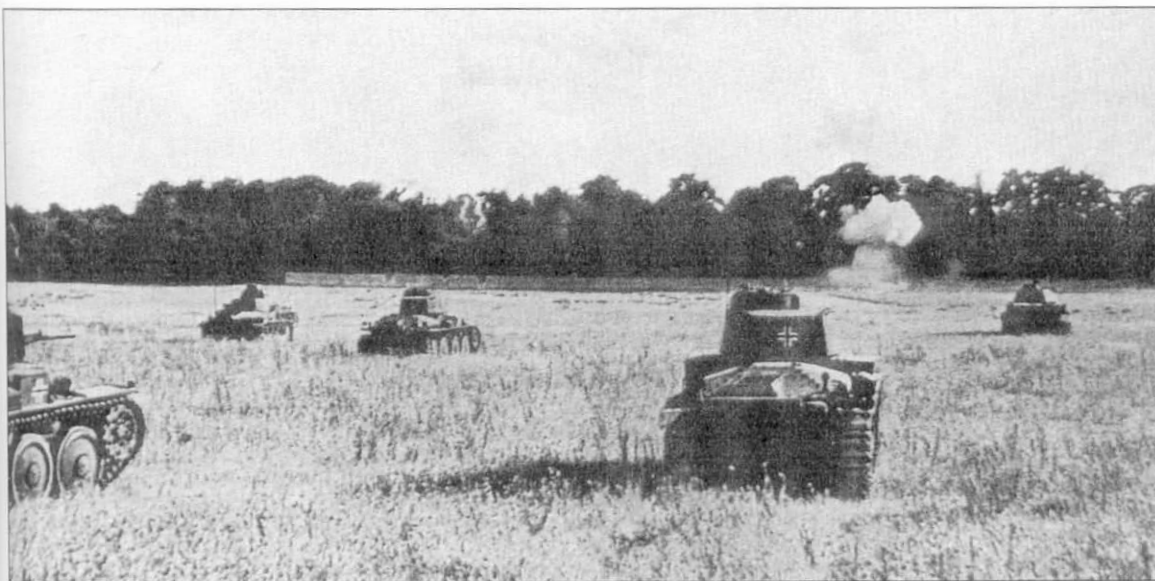
An Sd.kfz.251 Ausf.A halftrack towing a 10.5cm leFH18 field gun near the Somme River in early June. Although difficult to tell from this view, it is probably a 251/4, which was developed as a towing and ammunition vehicle for the 7.5cm leIG18 light infantry gun but eventually used as a prime mover for heavier guns such as the one shown here. It carries the white Gruppe von Kleist "K" marking on the rear door.

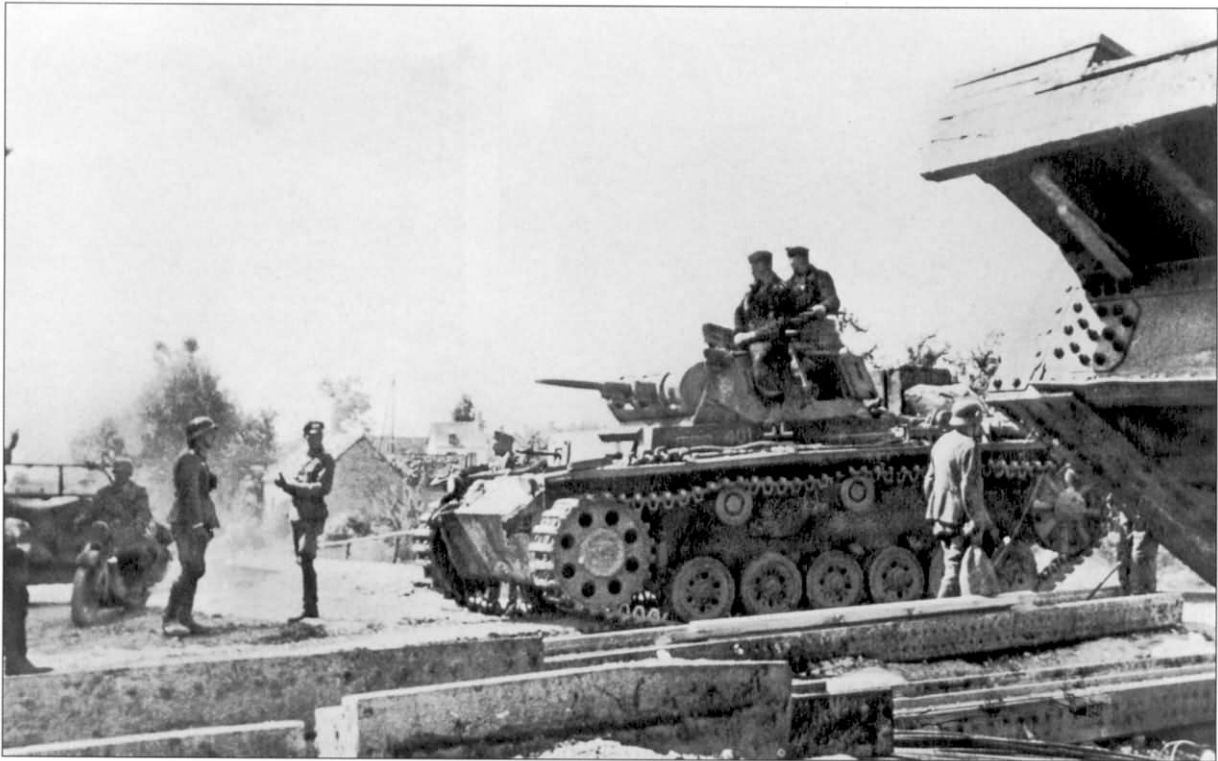
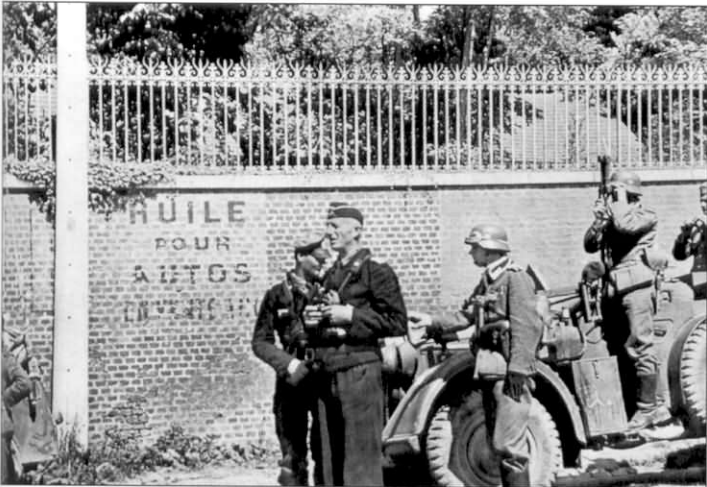
A Pz.Kpfw.III Ausf.F from 5.Panzer-Division crosses the Somme at Pont-Remy, on June 5 or June 6. On the turret side is the red devil's head insignia of Pz.Rgt.31, and the tactical number "401" is beside the national cross on the hull side. Other than Pz.Rgt.7 with its bison insignia, Pz.Rgt.31 was the only other regimental unit in Fall Gelb and Fall Rot to use a specific marking. A section of the destroyed road bridge is to the right.

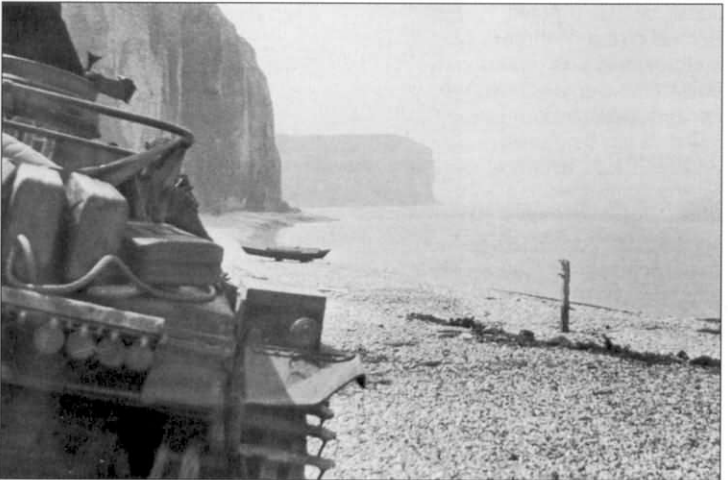
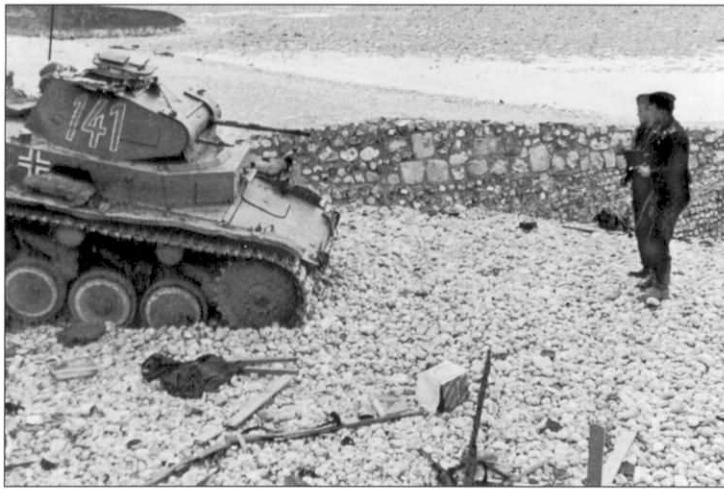
After reaching the Seine River near Rouen on June 9, 7.Panzer-Division turned back to the northwest to block the retreat of the French IXeme Corps d'Armee. An advance party from Pz.Rgt.25 reached the English Channel on June 10 at Les Petites-Dalles, a small seaside hamlet. These two photos show Oberst Rothenburg's Panzerbefehlswagen III Ausf.E that broke through the seawall and advanced down to the water's edge. In the distance can be seen the English coast.

Visible in this photograph is the tactical number "B01" on the turret rear and the frame antenna that was the prominent feature of the Pz.Bf.Wg.III. Of interest is the smoke grenade launcher, which has one round that has been fired.

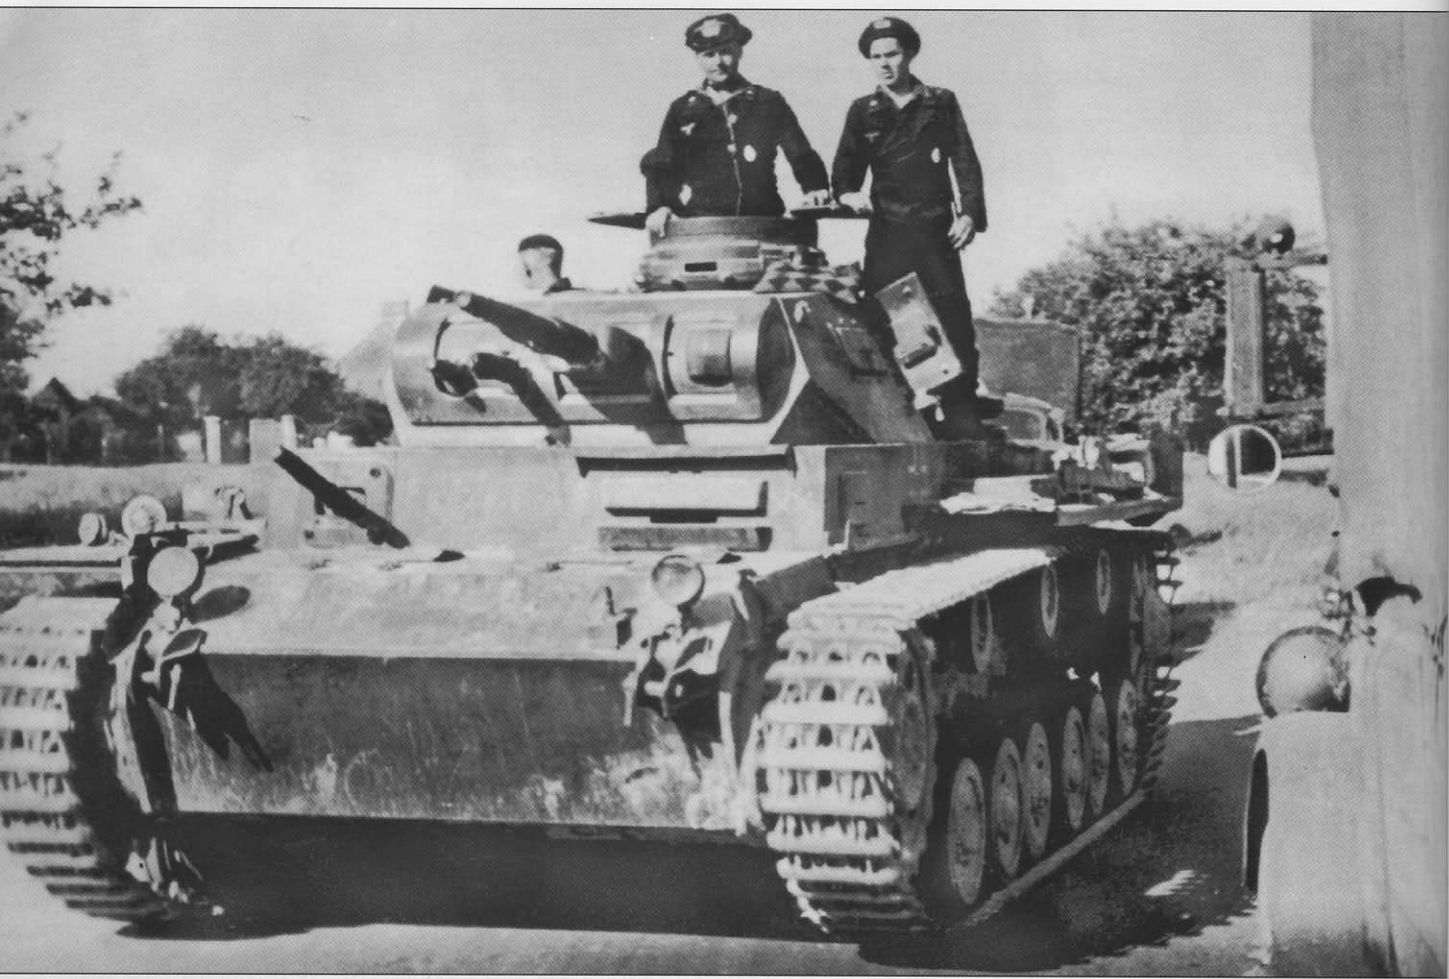
The 9. Panzer-Division insignia is just visible on this Pz.Kpfw.III Ausf.E as it advances on the Loire River during the final phase of Fall Rot in mid-June. The 9. Panzer-Division was the only armored unit to be involved in the invasion of Holland and was transferred to France after the Dutch capitulation on May 15. For Fall Rot it was assigned to XIV. Armeekorps, part of Panzergruppe von Kleist. The vehicle has suffered some considerable damage, having lost half its fender and Nottel light. All the weapons have dust covers in place and the crew wear the Schutzmutze (literally "protective cap") or beret that was commonly worn at this stage of the war.

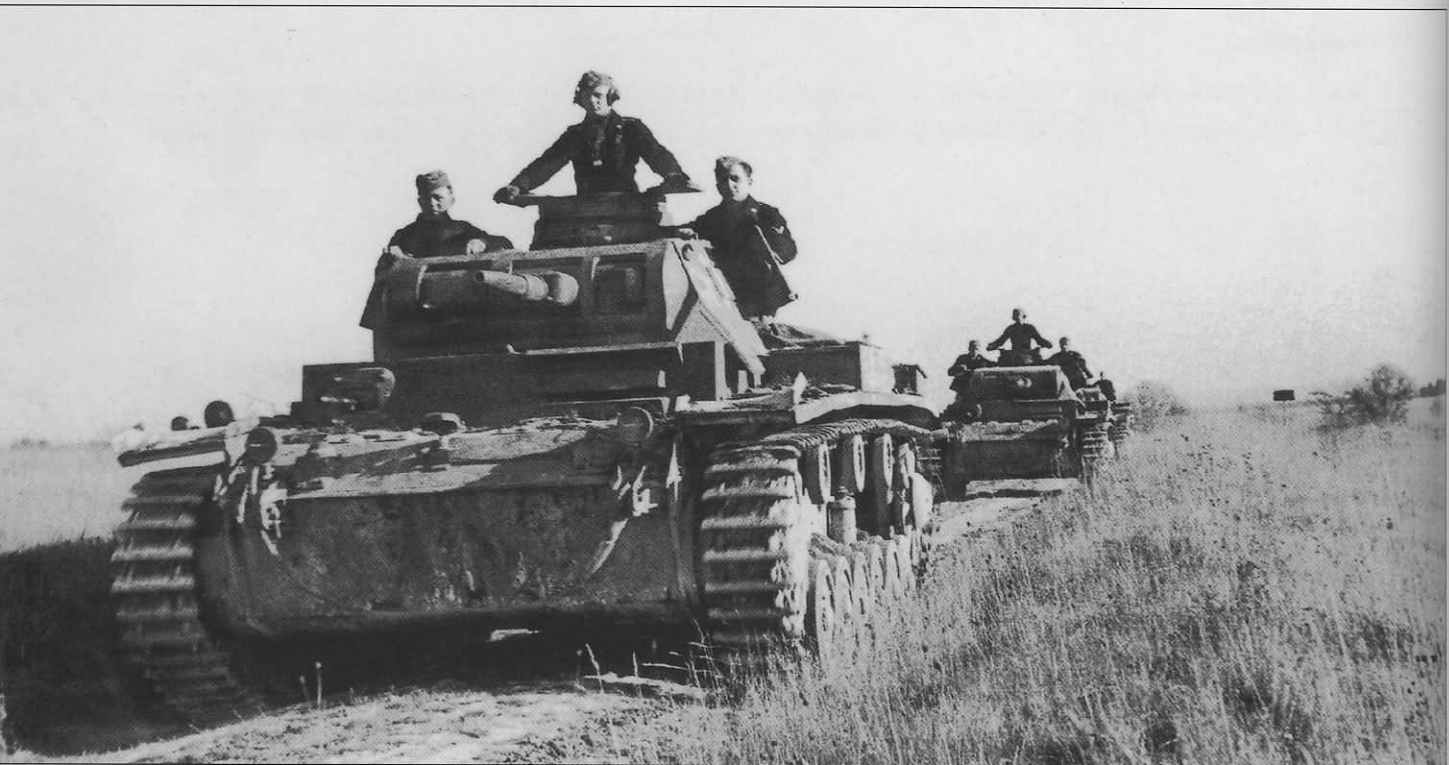
A column of Pz.Kpfw.III advance along a dirt track while the turret crewmen catch a breath of fresh air. The lead vehicle is an Ausf.F, while the second is an E model since it is missing the brake cooling air intake covers on the glacis plate. Barely visible on the turret side is the stenciled bison insignia of the 9. Panzer-Division's Pz.Rgt.7. A national cross is located on the field fitted stowage box mounted on the fender.

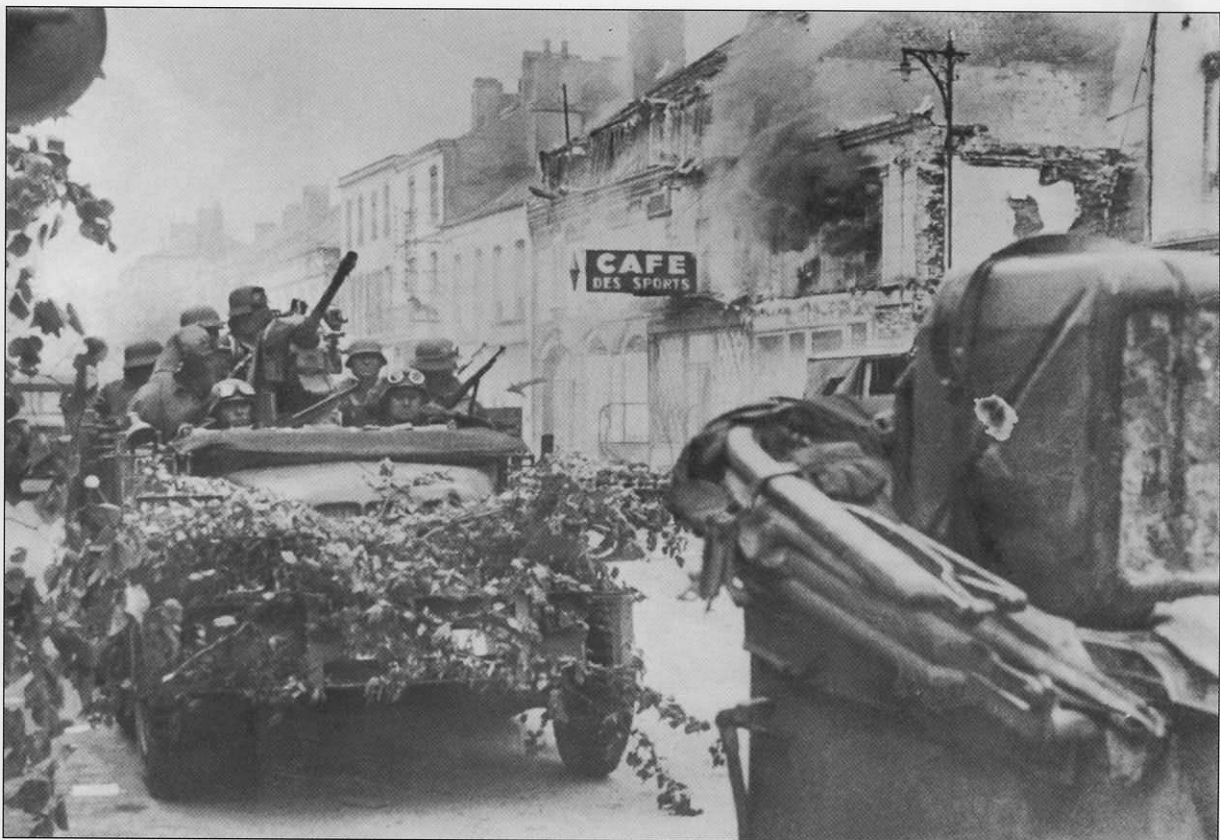
An Sd.Kfz. 10/4 passes through a French town in mid-June. These 1-ton halftracks mounted 2cm Flak 30 anti-aircraft guns and were operated by independent Fliegerabwehr-Bataillon (anti-aircraft battalions) during the 1940 campaign. Self-propelled AA guns such as these were vital to Blitzkrieg tactics, as they were the only units capable of keeping pace with the armored units. Although in general the Luftwaffe ruled the skies during Fall Gelb and Fall Rot, the French and British still had formidable air forces and Wehrmacht ground units were subjected to periodic air attacks. This crew has attached some foliage for camouflage and covered the folded windshild with a tarpaulin to minimize glare.

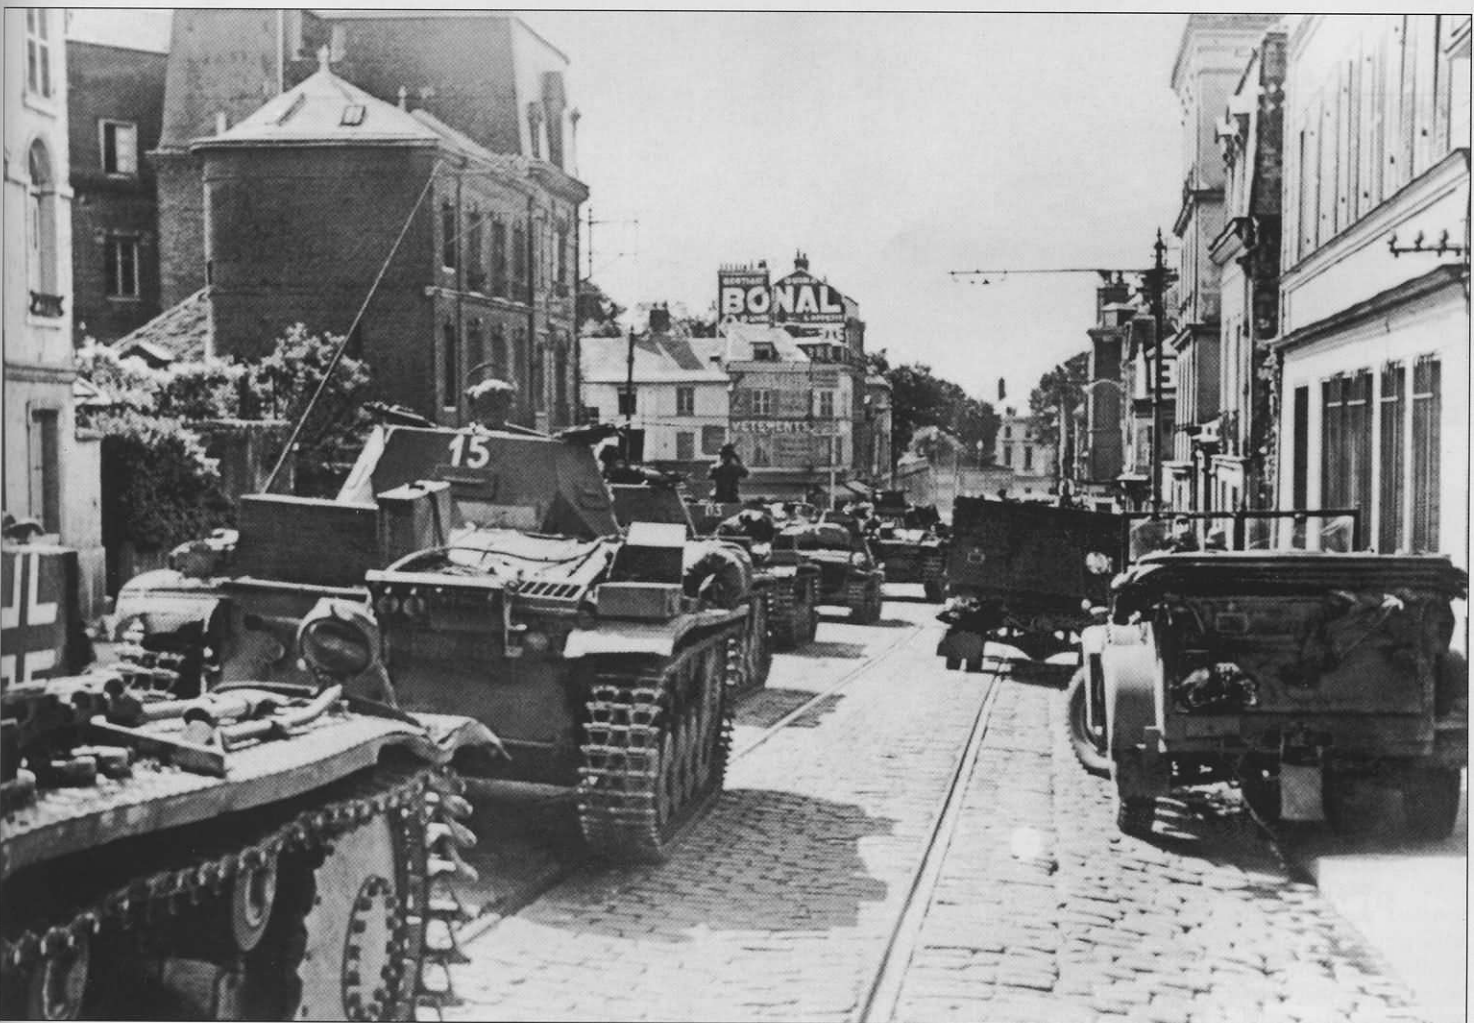
Four Pz.Kpfw.II follow a Pz.Kpfw.I Ausf.A and a Pz.Kpfw.III through a French town sometime in June. These tanks are from 5.Panzer-Division, with a yellow elongated rhomboid seen below the turret vision port on the nearest Panzer II with the number "15". "03" can be seen further up the line. The Kfz.15 passenger car and truck appear to be from a Pionier unit based on the tactical sign. The license plates have been censored.

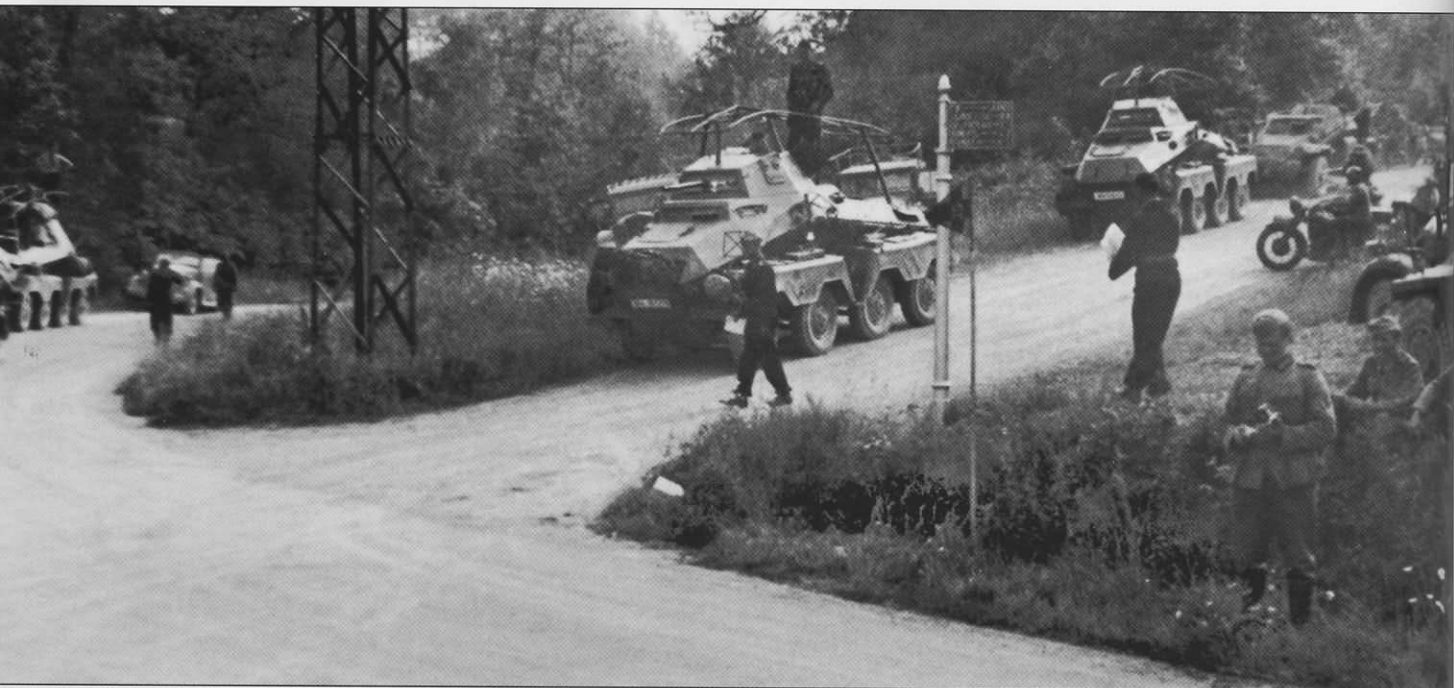
Reconnaissance elements of Rommel's 7. Panzer-Division, presumably from Aufklärungs Abteilung 37, in the vicinity of Cherbourg on June 18, 1940. An Sd.Kfz. 223 with its frame antenna folded down follows two Sd.Kfz. 232 (8 Rad) and a Sd.Kfz. 263 is to the left. Notice the command pennant frame on the tender of the nearest armored car.

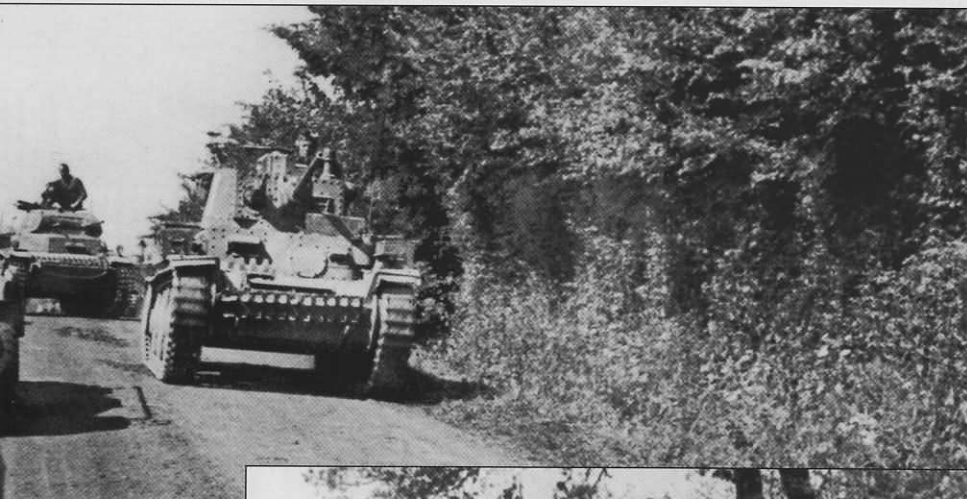
Two photographs taken of a column of 7. Panzer-Division tanks during the advance to Cherbourg sometime around June 18. In the first photograph is a Panzerbefehlswagen 38(t), although it is not equipped with the prominent frame aerial. Its role as a command vehicle is evident by the plated over hull machine-gun port, which was removed to make room for the additional radio equipment. The divisional insignia is barely visible over the radio operator's vision port.

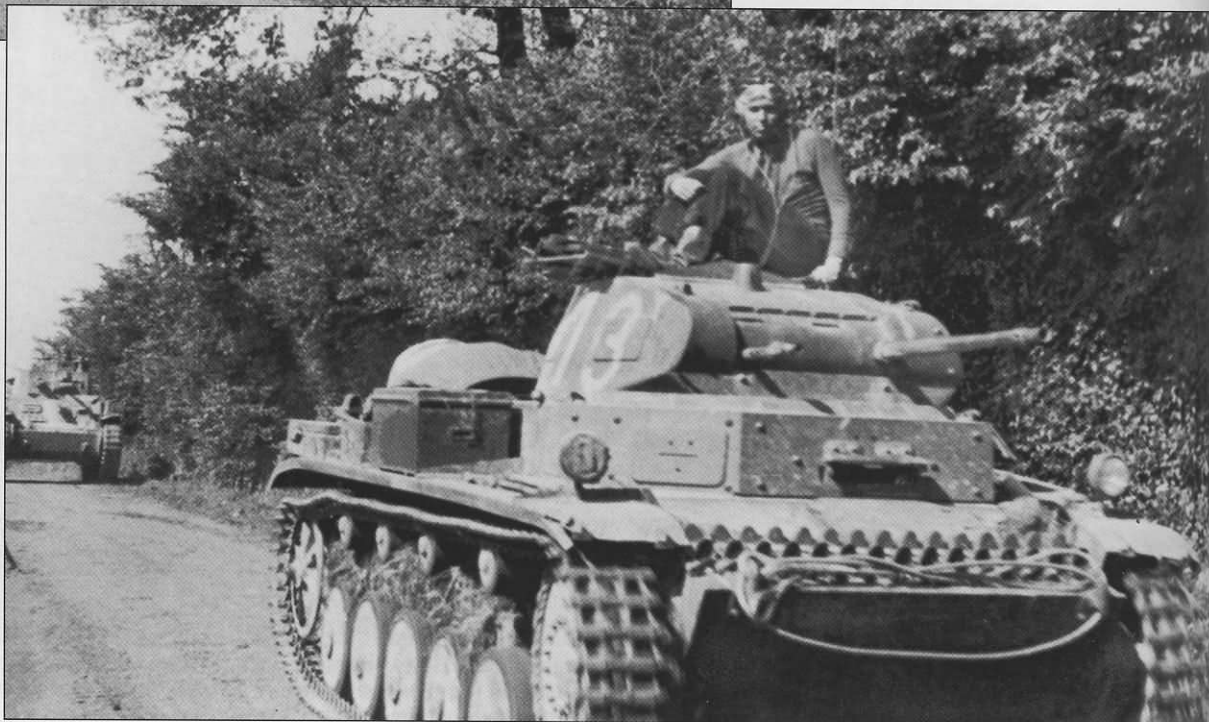
The Pz.Kpfw. II that is seen behind the z.Bf.Wg. 38(t) is shown in the second photograph. The commander has removed his black fieldjacket to expose the house gray shirt, which is unusual as the Panzer troops still took great pride in their appearance at this stage of the war. Shown to advantage is the additional 20mm armor plate that was installed on the lower hull, glacis and turret front to improve the survivability of these vehicles. An aerial recognition flag has been tied to the engine deck over the stowage.

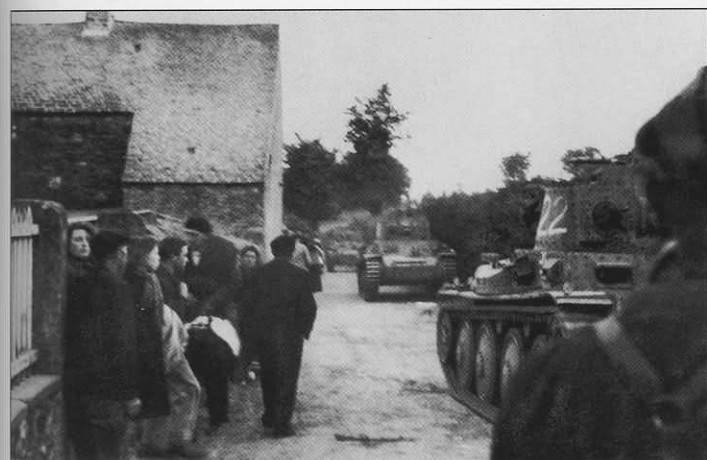
The advance on Cherbourg continues as a column of Pz.Kpfw.38(t)s pass a group of French civilians looking on in disbelief. The nearest tank carries unusual turret numbers that appear to be in solid white and irregularly shaped.

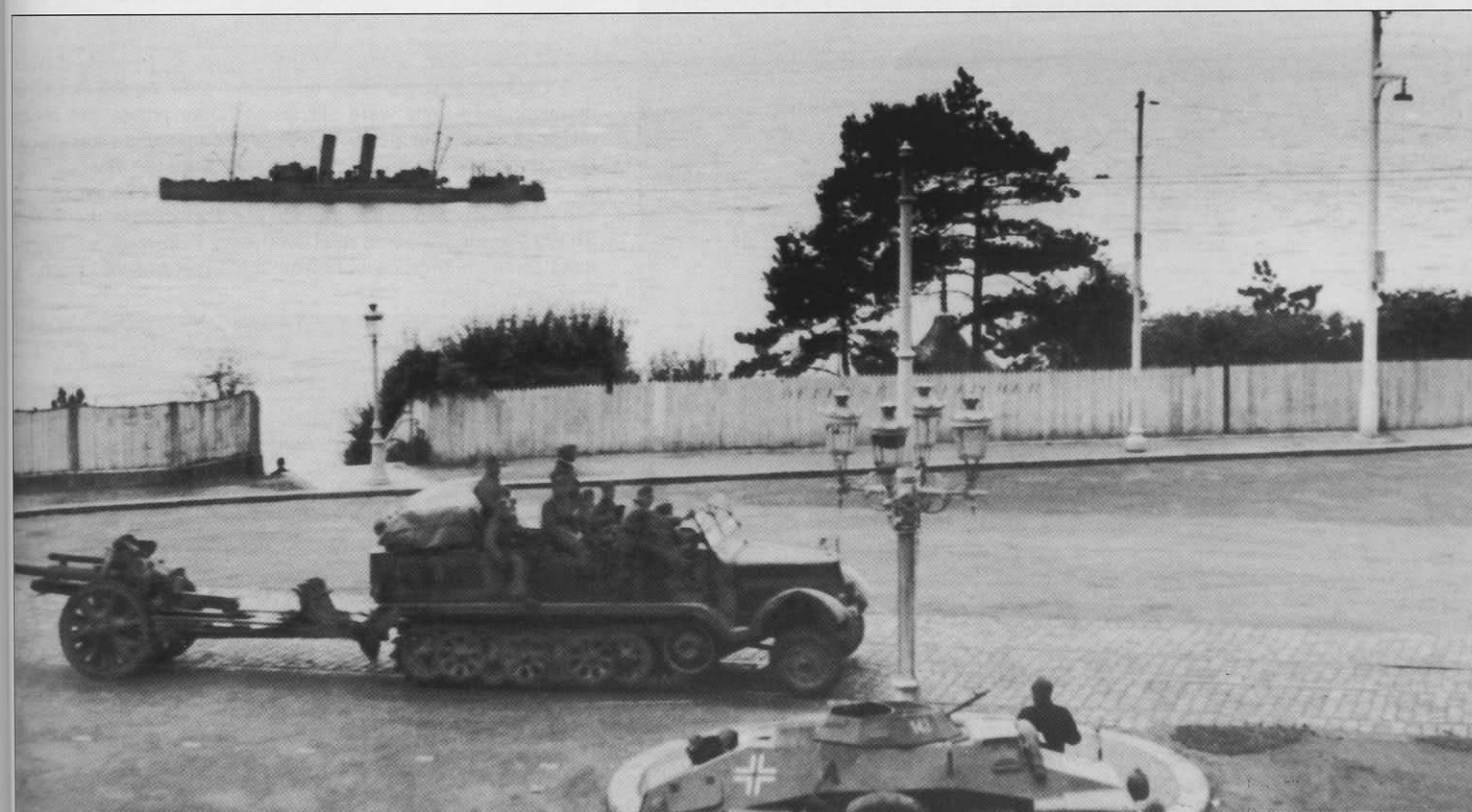
Cherbourg was officially in German hands on June 19, by which time more than 30,000 Allied troops had been evacuated. On the Cherbourg waterfront, a relatively rare Sd.Kfz.6/1 5-ton artillery tractor tows a 10.5 cm leFH 18 past an Sd.Kfz.221 armored car. A solid white tactical number "143" appears on the turret. The ship in the background is of unknown origin, but given the attitude of the soldiers it is most likely a Kriegsmarine vessel and therefore the scene probably took place a few days after the fall of Cherbourg.

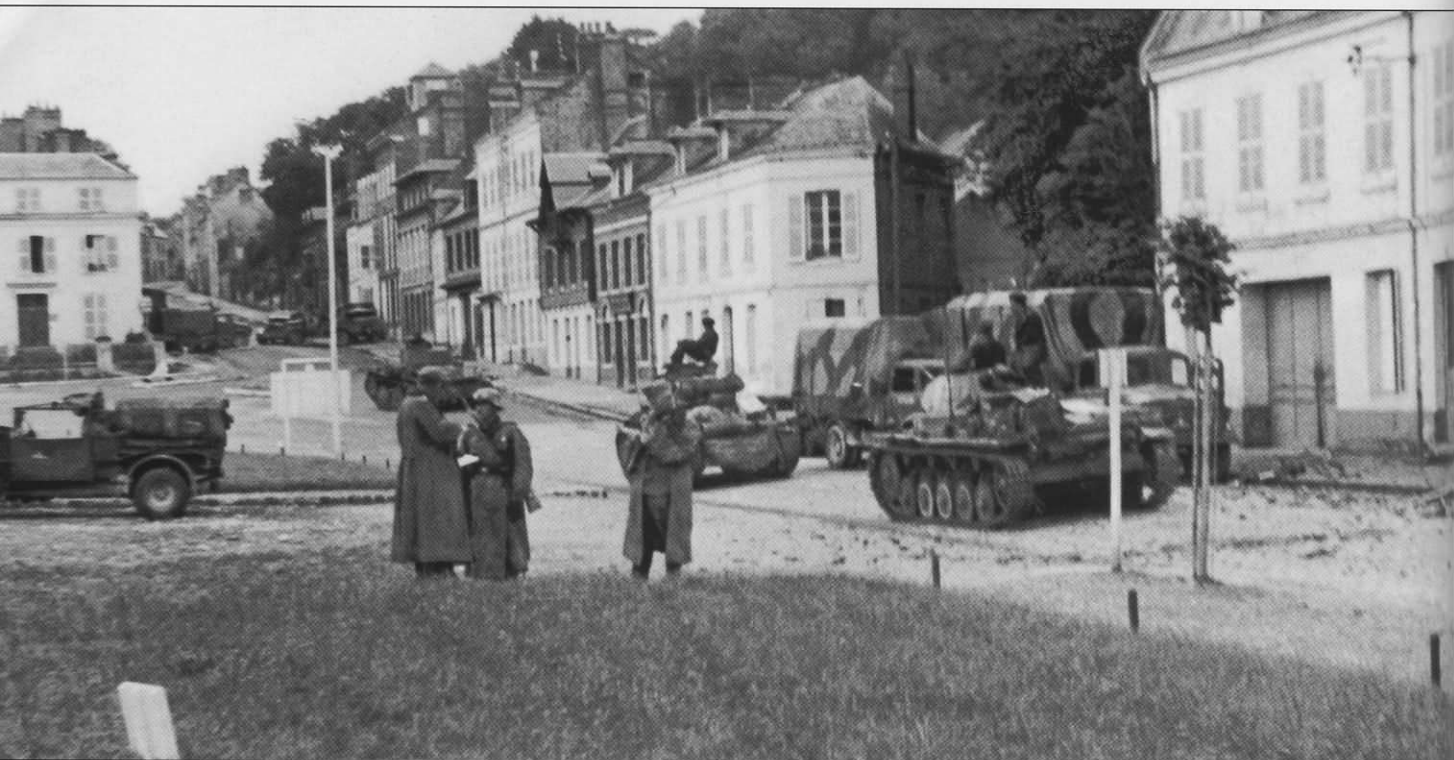
Tanks from 7. Panzer-Division on the streets of Cherbourg, with two Pz.Kpfw. 38(t)s leading, followed by a Pz.Kpfw.II. Abandoned British trucks are seemingly parked at random, their former owners evacuated back to England. To the right is what appears to be a Bedford OYD 3 ton, while on the left a Humber or Bedford 8cwt General Service is parked along the curb. The trucks further up the road have obviously been positioned to form a makeshift roadblock, now little more than an inconvenience for the invaders.

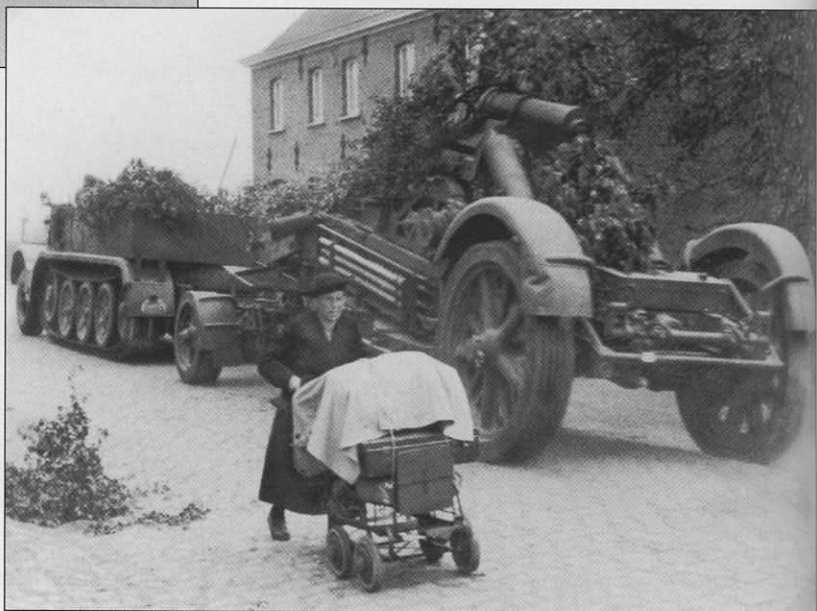
In the second photograph, an 18-ton Sd.Kfz.9 tows the carriage of a 21cm Mörsers 18 "Brummbär". This was an extremely large gun, weighing over 3 times as much as the sFH18, and therefore for longer moves, it was broken down into two components, the barrel and the carriage. The Famo 18-ton halftrack, though, was more than capable of pulling it in one piece, as was done for shorter distances. It is interesting to note that both guns have been heavily camouflaged with foliage, as well as the Famo, so the crews must have been somewhat concerned about possible air attacks.

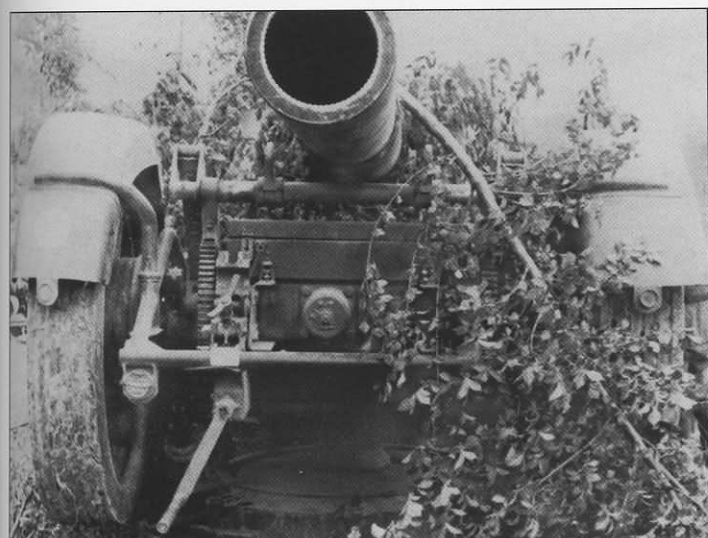
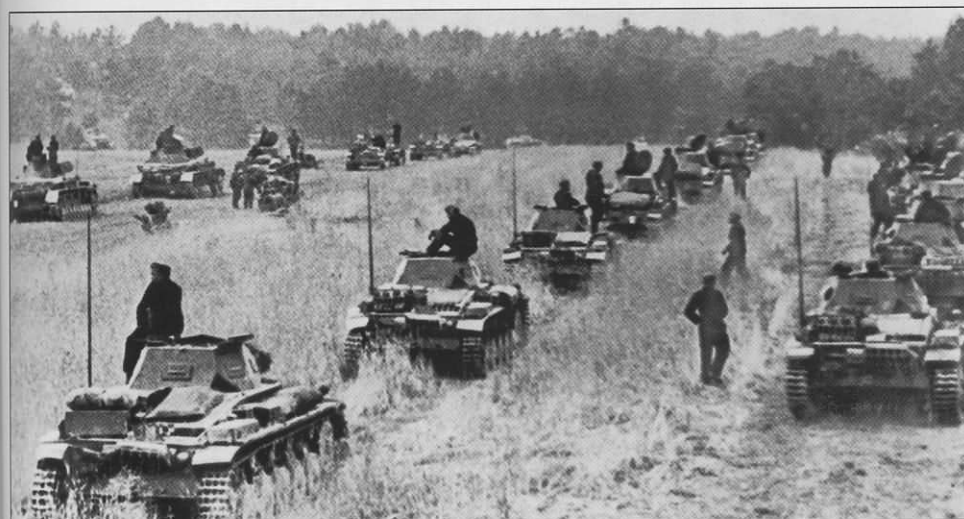
Two additional photographs of a 21cm Mörser 18. It would appear that this gun has been emplaced and subsequently concealed with foliage as the traverse platform is lowered and the wheels raised off the ground. Note the unusual barrel or keg emblem on the right mudguard from an unidentified unit.

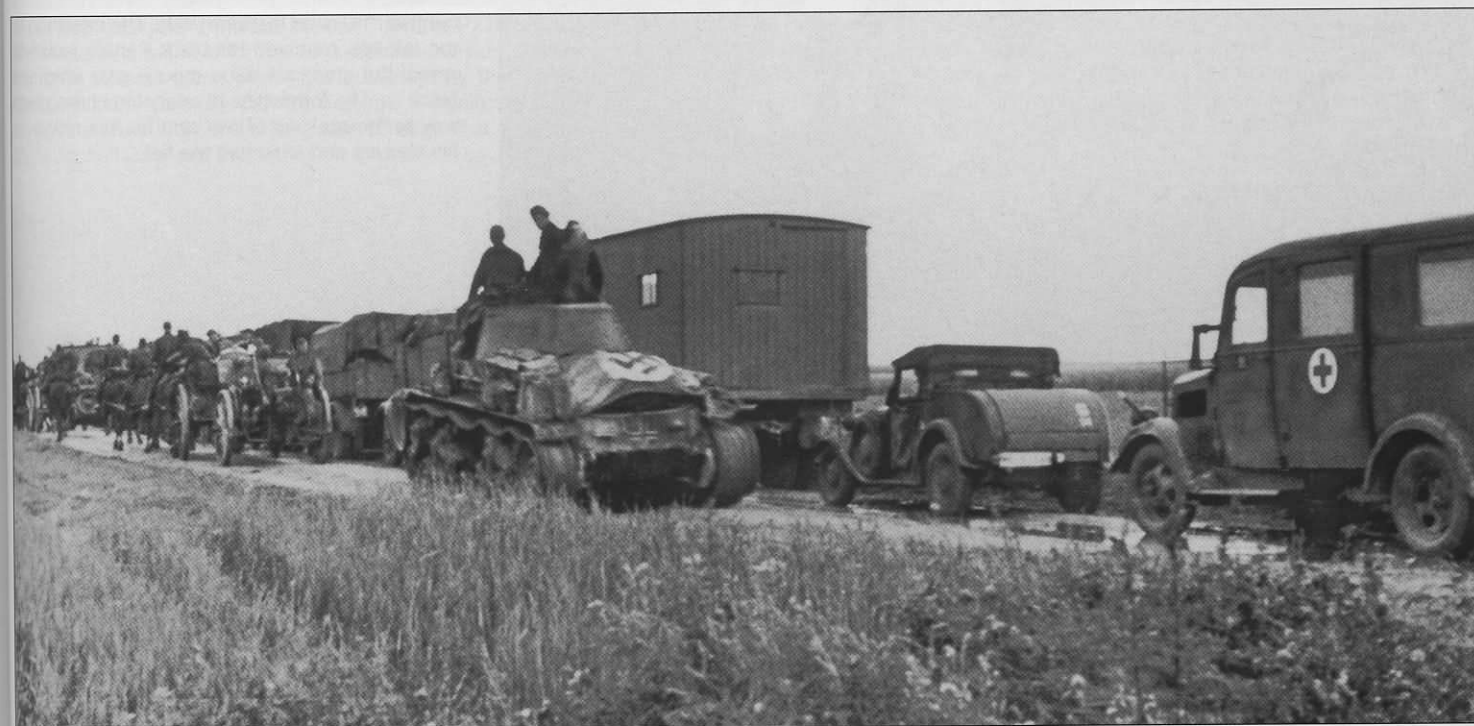
Hurry up and wait! Although the word "blitzkrieg" conjures up images of fast-moving tanks, the German Wehrmacht was no different than any other military force, then or now, and invariably spent more time waiting for things to happen than actually fighting. This is a group from 6.Panzer.Division, as evidenced by the Pz.Kpfw.35(t)s at the front of the first two columns. This was the only division to be equipped with this Czech-built tank. In the foreground are Panzer IIs and to the far left are a pair of Panzer IVs.

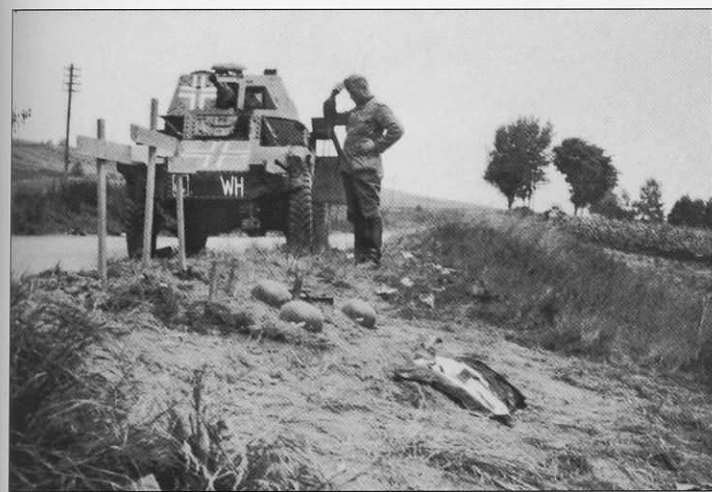
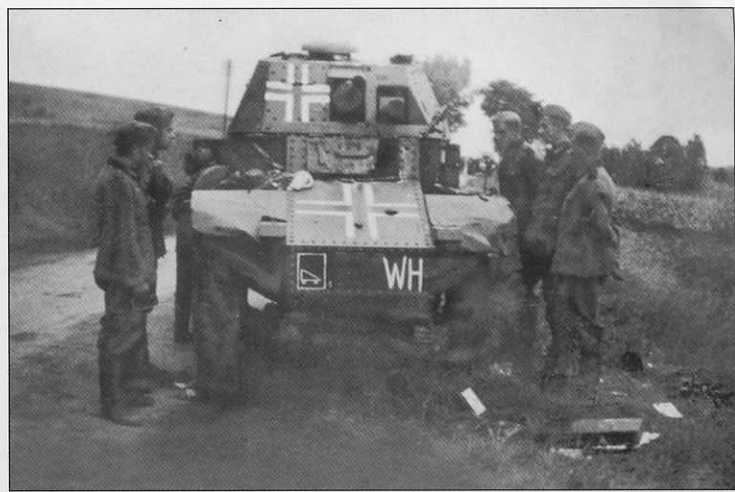
Two unique photographs of a AMD Panhard 178 French armored car that was captured and subsequently put to use by the Germans, only to be knocked out by its former owners on June 12 in the Champagne region. Two shell penetrations are clearly seen on the glacis and a portion of the driver's vision port cover has been damaged. The three occupants have been buried on the roadside complete with helmets and national flag. Between 200 and 300 Panhards were eventually taken into the Wehrmacht's inventory after the French surrender. Like the one shown here though, many were put to use immediately upon capture, after the application of large crosses to avoid friendly fire. These markings were obviously hand painted and the tactical marking is for an anti-tank unit. In this case, it is I/Panzerjäger Abteilung 5, which operated a least one other Panhard 178 with similar markings during Fall Rot.

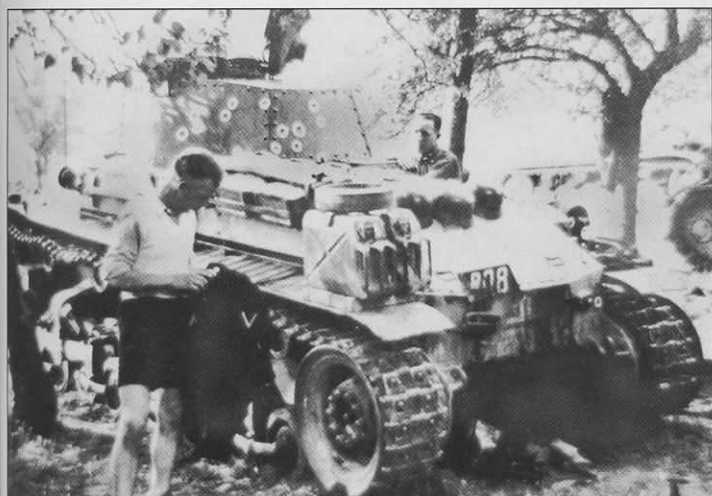
"R08" after the armistice in June, 1940, a Pz.Kpfw.35(t) belonging to the headquarters unit of Pz.Rgt.65 (6.Panzer-Division). The white circles on the turret indicate some of the hits sustained by this tank throughout the campaign that obviously did not damage it significantly. This photograph provides a good view of the jerry can stowage that was common on most 35(t)s for Fall Gelb and Rot.

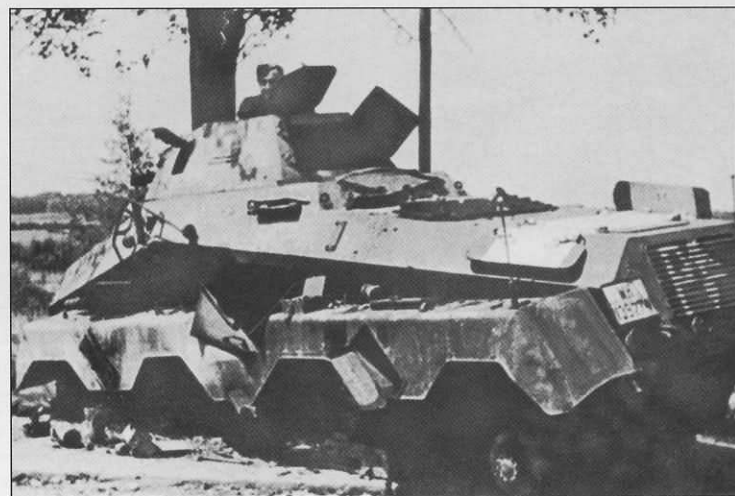
A destroyed Sd.Kfz.231, license number WH139274, that clearly shows the large white aerial recognition rectangle, in this case extending onto the hull sides. The marking on the rear louvers is unidentified, but it may be some type of reference number for the recovery units. These vehicles were vulnerable to almost any fire, with a maximum armor thickness of only 15mm.

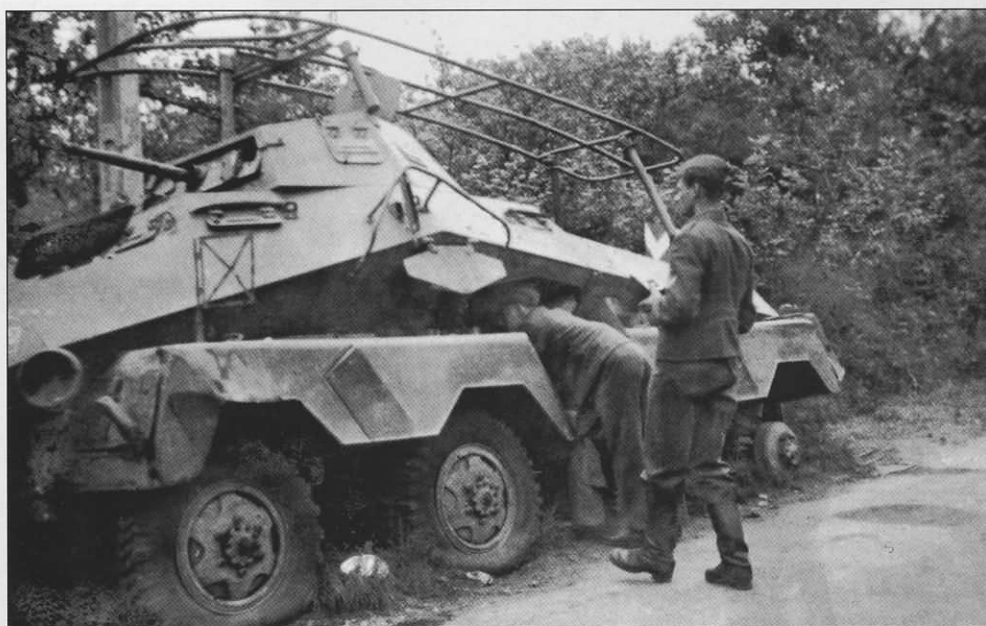
Two German soldiers examine a wrecked Sd.Kfz.232 radio car somewhere in France. For no apparent reason, the 7.Panzer-Division insignia appears twice, once behind the frame for a command pennant, and again at the front corner of the hull near the left edge of the picture. The marking below is unidentified. Notice the open port in the turret mantlet for the MG34, obviously removed by the crew while abandoning the vehicle.
