# ACHTUNG

# PANZER

The German Invasion of  
France and the Low Countries

Jon Feenstra

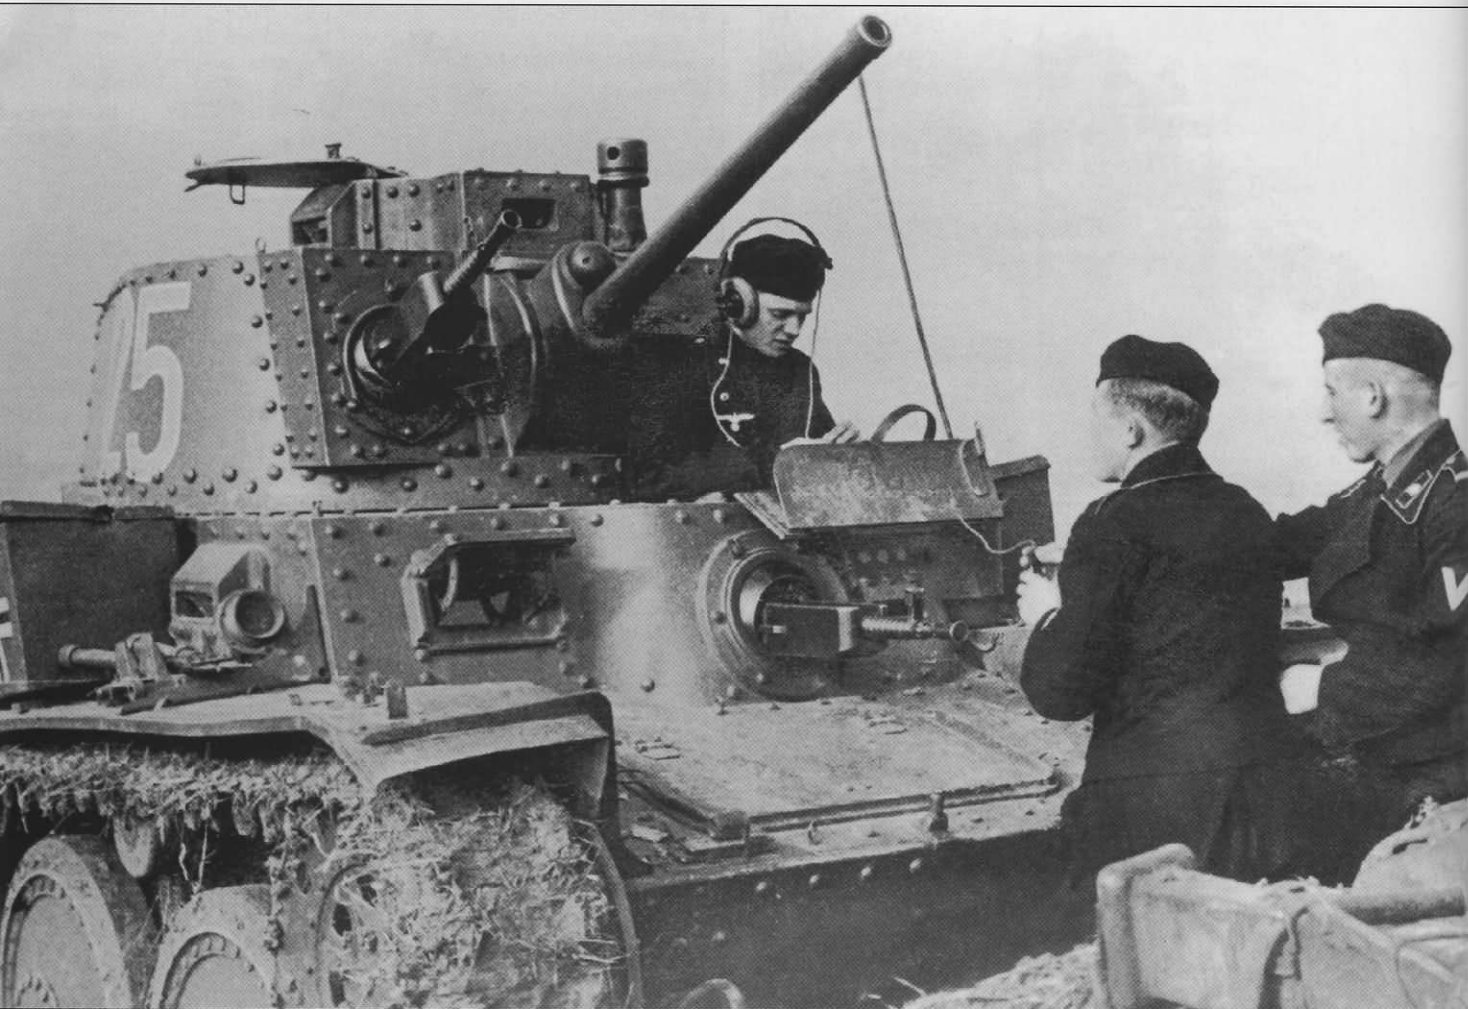
Crewmembers of a Pz.Kpfw.38(t) Ausf. C or D perform a radio check while on maneuvers in France in October 1940. All of them wear the black M1940 field cap (Feldmütze) and the man on the right carries Obergefreiter (Lance-Corporal) rank insignia on his sleeve. The tank belongs to 7.Panzer-Division with the insignia below the open hatch and carries the characteristic large red and white turret numbers, in this case "25", although the first digit may not be visible.

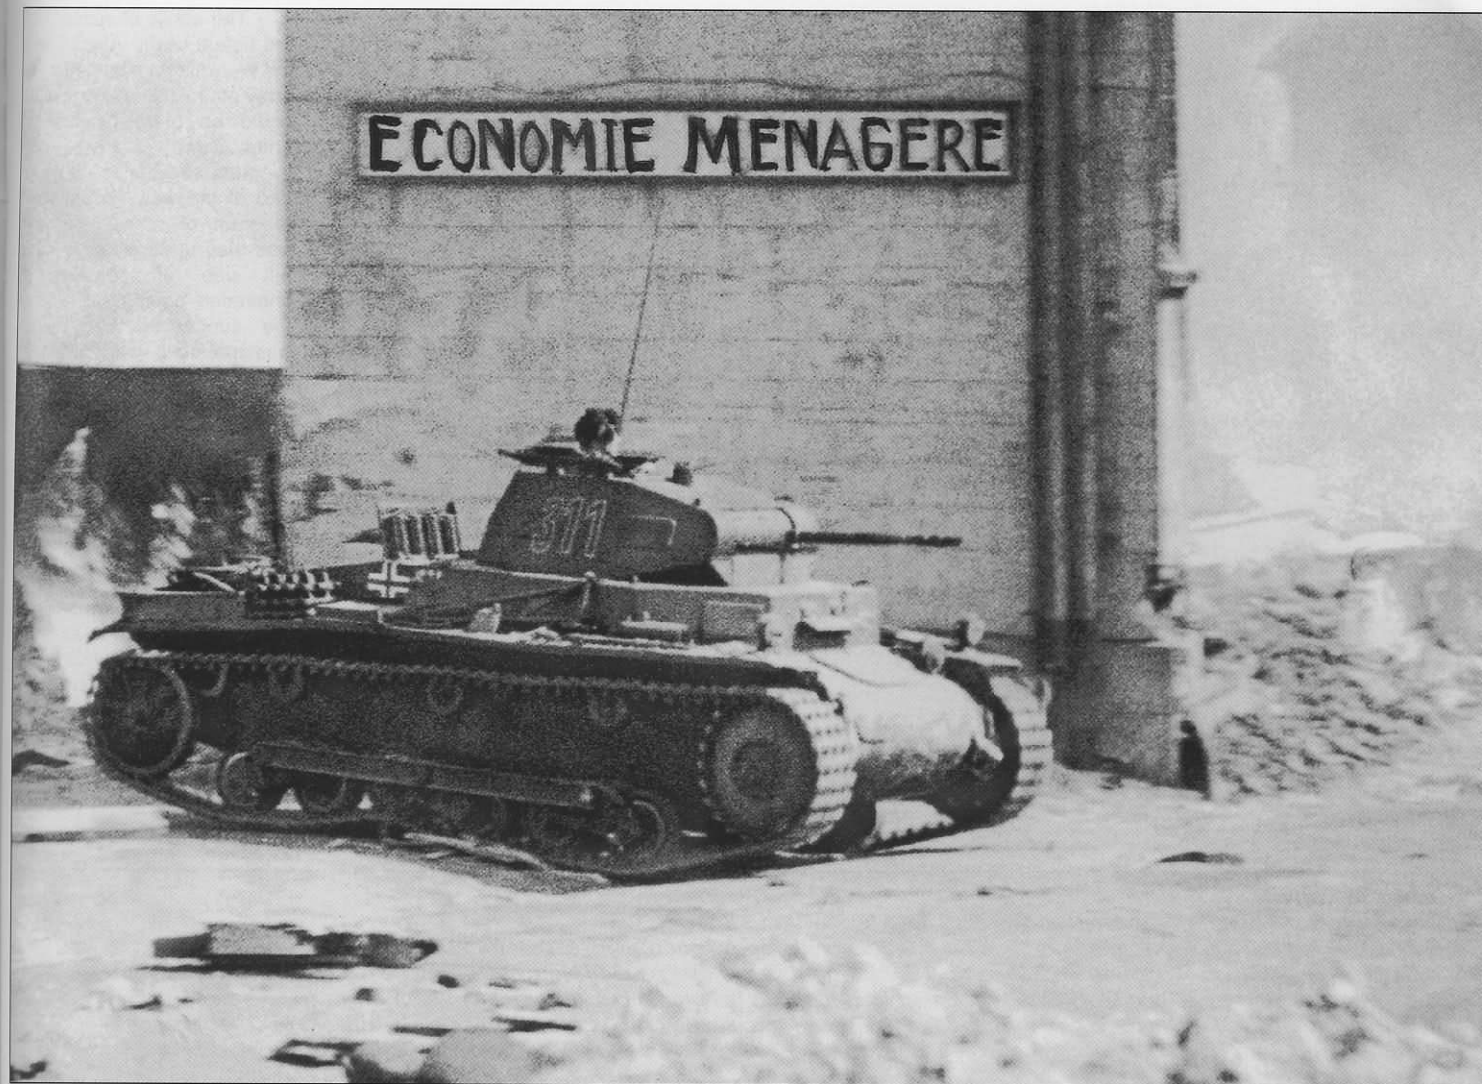
This is another photograph taken from "Sieg im Westen", with the original film footage in color. It is unclear if the assault of June 5 on the French town of Hangest depicted in the film is from the actual fighting, or staged as it appears. Other photos from the same sequence have been published elsewhere. The Pz.Kpfw.II is quite unique as it is an Ausf.b, of which only 25 were produced. The 7.Panzer-Division emblem is visible in front of the national cross and on the front of the superstructure.

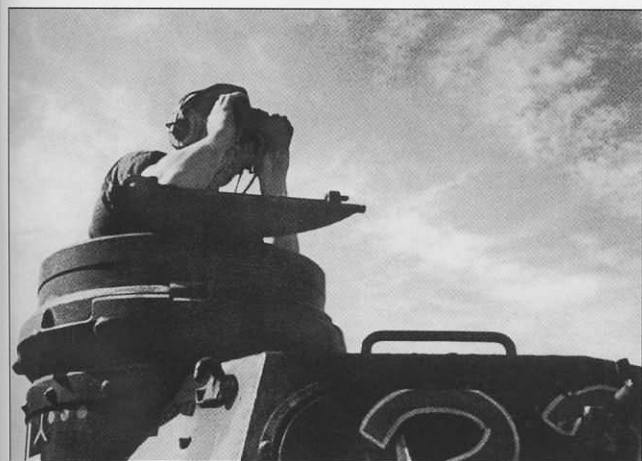
A star is born! This Pz.Kpfw.IV commander is playing a role in "Sieg im Westen" by peering through his binoculars at something in the distance. The photo shows very clearly the emblem for 7.Panzer-Division on the cupola bulge, painted in yellow, and the red and white tactical numbers. A portion of the "balkankreuz" national insignia is also visible.

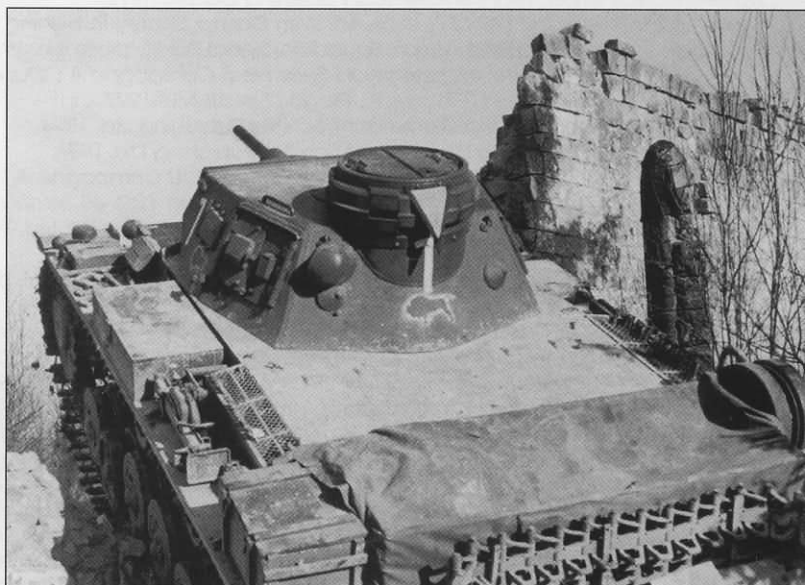
Prominently displaying the bison marking of Pz.Rgt.7 from 10.Panzer-Division, a Pz.Kpfw.III Ausf.G takes part in an exercise in France after the capitulation. With a tactical number "1" and an unidentified pennant hanging through one of the cupola vision slits, this is invariably a command vehicle. The pennant appears to be yellow or orange with a black outline. The stowage box mounted on the fender is similar to the one seen in a previous photograph so was probably a unit wide modification. The national marking is applied to the side of the box.

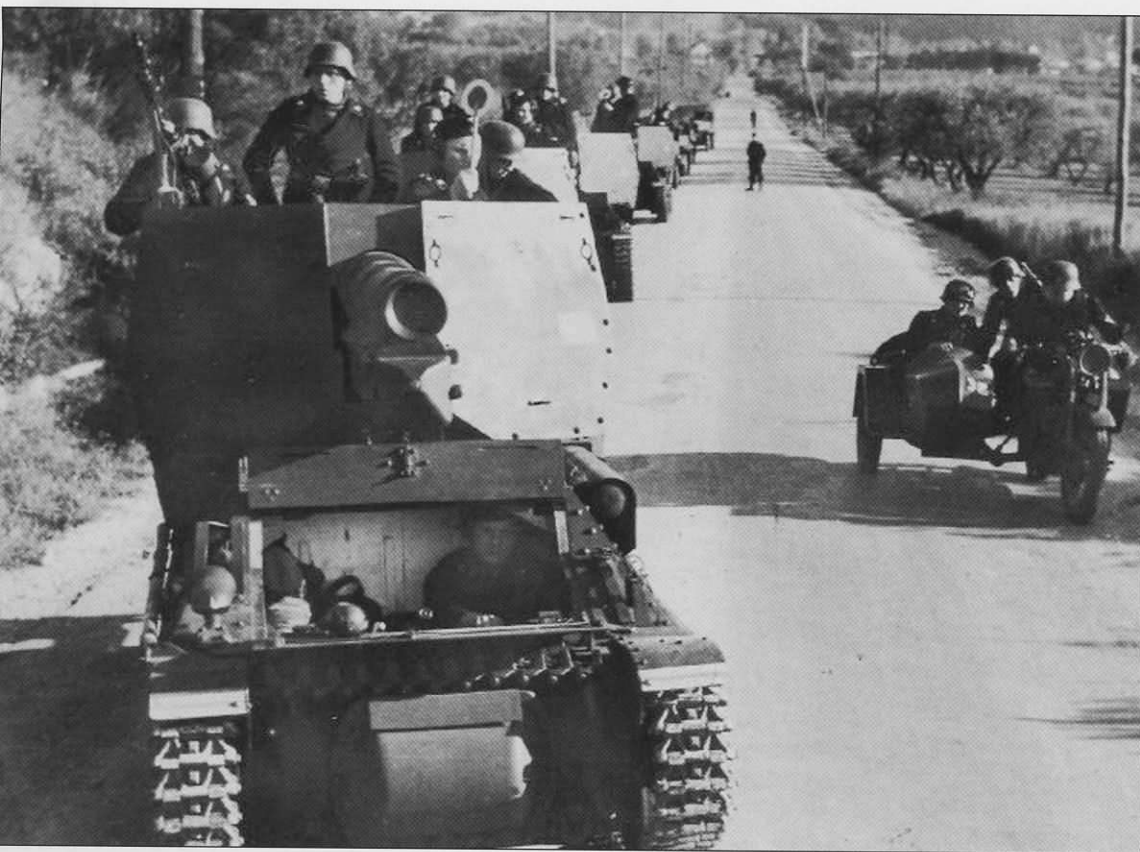
The spoils of victory. With the defeat of the Allied forces, the Wehrmacht inherited a vast array of tanks and vehicles that could be used by German units, and many would eventually see service until the end of the war. An ambitious program of conversion work was also undertaken to make full use of obsolete or unneeded equipment. One of the successful conversions was mounting the 15cm sFH 13 L/17 howitzer on the French Lorraine Schlepper, designated the Sd.Kfz.135/1. This photograph of a column stopped somewhere in France was probably taken in late 1942 or 1943, during a training exercise. Thirty 15cm Lorraine Schleppers went to Rommel's Afrika Korps, while the remaining 64 went to units stationed in France and eventually saw action when the Allies invaded in 1944. Of interest is the MG34 AA machine gun, which is seldom, if ever, seen in photographs of these vehicles.
